**Tree Inventory and Preservation Plan
2225 Erin Mills Parkway
Mississauga, Ontario**

**Dunpar
105 Six Point Road
Etobicoke, Ontario M8Z 2X3**

24 March 2023

KUNTZ FORESTRY CONSULTING INC. Project P3638

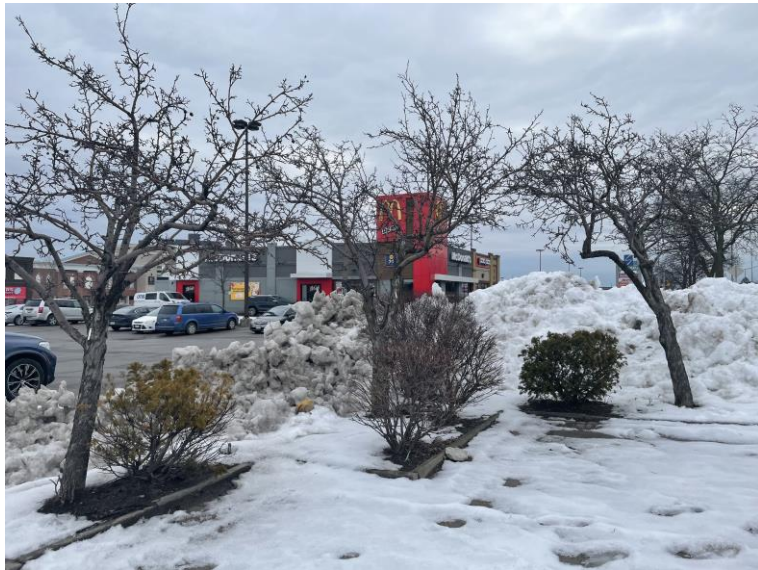
Image 1. From right to left, Trees 836 – 838

836	Apple species	<i>Malus spp.</i>	11.5, 10	15	FG	FG	FG		2.0	1.5	Lean (L), union at 1.3m, pruning wounds (L), asymmetrical crown (L)	Preserve	Subject Site	-
837	Apple species	<i>Malus spp.</i>	12.5, 11	16.5	G	FG	FG		2.0	1.5	Union at 1m, pruning wounds (L), asymmetrical crown (L)	Preserve	Subject Site	-
838	Apple species	<i>Malus spp.</i>	12	-	FG	G	FG		2.0	1.5	Lean (L)	Preserve	Subject Site	-
839	Thornless Honey Locust	<i>Gleditsia triacanthos</i> var. <i>inermis</i>	15	-	G	G	FG		2.5	1.5	Pruning wounds (L)	Preserve	Subject Site	-
840	Thornless Honey Locust	<i>Gleditsia triacanthos</i> var. <i>inermis</i>	15	-	G	G	FG		2.5	1.5		Preserve	Subject Site	-
841	Thornless Honey Locust	<i>Gleditsia triacanthos</i> var. <i>inermis</i>	17	-	FG	F	F		2.5	1.5	Stem wounds (L) at base, epicormic branching (M)	Preserve	Subject Site	-
842	Thornless Honey Locust	<i>Gleditsia triacanthos</i> var. <i>inermis</i>	25.5	-	FG	FG	FG		3.5	1.8	Poor unions	Preserve	Subject Site	-

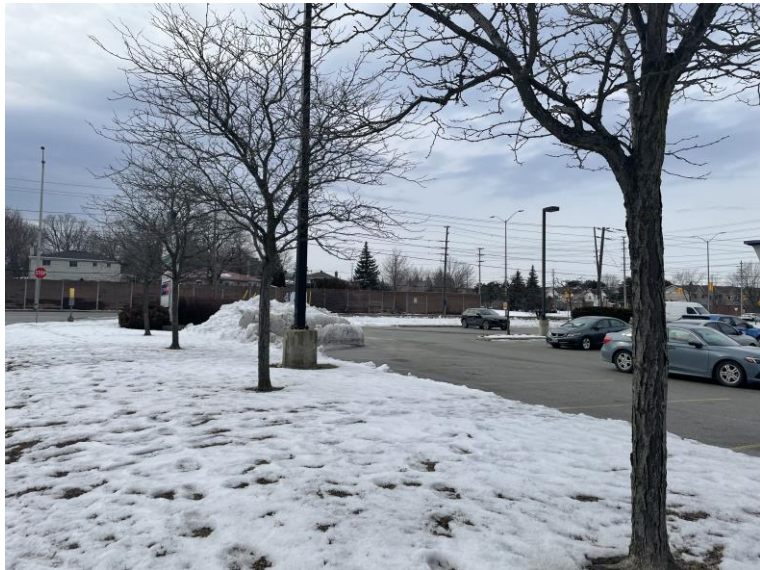
Image 3. From near to far, Trees 843 – 846

Encroachment into the mTPZs of Trees 843 – 846 will be required to accommodate the construction of the proposed vehicular access within the Zone A subject area. If the following mitigation measures are employed, long-term adverse effects are not anticipated for these trees.

843	Thornless Honey Locust	<i>Gleditsia triacanthos</i> var. <i>inermis</i>	17	-	G	FG	F		3.0	1.5	Epicormic branching (L)	Injure	Subject Site	-
844	Thornless Honey Locust	<i>Gleditsia triacanthos</i> var. <i>inermis</i>	16	-	G	FG	F		3.0	1.5	Epicormic branching (L)	Injure	Subject Site	-

845	Thornless Honey Locust	<i>Gleditsia triacanthos</i> var. <i>inermis</i>	15.5	-	G	FG	F		3.0	1.5	Epicormic branching (L)	Injure	Subject Site	-
846	Thornless Honey Locust	<i>Gleditsia triacanthos</i> var. <i>inermis</i>	15.5	-	F	FG	F		3.0	1.5	Epicormic branching (L), stem wounds (L), bow (L)	Injure	Subject Site	-
847	White Oak	<i>Quercus alba</i>	13	-	F	FG	F		3.0	1.5	Epicormic branching (L), pruning wounds (L), lean (L), one lost leader at base	Remove	Subject Site	1
848	Thornless Honey Locust	<i>Gleditsia triacanthos</i> var. <i>inermis</i>	10.5	-	G	FG	F		2.5	1.5	Epicormic branching (L)	Remove	Subject Site	1
849	Apple species	<i>Malus spp.</i>	8.5	-	G	FG	F		2.0	1.2	Epicormic branching (L)	Remove	City	1
850	Apple species	<i>Malus spp.</i>	15	-	FG	FG	F		2.5	1.5	Epicormic branching (L), lean (L)	Remove	City	1
851	Apple species	<i>Malus spp.</i>	9.5	-	FG	FG	F		2.0	1.2	Epicormic branching (L), poor unions	Remove	City	1

1. Tree preservation fencing must be installed, as depicted on Figure 1, prior to the commencement of the proposed works and maintained throughout construction.
2. Low-pressure hydro-vac or air-spade technology should be used to excavate trenches, under the supervision of a Certified Arborist, at the anticipated limit of excavation for the proposed vehicular access curb within the mTPZs of these trees, as indicated on Figure 1 with solid cyan.

3. The depth of the trenches adjacent to the proposed vehicular access will depend on the depth of excavation required to install the proposed curb.
4. The roots of these trees are to be pruned inside the trenches by a Certified Arborist in accordance with Good Arboricultural Standards.
5. The trenches are to be backfilled with clean topsoil.
6. All works to occur within the mTPZs of these trees should be supervised by a Certified Arborist in accordance with Good Arboricultural Standards.

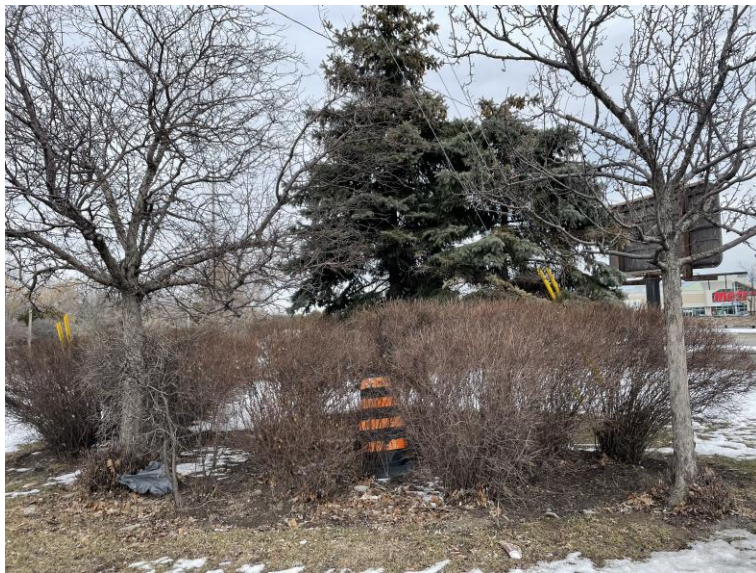
Image 7. From right to left, Trees 852, 854, 855, and 853

852	Apple species	<i>Malus spp.</i>	13	-	F	FG	F		2.5	1.5	Epicormic branching (L), lean (L), decay (L) in trunk	Remove	City	1
853	Apple species	<i>Malus spp.</i>	18	-	F	F	F		3.0	1.5	Epicormic branching (L), poor unions, multiple branch attachments	Remove	City	2
854	Blue Spruce	<i>Picea pungens</i>	18	-	G	FG	F	20	2.0	1.5	Epicormic branching (L), deadwood (L)	Remove	City	2
855	Blue Spruce	<i>Picea pungens</i>	22	-	G	G	G		2.5	1.8		Remove	City	2
856	White Mulberry	<i>Morus alba</i>	6 - 14	-	F	F	F	20	3.0	1.5	Average DBH = ~10cm, v-union at base, included branches, deadwood (L), epicormic branching (M)	Remove	City	1
857	Apple species	<i>Malus spp.</i>	14.5	-	F	F	F		3.0	1.5	Stem wounds (M), epicormic branching (L), bow (L), asymmetrical crown (L)	Remove	City	1
858	Norway Maple	<i>Acer platanoides</i>	19	-	G	F	F	30	3.5	1.5	Deadwood (M)	Remove	City	2
859	Blue Spruce	<i>Picea pungens</i>	22	-	G	F	F	20	2.0	1.8	Deadwood (L), epicormic branching (L)	Remove	City	2

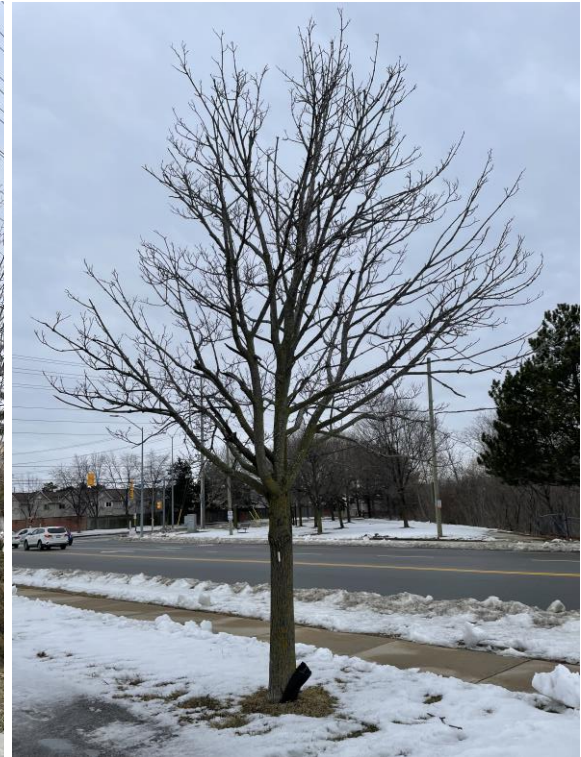
Image 11. Tree 862

860	Blue Spruce	<i>Picea pungens</i>	21	-	G	F	F	20	2.0	1.8	Deadwood (L), epicormic branching (L)	Remove	City	2
861	Apple species	<i>Malus spp.</i>	~10	-	G	PF	F		1.5	1.5	Epicormic branching (H) at base	Remove	City	1
862	Norway Maple	<i>Acer platanoides</i>	21	-	PF	F	PF	20	2.5	1.8	Girdling roots (H), deadwood (L)	Remove	City	2
863	Blue Spruce	<i>Picea pungens</i>	24	-	FG	PF	PF	10	2.5	1.8	Epicormic branching (M), deadwood (L), crook (L)	Remove	City	2
864	Blue Spruce	<i>Picea pungens</i>	18	-	FG	PF	PF	30	2.5	1.5	Epicormic branching (M), deadwood (M), lean (L)	Remove	City	2
865	Serviceberry species	<i>Amelanchier sp.</i>	~3	-	G	G	G		0.5	1.2		Remove	City	1
866	Japanese Flowering Lilac	<i>Syringa reticulata</i>	~3	-	G	G	G		0.5	1.2		Remove	City	1
867	Serviceberry species	<i>Amelanchier sp.</i>	~3	-	G	G	G		0.5	1.2		Remove	City	1

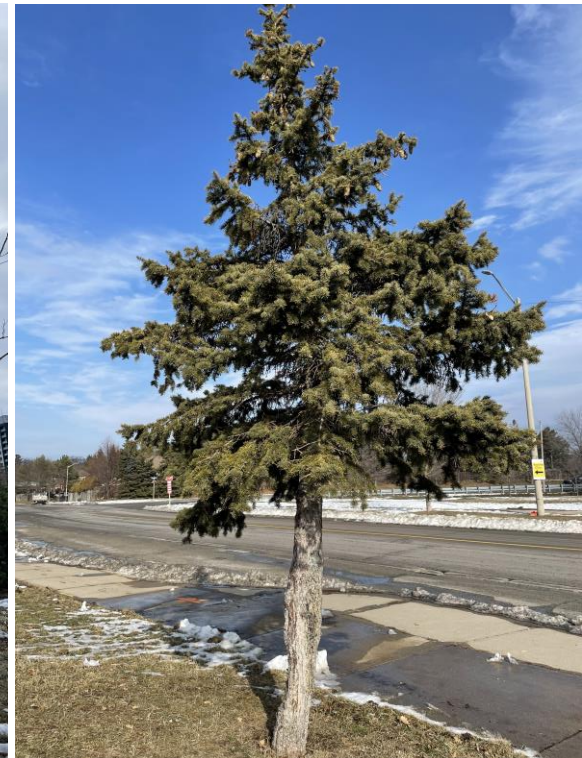
Image 29. Tree 801

Tree #	Common Name	Scientific Name	DBH	Calculated DBH for Multistem Trees	TI	CS	CV	CDB	DL	mTPZ	Comments	Action	Owner	# Rep.
800	Norway Maple	<i>Acer platanoides</i>	24	-	G	FG	F	20	2.5	1.8	Deadwood (L)	Remove	Subject Site	2
801	Blue Spruce	<i>Picea pungens</i>	18.5	-	P	F	P	10	1.5	1.5	Deadwood (L), stem wounds (H), epicormic branching (L)	Remove	Subject Site	2
802	Norway Maple	<i>Acer platanoides</i>	22.5	-	G	G	F		3.5	1.8		Remove	Subject Site	2
803	Norway Maple	<i>Acer platanoides</i>	18.5	-	F	PF	PF	30	2.5	1.5	Asymmetrical crown (L), crook (L), seam (L), deadwood (M)	Remove	Subject Site	2
804	Norway Maple	<i>Acer platanoides</i>	25	-	FG	PF	PF	30	3.5	1.8	Asymmetrical crown (L), sweep (L), multiple branch attachments, deadwood (M)	Remove	Subject Site	2
805	Thornless Honey Locust	<i>Gleditsia triacanthos</i> var. <i>inermis</i>	16.5	-	G	FG	F		3.0	1.5	Epicormic branching (L)	Remove	Subject Site	2
806	Thornless Honey Locust	<i>Gleditsia triacanthos</i> var. <i>inermis</i>	18	-	G	G	F		3.0	1.5		Remove	Subject Site	2
