ARBORIST REPORT

PROPOSED RESIDENTIAL DEVELOPMENT NORTHEAST OF DOUG LEAVENS BOULEVARD & LISGAR DRIVE MISSISSAUGA

November 14, 2023

**Revised – February 27, 2024
(As Per New Draft Plan)**

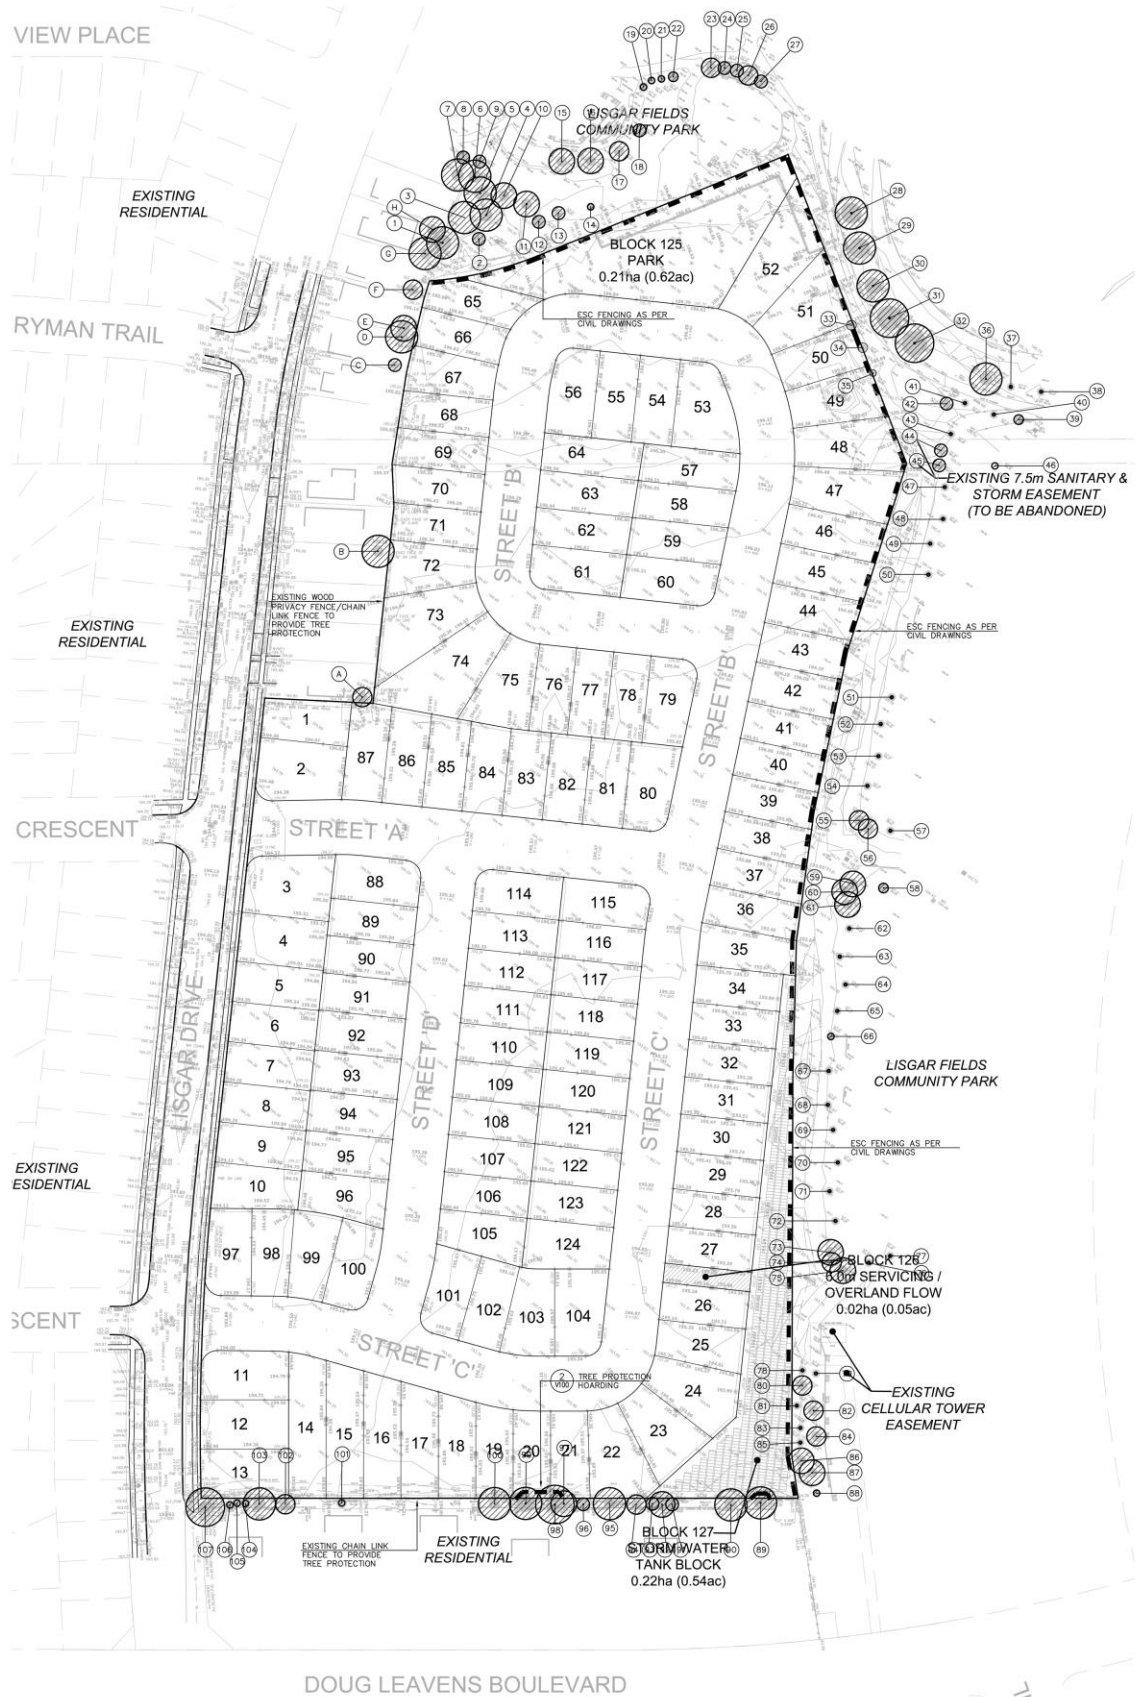
APPENDIX A – CONTEXTUAL TREE INVENTORY & PRESERVATION PLAN (for context only)

There are no trees within the subject site with the exception of three, recently planted Kentucky Coffee Trees (Tree# 33-35) which flank the parkland walkway. Based on the surveyed location, Tree# 33 & 34 have been planted within the subject lands or along the boundary and tree# 35 is within 300mm of the property. These trees will interfere with the proposed lot grading and fence requirements. Since these trees were recently planted, it is recommended that they be transplanted further into the parkland by the Parks Department so that they do not interfere with the development construction works. All other trees are located within the adjacent residential lots and parkland and are to be retained.

Existing wood privacy fences and chain link fences flank the existing rear lots. These fences will provide adequate tree protection for the neighbouring trees. Where the minimum tree protection zone (TPZ) of a neighbouring tree encroaches into the subject site, City approved tree protection hoarding is to be installed to that limit. Further, erosion control fencing will be required along the perimeter of the property as per the Civil plans. This fencing will provide adequate protection for the adjacent parkland trees where there are no TPZ encroachments.

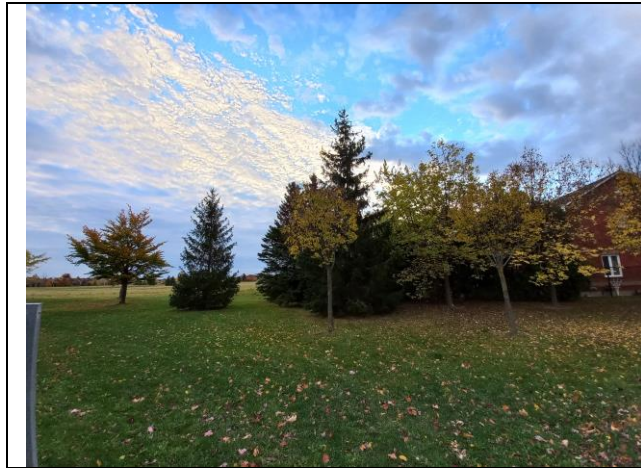
Northwest corner of site (view from existing park looking southwest)

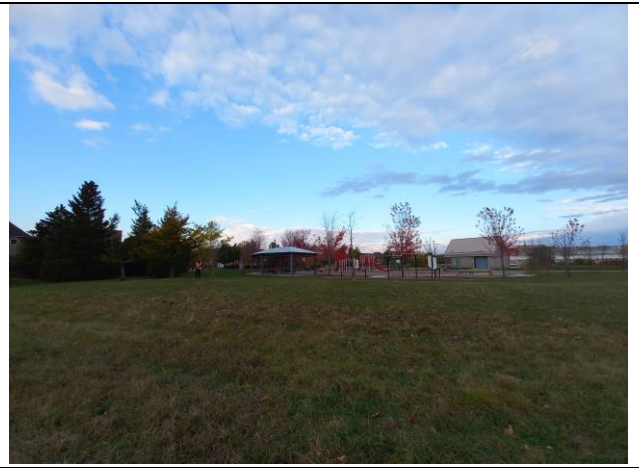
North end of site (view north into existing playground)

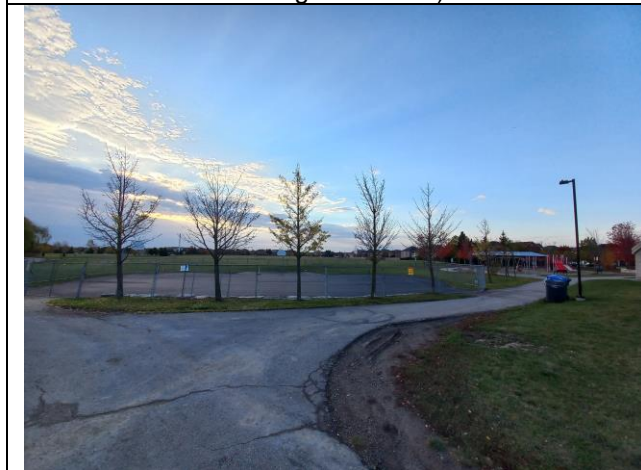
Northwest corner of site (view from existing park looking south)

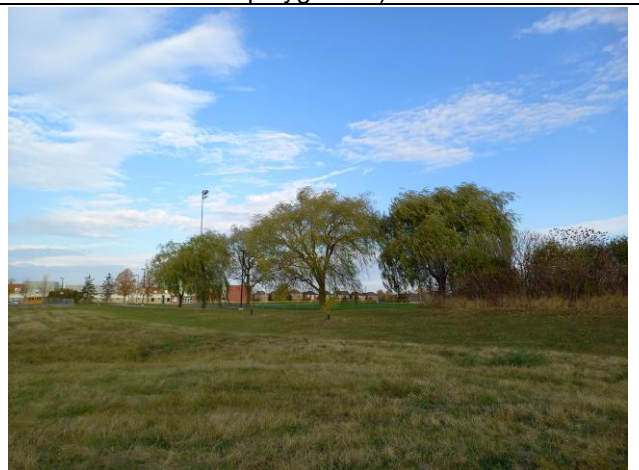
View northeast from site

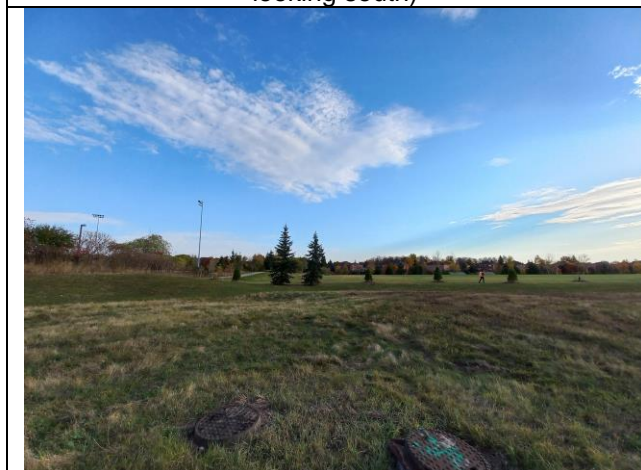
View east from site

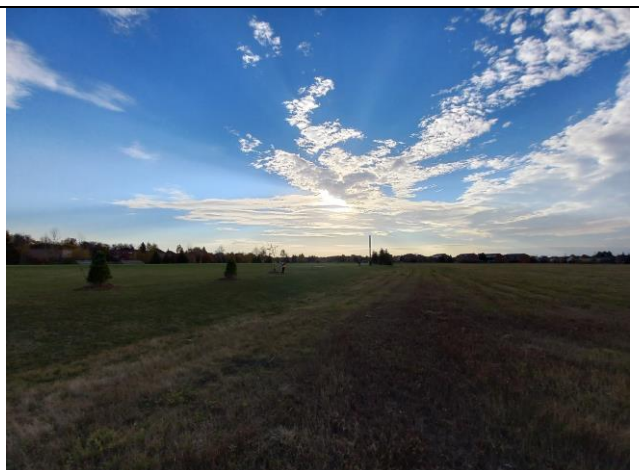
View south from east side of site

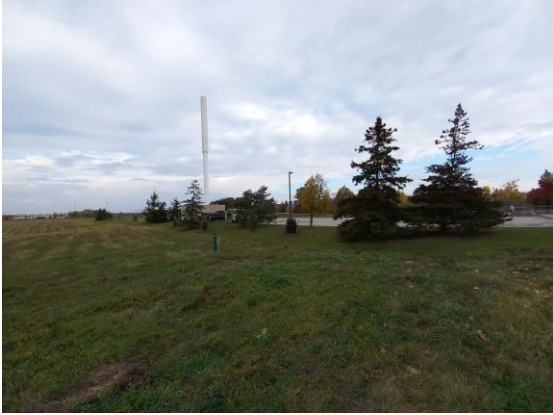
Southeast corner of site (view north)

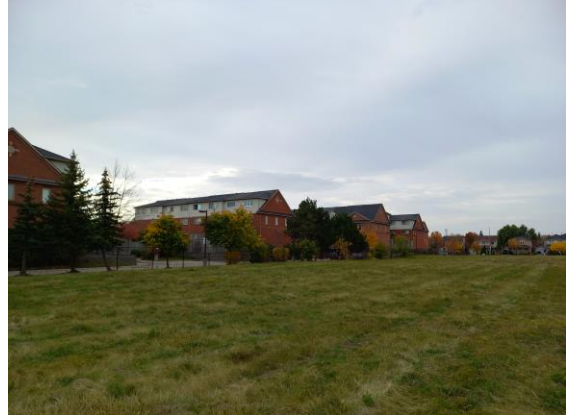
South side of site (view southwest)
