## **ARBORIST REPORT**

**PROPOSED MIXED-USE DEVELOPMENT  
142-148 QUEEN STREET SOUTH  
CITY OF MISSISSAUGA**

**ISA CERTIFIED ARBORIST  
MATTHEW GEHRES  
ISA# ON-1114A  
OUR PROJECT NO:  
5903**

**REVISED May 15, 2024 – AS PER CITY COMMENTS**

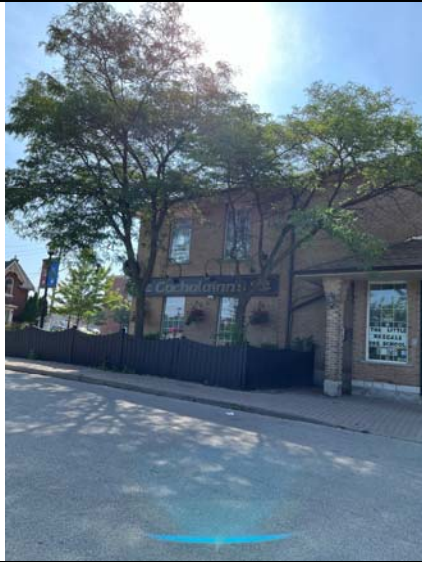
**Tree# 371 & 372**

EXISTING TREE INVENTORY										
KEY	SPECIES	DBH (cm)	CROWN (m)	HEALTH G/F/P	STRUCTURE	COMMENTS	PRESERVATION DIRECTION	OWNERSHIP	MIN. TPZ (m)	KEY
371	Honey Locust	21	6	Fair	One-sided	Leaning, crowded by adjacent tree, adjacent to building, rootzone covered with concrete	Remove	Private	1.8	371
372	Honey Locust	30	8	Fair	Irregular	Leaning, crowded by adjacent tree, adjacent to building, rootzone covered with concrete, double leader	Remove	Private	2.4	372
373	Siberian Elm	26	6	Fair	One-sided	Crowded by adjacent tree, adjacent to fence, vine entangled	Remove	Private	1.8	373
374	Black Walnut	31	8	Good	Irregular	Crowded by over head wire, broken branches, crowded by adjacent tree	Preserve*	Boundary	2.4	374
375	Black Walnut	19	4	Fair	Irregular	Crowded by over head wire, crowded by adjacent tree	Preserve*	Boundary	1.8	375
376	Crabapple	11-21	8	Fair	Multi-stem	4 stems, crowded by adjacent tree	Preserve*	Boundary	1.8	376

KEY	SPECIES	CALIPER (cm)	HEALTH G/F/P	REASON	STATUS	OWNERSHIP	COMPENSATION
371	Honey Locust	21	Fair	Construction, Servicing & Grading	Remove	Private	1
372	Honey Locust	30	Fair	Construction, Servicing & Grading	Remove	Private	2
373	Siberian Elm	26	Fair	Construction, Servicing & Grading	Remove	Boundary	2
374	Black Walnut	31	Good	Construction, Servicing & Grading	**Remove	Boundary	2
375	Black Walnut	19	Fair	Construction, Servicing & Grading	**Remove	Boundary	1
376	Crabapple	11-21	Fair	Construction, Servicing & Grading	**Remove	Boundary	1
377	Manitoba Maple	24	Poor	Construction, Servicing & Grading	**Remove	Boundary	0
378	Manitoba Maple	24	Poor	Construction, Servicing & Grading	**Remove	Boundary	0
379	Manitoba Maple	16-20	Poor	Construction, Servicing & Grading	**Remove	Boundary	0
380	Manitoba Maple	13-17	Poor	Construction, Servicing & Grading	**Remove	Boundary	0
381	Manitoba Maple	51-24	Poor	Construction, Servicing & Grading	**Remove	Boundary	0

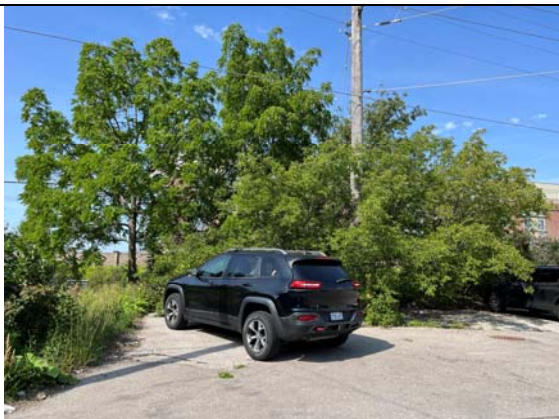
**Tree# 374-379**

377	Manitoba Maple	24	6	Poor	Leaning	Crowded by over head wire, crowded by adjacent tree, double leader	Preserve*	Boundary	1.8	377
378	Manitoba Maple	24	6	Poor	Leaning	Crowded by adjacent tree, adjacent to building, crowded by overhead wire	Preserve*	Boundary	1.8	378
379	Manitoba Maple	16-20	8	Poor	Multi-stem	4 stems, crowded by adjacent tree, adjacent to building, crowded by overhead wire, crowded braching, decay at base	Preserve*	Boundary	1.8	379
380	Manitoba Maple	13-17	6	Poor	Multi-stem	3 stems, major prune at 0.3m, decay at base, epicormic growth, crowded by overhead wire	Preserve*	Boundary	1.8	380
381	Manitoba Maple	51-24	8	Poor	Multi-stem	2 stems, epicormic growth, crowded by overhead wire	Preserve*	Boundary	1.8	381
382	Manitoba Maple	19-26	8	Poor	Multi-stem	4 stems, epicormic growth, minor deadwood, poor pruning, crowded by overhead wire	Preserve*	Boundary	1.8	382
383	Manitoba Maple	12-22	8	Fair	Group	7 stems, crowded by adjacent tree, epicormic growth, broken branches, crowded by overhead wire	Remove	Private	1.8	383

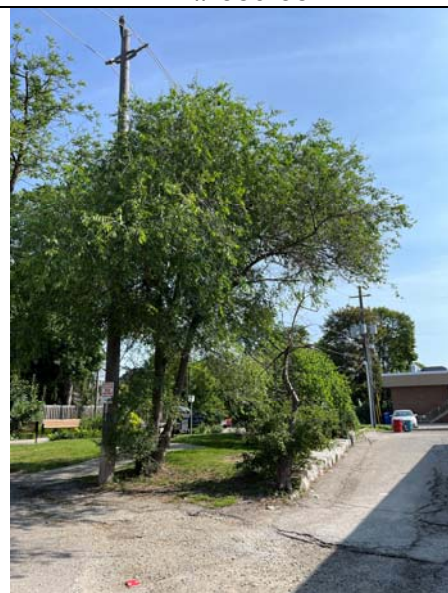
**Tree# 384**

384	Siberian Elm	18-27	8	Fair	Multi-stem	3 stems, basal decay, major deadwood, poor pruning, crowded by overhead wire	Preserve	Parkland	1.8	384
385	Linden	18	5	Fair	Irregular	Minor broken branches, girdling roots	Remove	Private	1.8	385
386	Linden	18	5	Fair	Irregular	Minor broken branches, exposed roots	Remove	Private	1.8	386
387	Linden	21	5	Fair	Irregular	Minor broken branches, girdling roots, cross branching	Remove	Private	1.8	387
388	Linden	26	6	Fair	Irregular	Adjacent to building, crowded branching, cross branching, broken branches	Remove	Private	1.8	388
389	Honey Locust	17	6	Good	One-sided	Crowded by adjacent tree, crowded branching	Remove	Private	1.8	389
390	Honey Locust	24	8	Good	One-sided	Crowded by adjacent tree, crowded branching	Remove	Private	1.8	390
391	Colorado Spruce	22	6	Poor	Pyramidal	Decilining, major deadwood, dead leader	Remove	Private	1.8	391
392	Red Maple	14	6	Fair	Irregular	Crowded by over head wire, girdling roots	Remove	Exempt	1.8	392

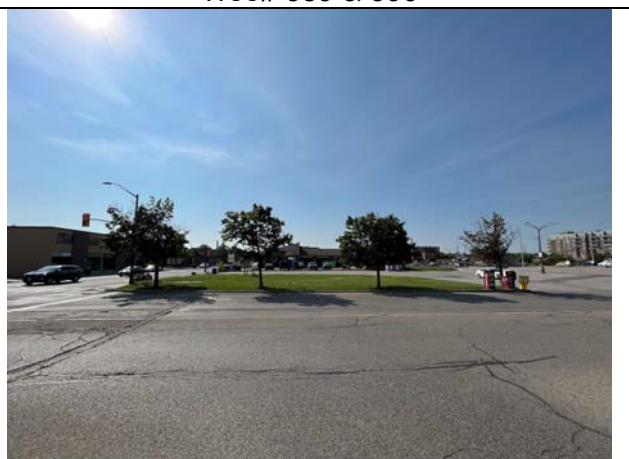
Tree# 393-396

393	Red Maple	16	4	Poor	One-sided	Major dieback, leaning, declining	Remove	Private	1.8	393
394	Red Maple	18	6	Fair	Irregular	Crowded branching, cross branching	Remove	Private	1.8	394
395	Red Maple	16	4	Poor	Irregular	Mechanical damage at base, open wound, minor bark peeling	Remove	Private	1.8	395
396	Red Maple	22	6	Fair	One-sided	Major deadwood, epicormic growth, declining	Remove	Private	1.8	396
397	Red Maple	20	6	Fair	One-sided	Crowded by over head wire, cross branching, girdling roots, double leader	Remove	Private	1.8	397
398	Red Maple	16	5	Poor	Irregular	Excessive dieback throughout	Remove	Private	1.8	398
399	Red Maple	7	2	Dead			Remove	Exempt	1.2	399
400	Red Maple	23	6	Fair	Irregular	Poor Pruning, broken branches, mionr deadwood, girdling roots, exposed roots	Remove	Private	1.8	400
401	Red Maple	22	5	Fair	Irregular	Poor Pruning, broken branches, mionr deadwood, girdling roots, exposed roots	Remove	Private	1.8	401

KEY	SPECIES	CALIPER (cm)	HEALTH G/F/P	REASON	STATUS	OWNERSHIP	COMPENSATION
383	Manitoba Maple	12-22	Fair	Construction, Servicing & Grading	Remove	Private	2
385	Linden	18	Fair	Construction, Servicing & Grading	Remove	Private	1
386	Linden	18	Fair	Construction, Servicing & Grading	Remove	Private	1
387	Linden	21	Fair	Construction, Servicing & Grading	Remove	Private	1
388	Linden	26	Fair	Construction, Servicing & Grading	Remove	Private	2
389	Honey Locust	17	Good	Construction, Servicing & Grading	Remove	Private	1
390	Honey Locust	24	Good	Construction, Servicing & Grading	Remove	Private	2
391	Colorado Spruce	22	Poor	Construction, Servicing & Grading	Remove	Private	0
393	Red Maple	16	Poor	Construction, Servicing & Grading	Remove	Private	0
394	Red Maple	18	Fair	Construction, Servicing & Grading	Remove	Private	1
395	Red Maple	16	Poor	Construction, Servicing & Grading	Remove	Private	0
396	Red Maple	22	Fair	Construction, Servicing & Grading	Remove	Private	1

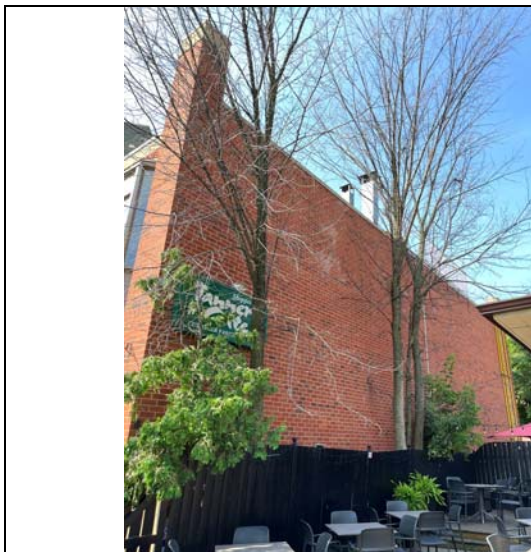
Tree# 403 & 404

403	Siberian Elm	22	6	Dead			Preserve*	Neighbour	1.8	403
404	Siberian Elm	24	6	Dead			Preserve*	Neighbour	1.8	404
405	Red Maple	12	4	Good	Symetrical	Boulevard tree, frost damage, double leader	Preserve	Municipal	1.5	405
406	Red Maple	9	4	Good	Symetrical	Boulevard tree, frost damage, broken branches	Preserve	Municipal	1.2	406
407	Red Maple	9	4	Good	Symetrical	Boulevard tree, open wound on trunk, broken branches	Preserve	Municipal	1.2	407
408	Red Maple	9	4	Fair	Symetrical	Boulevard tree, mechanical damage on trunk	Preserve	Municipal	1.2	408
409	Norway Maple	26	8	Poor	One-sided	Double leader, crowded by adjacent tree, adjacent to fence	Preserve	Neighbour	1.8	409
410	Manitoba Maple	18-23	6	Fair	Double Stem	2 stems, crowded by adjacent tree, adjacent to fence	Preserve	Neighbour	1.8	410
411	Norway Maple	24	6	Fair	Irregular	Crowded by adjacent tree, adjacent to fence, double leader, minor deadwood, broken branches	Preserve	Neighbour	1.8	411

397	Red Maple	20	Fair	Construction, Servicing & Grading	Remove	Private	1
398	Red Maple	16	Poor	Construction, Servicing & Grading	Remove	Private	0
400	Red Maple	23	Fair	Construction, Servicing & Grading	Remove	Private	2
401	Red Maple	22	Fair	Construction, Servicing & Grading	Remove	Private	1
403	Siberian Elm	22	Dead	Dead	**Remove	Neighbour	0
404	Siberian Elm	24	Dead	Dead	**Remove	Neighbour	0
423	Colorado Spruce	21	Poor	Construction, Servicing & Grading	Remove	Private	0

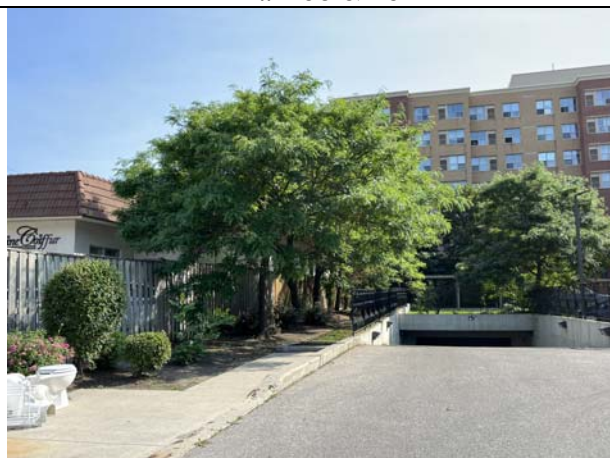
Tree# 410-418

412	Norway Maple	26	8	good	Irregular	Crowded by adjacent tree, adjacent to fence, double leader, minor deadwood, broken branches	Preserve	Neighbour	1.8	412
413	White Spruce	24	8	Fair	Pyramidal	Crowded by adjacent tree, adjacent to fence, branching to grade	Preserve	Neighbour	1.8	413
414	Honey Locust	20	8	Fair	One-sided	Crowded by adjacent tree, adjacent to fence, adjacent to building, double leader	Preserve	Neighbour	1.5	414
415	Norway Spruce	18-20 3 stems > 15cm	4	Fair	Group	3 stems, one sided form, adjacent to building, branching to grade	Preserve	Neighbour	1.5	415
416	Honey Locust	23	6	Fair	One-sided	Adjacent to building, crowded by adjacent tree, leaning	Preserve	Neighbour	1.8	416
417	Honey Locust	24	6	Good	Irregular	Adjacent to fence, crowded by adjacent tree	Preserve	Neighbour	1.8	417
418	Honey Locust	19	6	Good	Irregular	Adjacent to fence, crowded by adjacent tree	Preserve	Neighbour	1.5	418

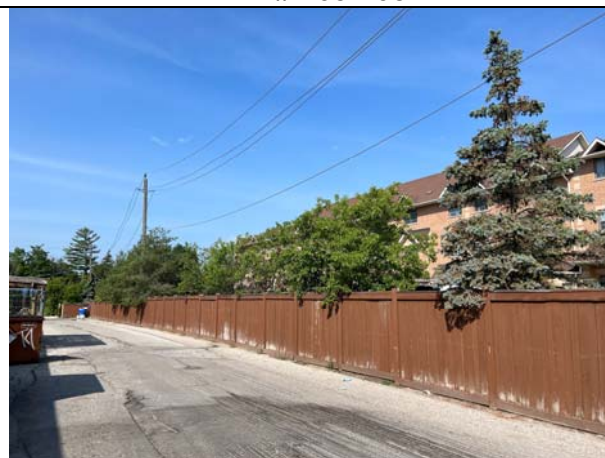
Tree# 419-423

419	Colorado Spruce	16	4	Fair	Pyramidal	Branching to grade, adjacent to fence, crowded by overhead wire, minor deadwood, exposed roots, dieback in lower branches	Preserve	Neighbour	1.5	419
420	Magnolia	8-9	3	Good	Group	5 stems, leaning, adjacent to fence	Preserve	Boundary	1.2	420
421	Scots Pine	16-18 4 stems > 15cm	5	Good	Group	4 stems, crowded by adjacent tree, dieback in lower branches	Preserve	Boundary	1.5	421
422	Crabapple	12-14	4	Fair	Group	4 stems, epicormic growth, frost crack on trunk, exposed roots	Preserve	Boundary	1.5	422
423	Colorado Spruce	21	5	Poor	Pyramidal	Major deadwood, declining, adjacent to fence, crowded by overhead wire	Remove	Private	1.8	423
