# Arborist Report

## 51 & 57 Tannery Street and 208 Emby Avenue City of Mississauga

*Prepared For:*  
**NYX Tannery LP**

*Prepared By:*  
**Beacon Environmental Limited**

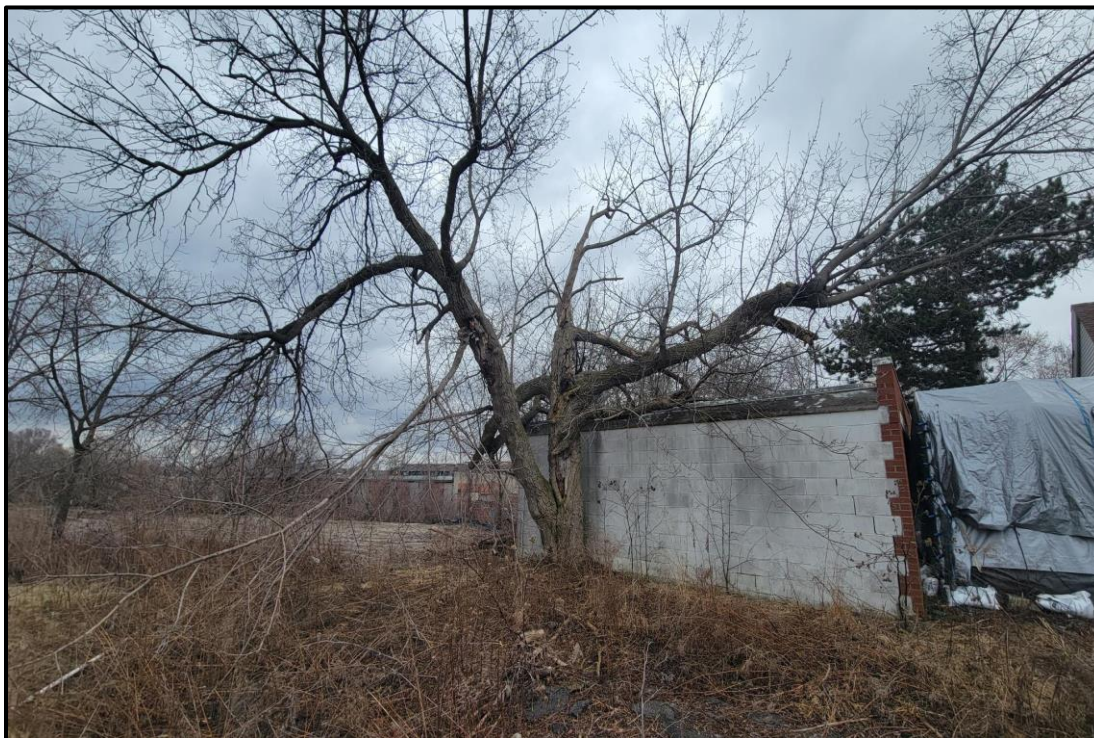
**Photograph 1. Tree 467 (March 2024)**

In addition, one tree (#467), located on adjacent private property, is recommended for removal due to poor structural condition and potential risk. One trunk leans toward the subject property and the other leans over a garage on the adjacent property. The tree exhibits branch and leader dieback,

broken/hanging branches, large patches of missing bark, and extensive trunk decay (**Photograph 1**). Permission from the adjacent property owner must be obtained in order to remove the tree.

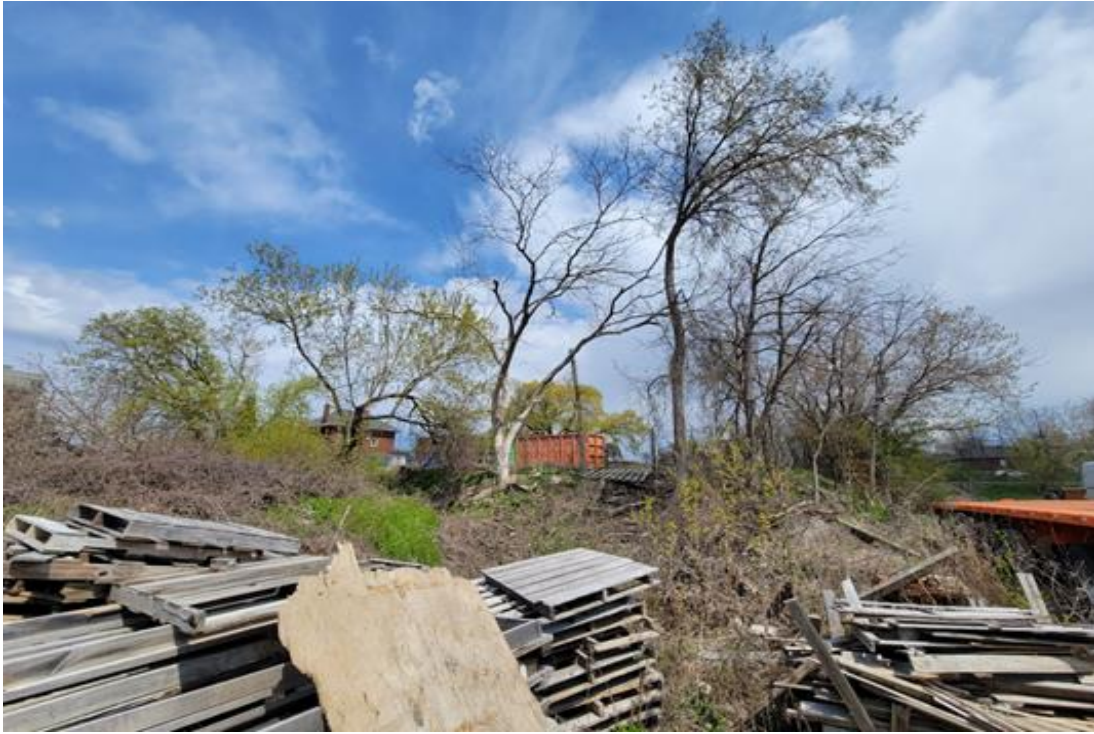
**Photograph 1. View of trees (355-375) looking northeast toward residence (March 25, 2022)**

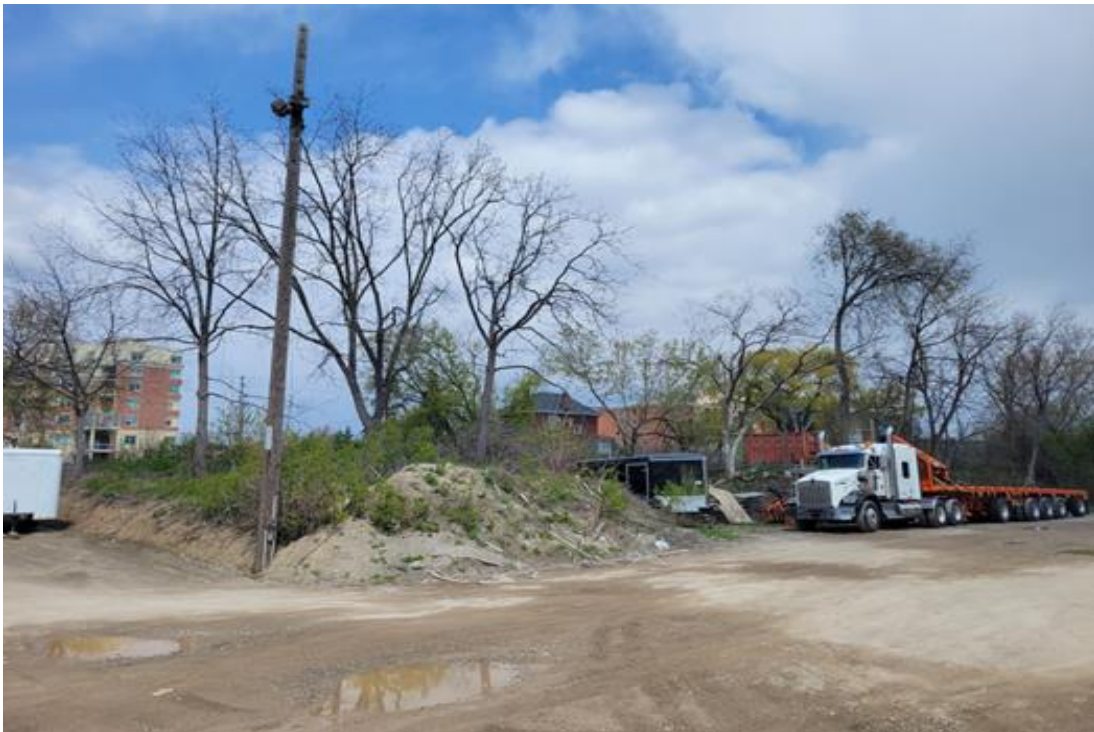
**Photograph 2. View of trees (447, 449, and 451) looking northeast (March 25, 2022)**

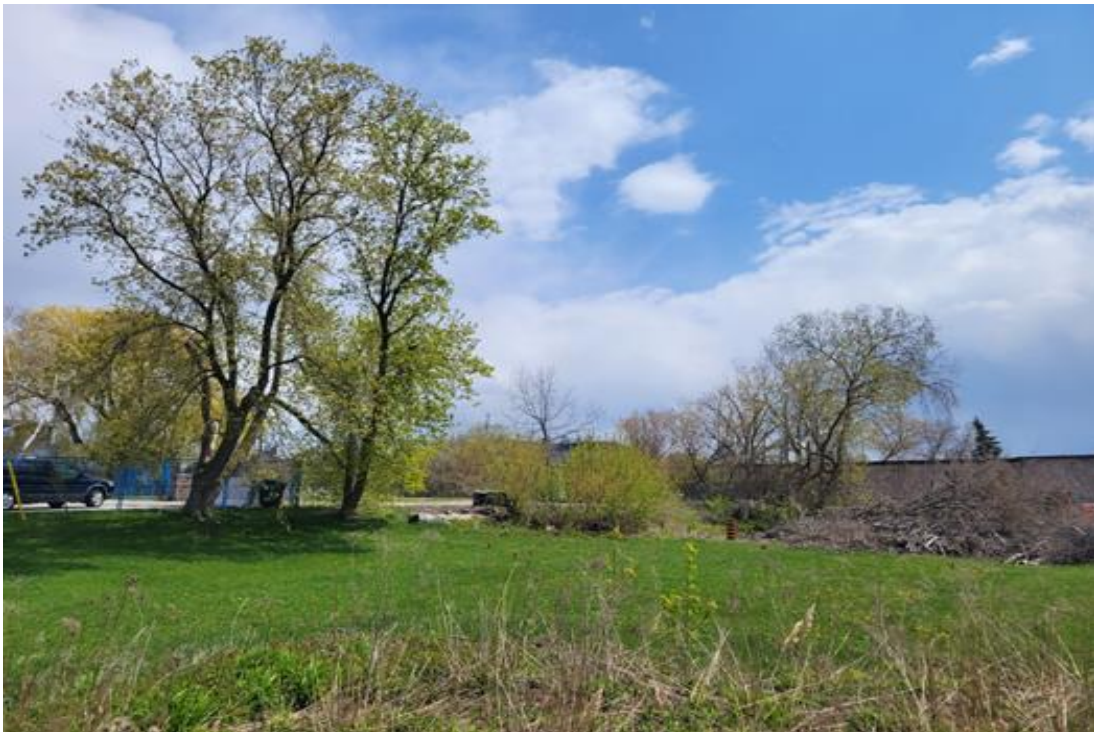
**Photograph 4. View of trees looking northeast (355 and 356 in foreground)**

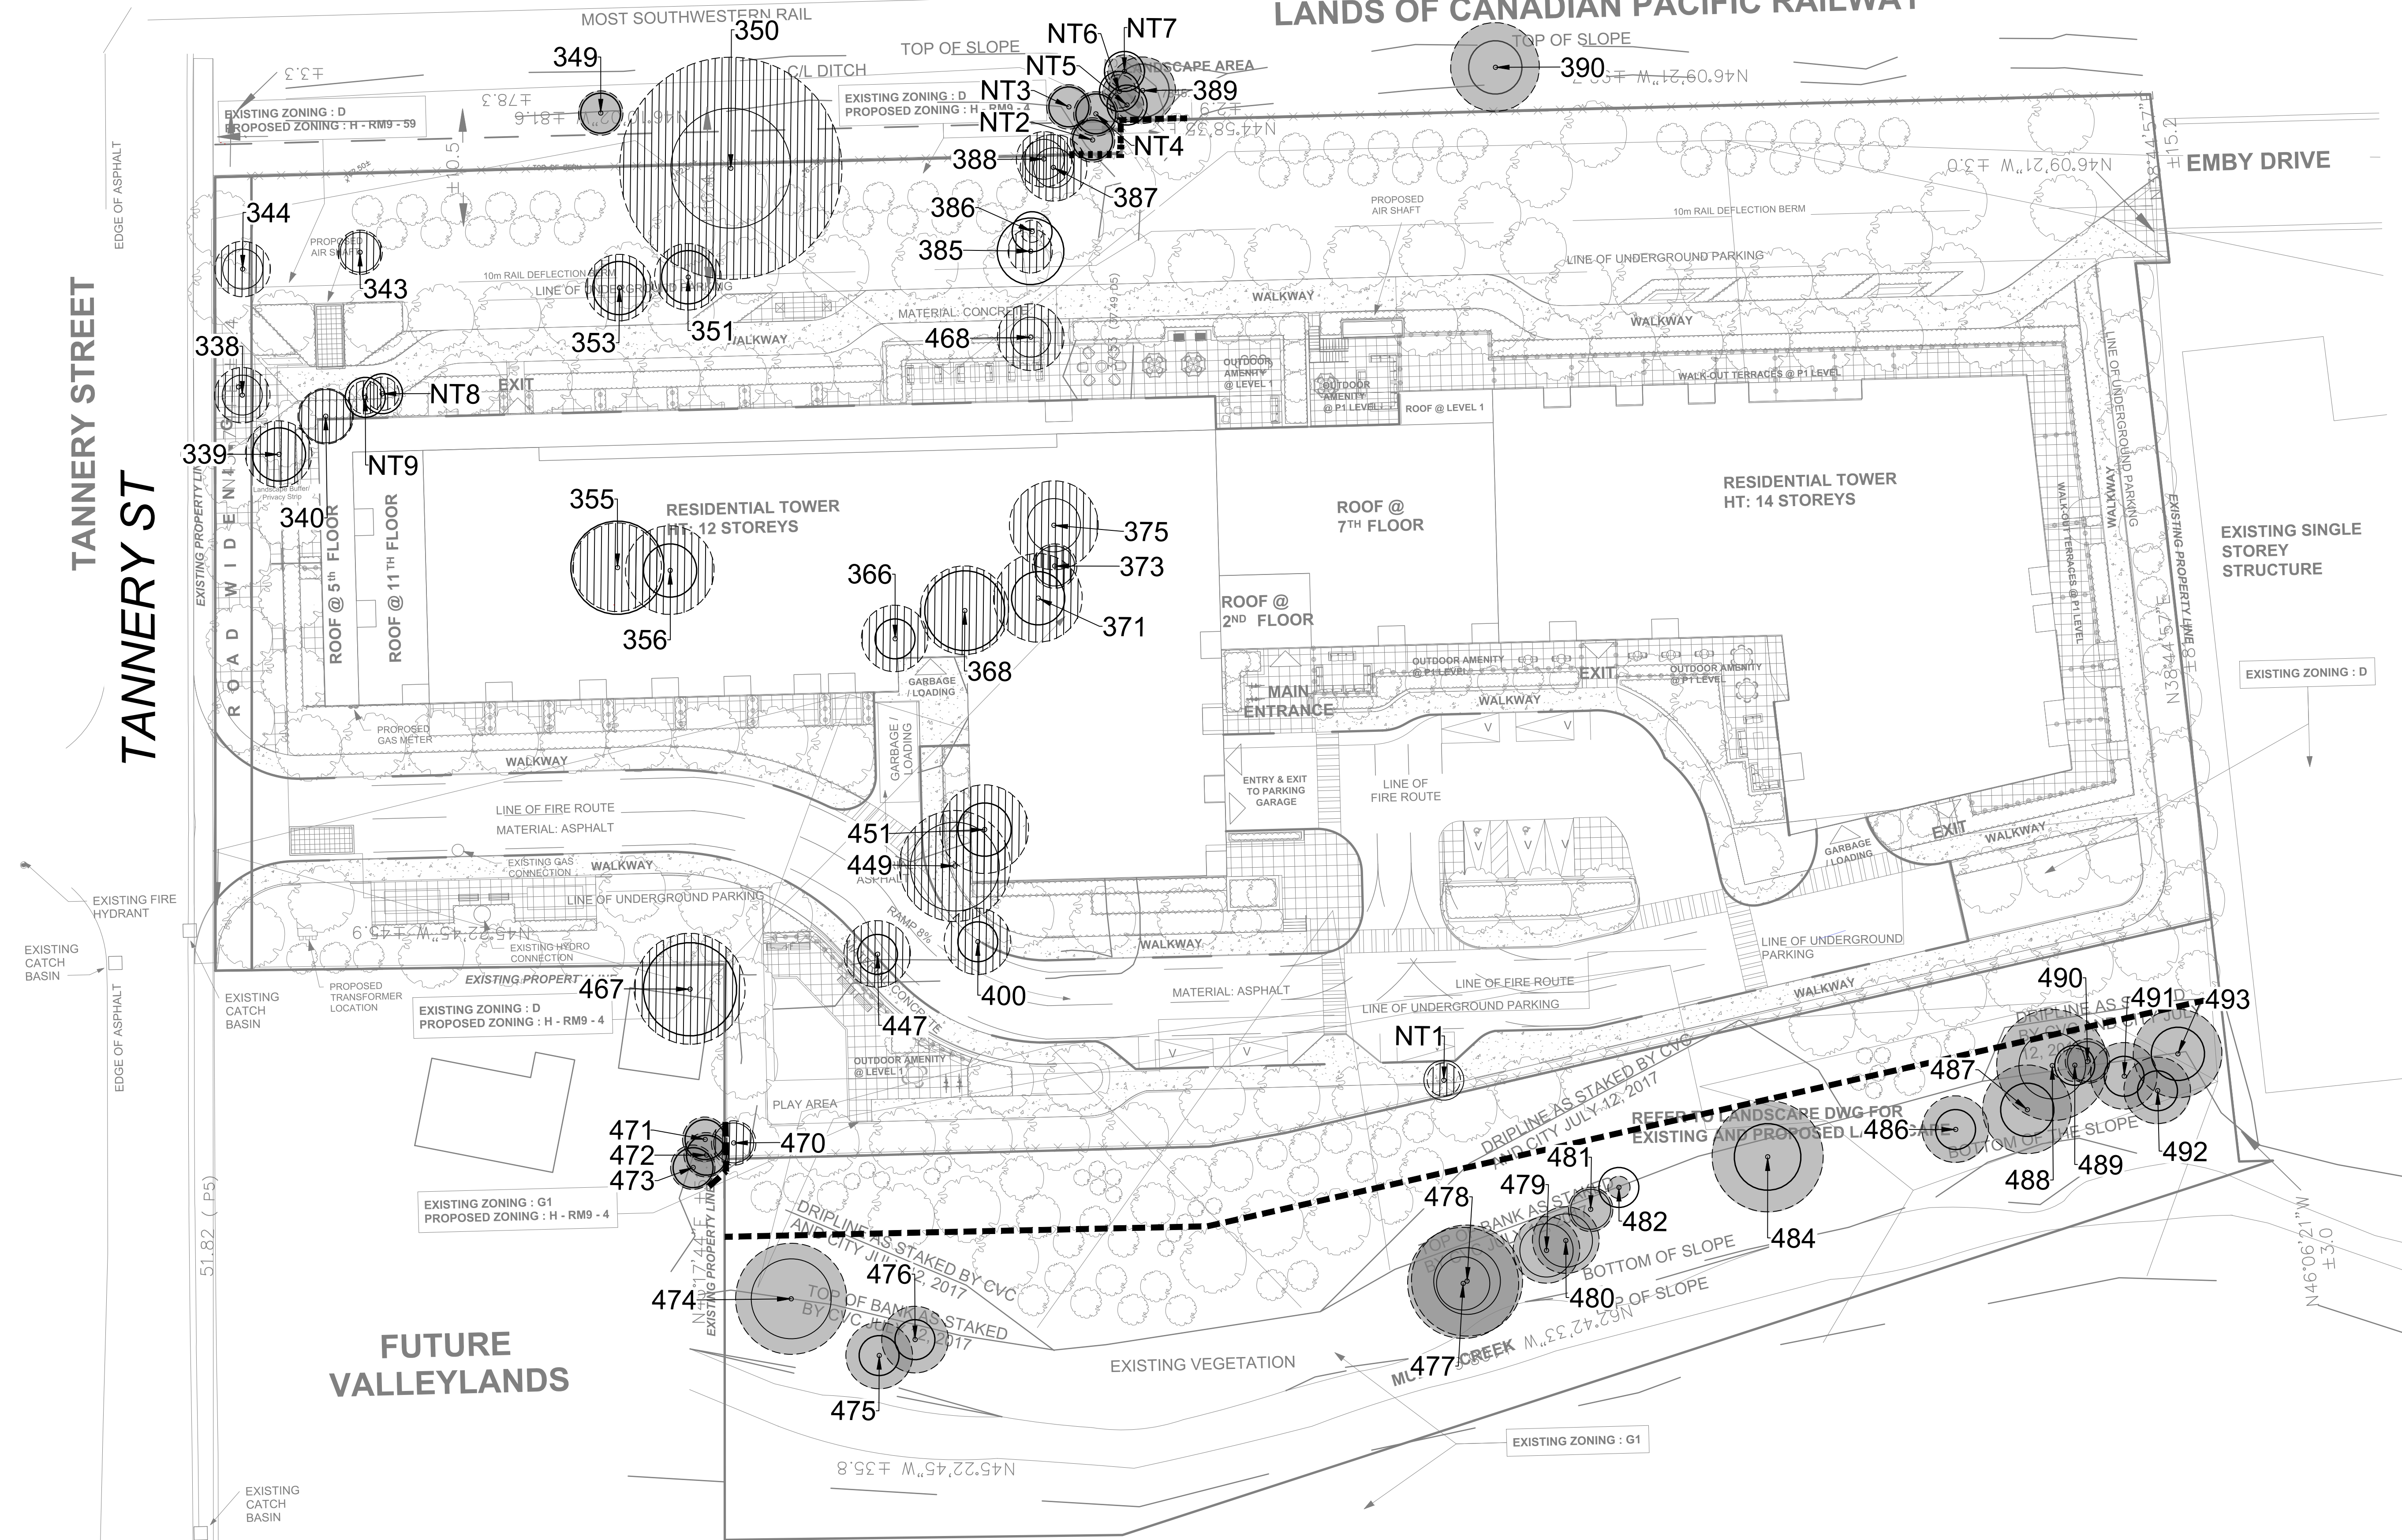
DESIGN BY: --	PROJECT N°: 217069
DRAWN BY: JA	FIGURE N°:
CHECKED BY: DW	<b>TP-1</b>
DATE: 29 April 2024

Based on the most recent assessment (March 2024), 61 trees were inventoried on and adjacent to the subject property. Tree locations are illustrated in **Drawing TP-1 (Appendix C)**. A summary of the trees is provided in **Drawing TP-2 (Appendix C)**. Of the 61 trees, 50 are located on the subject property, seven are located on the adjacent CNR property, and four are located on adjacent private property.

A total of 29 trees are recommended for removal to accommodate the proposed re-development (see **TP-1 and TP-2**), of which 17 are in fair or good condition, nine (9) are in poor condition, four (2) are in fair-poor condition, and one is dead.

A total of 32 trees are identified for preservation (see **Drawings TP-1 and TP-2**), primarily along Mullet Creek in the southern portion of the property and along the CPR Railway to the north.

The TPZ should be demarcated with tree protection hoarding consisting of solid wood hoarding as per City of Mississauga specifications or an alternative approved by the City. The location of tree protection hoarding and design specifications are illustrated **Drawings TP-1** and **TP-2**. Hoarding should be installed before any construction or site alteration takes place.
