**S2S PROJECT NO. 11398**

**MILANI GROUP**

**PHASE I ENVIRONMENTAL SITE ASSESSMENT**

**1489 HURONTARIO STREET  
MISSISSAUGA, ONTARIO**

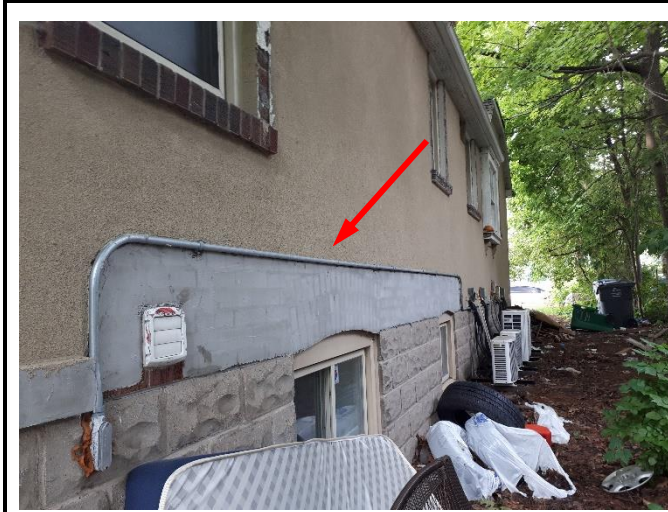
**Photo 1: View of a portion of the north elevation (see arrow) of the Subject Building, looking west.**

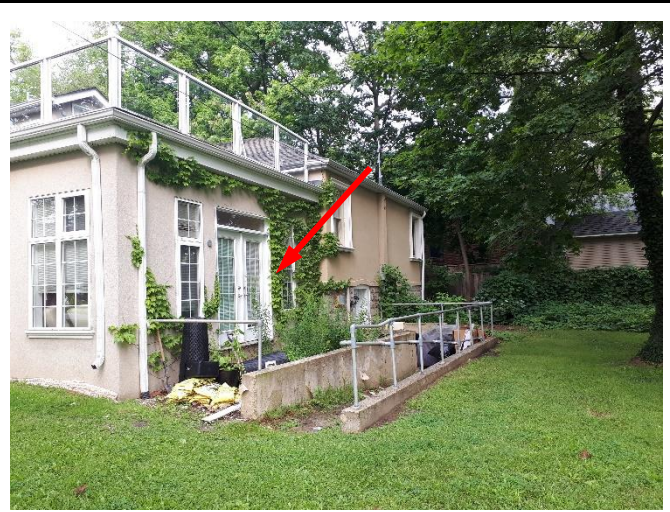
**Photo 2: View of a portion of the east elevation (see arrow) of the Subject Building, looking northwest.**

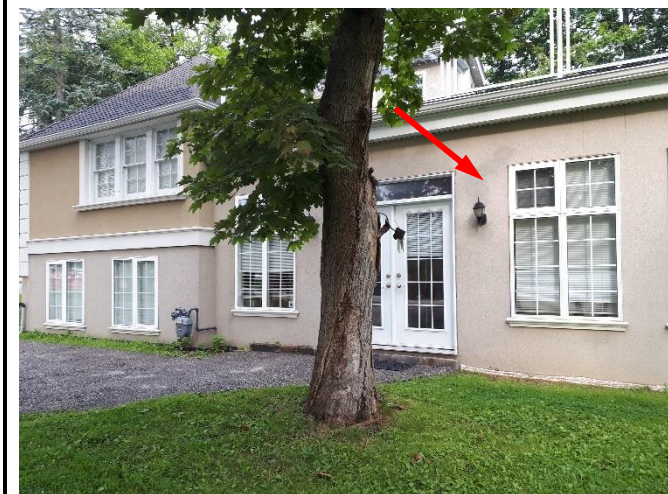
**Photo 3: View of a portion of the south elevation (see arrow) of the Subject Building, looking northwest.**

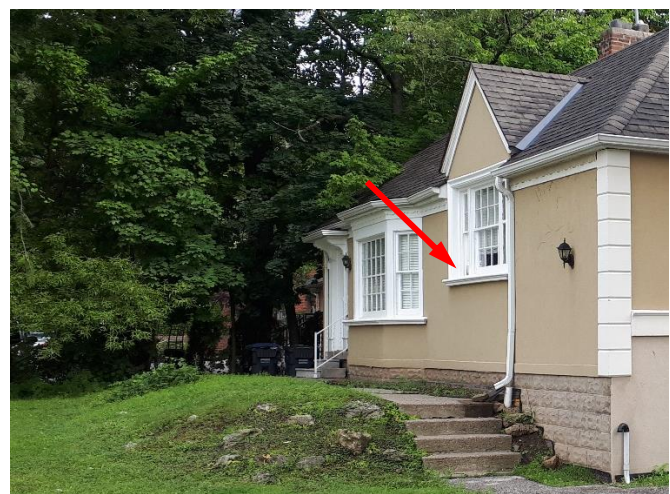
**Photo 4: View of a portion of the west elevation (see arrow) of the Subject Building, looking northeast.**

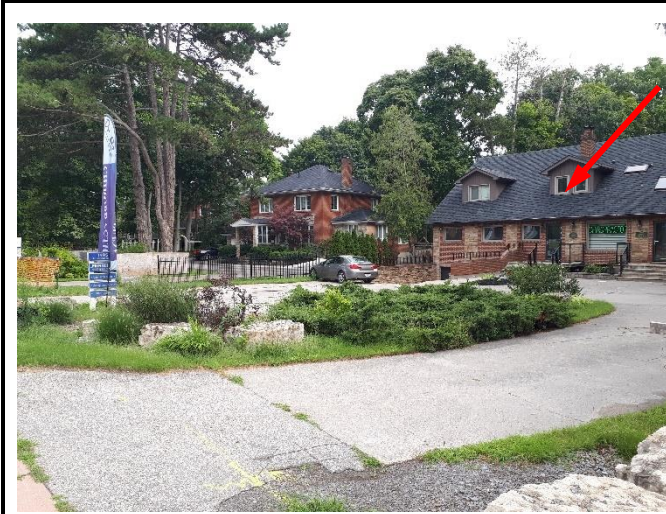
**Photo 5: View of a portion of the adjacent residential/commercial property (see arrow), located to the north of the Subject Property, looking northeast.**

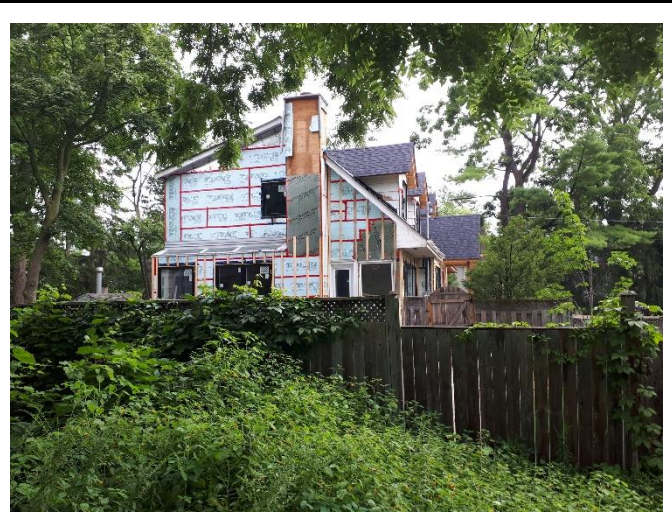
**Photo 6: View of a portion of the adjacent single-family residential home, located to the east of the Subject Property, looking east.**

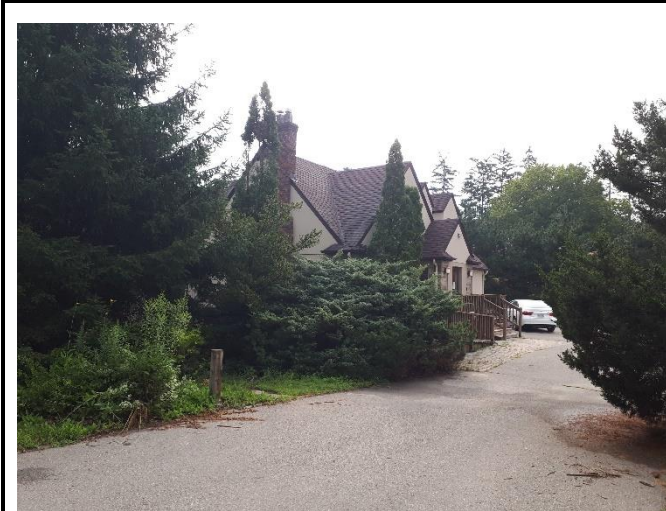
**Photo 7: View of a portion of the neighbouring residential/commercial property, located to the south (across Pinewood trail) of the Subject Property, looking southeast.**

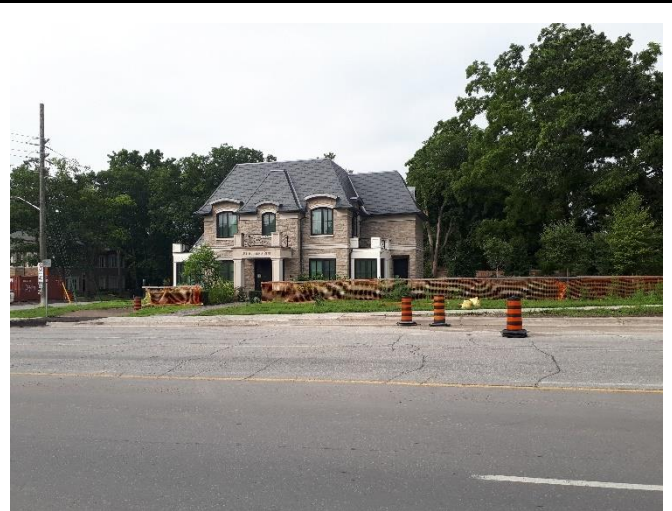
**Photo 8: View of a portion of the neighbouring residential/commercial property, located to the west (across Hurontario Street) of the Subject Property, looking west.**

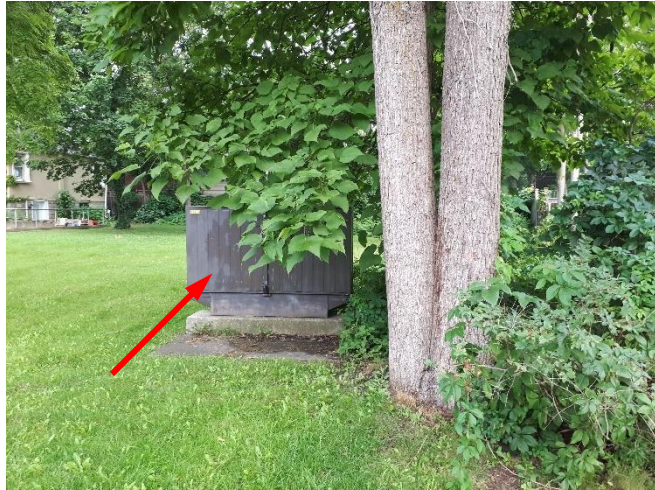
An undetermined number of fluorescent light fixtures were present at the Subject Property. A concrete pad-mounted transformer was observed on the southeast portion of the Subject Property. No obvious visual evidence of significant spills or staining was identified in the vicinity of the transformer. Dry-type (air-cooled) transformers were also observed on the Subject Property; however, the dry-type transformers would not contain oils/PCBs.

**Photo 9: View of the concrete pad mounted transformer (see arrow) located on the southeast portion of the Subject Property.**

There were no environmental concerns noted with respect to PCBs at the Subject Property. If on-site electrical equipment from the Subject Building is being serviced or decommissioned, appropriate testing and inspection of the equipment should be undertaken to determine if PCBs are present.

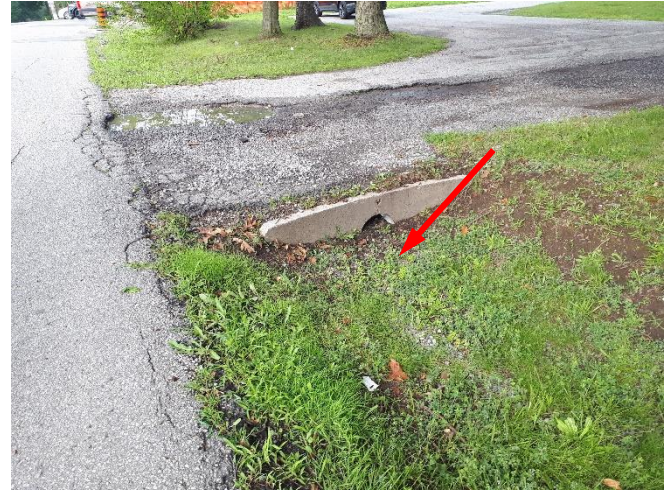
**Photo 10: View of a portion of the drainage ditch (see arrow) located on the south portion of the Subject Property.**

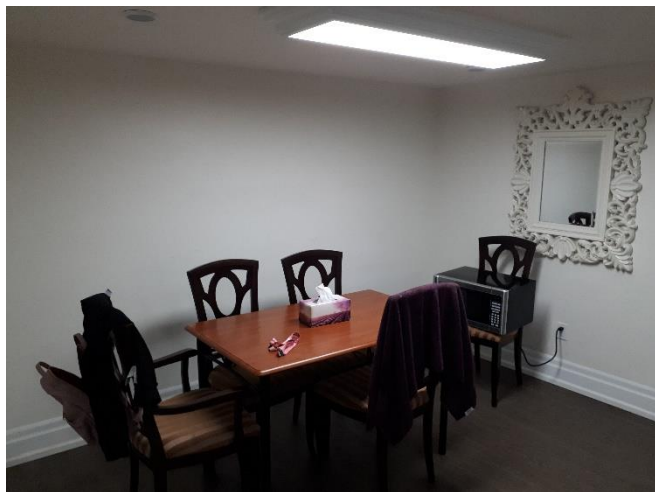
**Photo 11: View of a portion of the interior of the residential space of the Subject Building.**

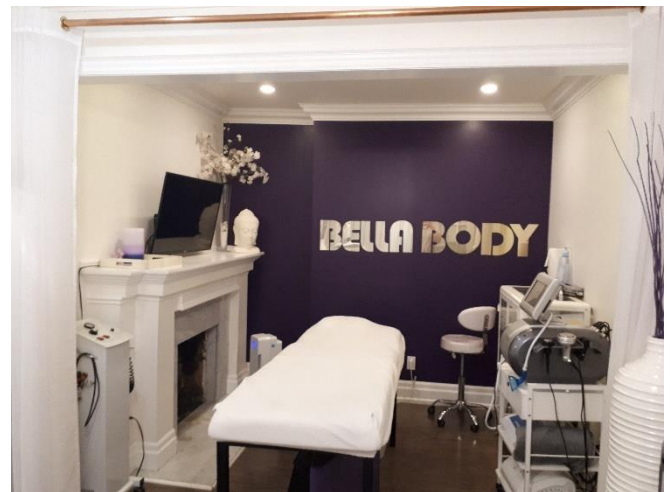
The Subject Building was occupied by a residential living area and a commercial unit. The commercial unit of the Subject Building was occupied by Bella Body (cosmetic procedure clinic). The operations in the Subject Building generally included various health and wellness procedures, and patient care. Based on discussions with Mr. Nicolson, no hazardous wastes were generated in association with the commercial unit.

**Photo 12: View of a portion of the interior of the commercial tenant unit (Bella Body) of the Subject Building.**
