ARBORIST REPORT

**PROPOSED TOWNHOUSE DEVELOPMENT
CITY OF MISSISSAUGA**

SITE LOCATION:
**1489 HURONTARIO STREET
MISSISSAUGA, ONTARIO**

**October 15, 2021
August 26, 2022**

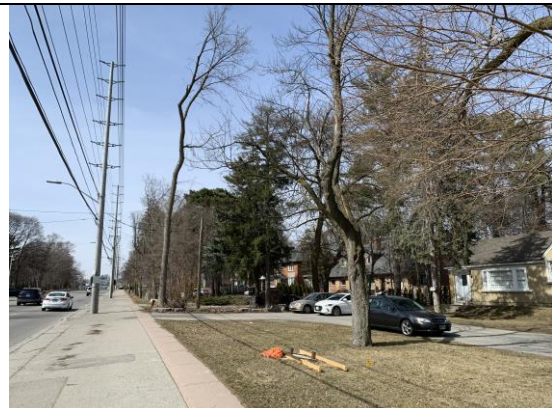
Tree# 45

44	WHITE MULBERRY	75.0	12.0	POOR	IRREGULAR FORM	SIGNIFICANT WOUND ON WEST SIDE OF STEM, CROWN COMPOSED MAINLY OF EPICORMIC SHOOTS WITH DIEBACK THROUGHOUT	REMOVED BY CITY	CITY	4.8	44
45	SILVER MAPLE	52.0	10.0	DEAD			REMOVED BY CITY	CITY	3.6	45
46	COLORADO BLUE SPRUCE	39.0	7.0	FAIR	GOOD FORM	ELEVATED CROWN, BURIED ROOT COLLAR, SOME TWIG TIP DIEBACK THROUGHOUT	REMOVE	PRIVATE	2.4	46
