**Tree Inventory and Preservation Plan
&
Ravine Rehabilitation Stewardship Plan Report
2570 – 2590 Argyle Road
Mississauga, Ontario**

11 May 2023; revised 4 July 2023

KUNTZ FORESTRY CONSULTING INC. Project P3714

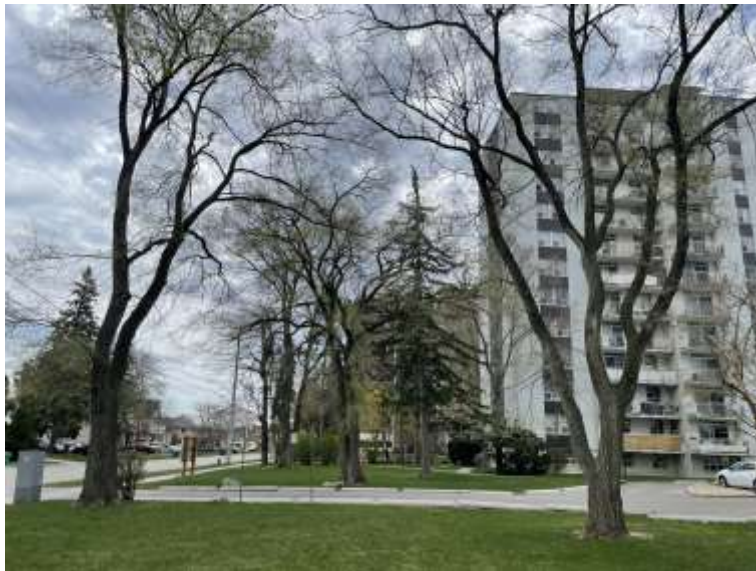
Image 1. Trees 481 (left) and 482 (right)

137	White Ash	<i>Fraxinus americana</i>	11	-	G	FG	FG		2	1.5	Emerald Ash Borer	Subject Site	Preserve	-
138	White Ash	<i>Fraxinus americana</i>	10	-	FG	FG	FG		2	1.5	Emerald Ash Borer	Subject Site	Preserve	-
481	Siberian Elm	<i>Ulmus pumila</i>	70	-	FG	F	F	10	5	4.2	Lean (L), epicormic branching (L), branch fused in crown, broken branches (L), deadwood (L)	Subject Site	Remove (TIPP - Development)	5
482	Siberian Elm	<i>Ulmus pumila</i>	64	-	F	F	F	10	5	4.2	Stem wounds (M), girdling roots (L), lean (L), epicormic branching (M), deadwood (L), broken branches (L)	Subject Site	Remove (TIPP - Development)	5
483	Siberian Elm	<i>Ulmus pumila</i>	52, 34	62	PF	F	F	20	6	4.2	V-union at 0.5m with included bark and one leader cut at union, v-union at 2.5m with included bark, deadwood (L), epicormic branching (L)	Subject Site	Remove (TIPP - Development)	5
484	Green Ash	<i>Fraxinus pennsylvanica</i>	36	-	P	P	P	90	5	2.4	Deadwood (H), lean (L), Emerald Ash Borer (H), moribund	Subject Site	Remove (TIPP - Condition)	3

The removal of three additional trees is recommended regardless of the proposed development due to their poor condition. Trees identified for removal due to their condition include Trees 484, 494, and 1351.

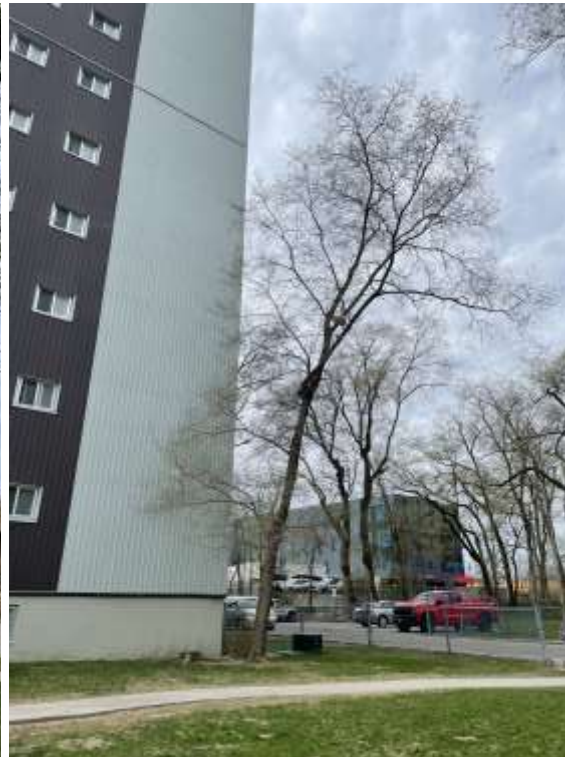
Image 4. Tree 487

Encroachment into the mTPZs of Trees 487 and 490 will be required to accommodate the installation of new curbs and surface parking area / laneway. If the following mitigation measures are employed, long-term adverse effects are not anticipated for these trees.

1. Prior to the commencement of the proposed works, tree preservation fencing is to be installed as depicted in Figure 1.
2. Air-spade or low-pressure hydro-vac technology should be used to excavate trenches in the locations indicated on Figure 1 with solid cyan. The depth of the trenches will depend on the depth of excavation required to install the proposed curbs and surface parking area / laneway.
3. Any roots encountered within the trenches are to be pruned by a Certified Arborist in accordance with Good Arboricultural Standards.
4. The trenches are to be backfilled with clean topsoil.

5. Branches that extend into the proposed development and require pruning should be pruned by a Certified Arborist or other tree professional in accordance with Good Arboricultural Standards.

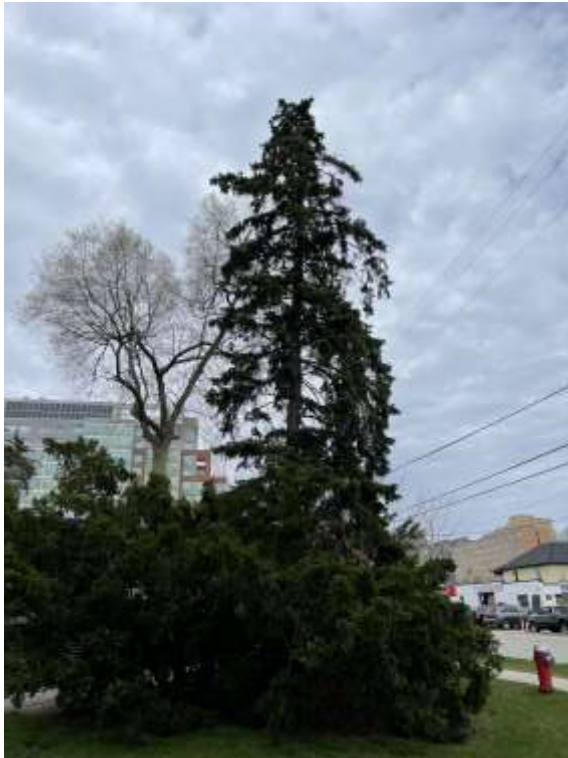
Image 6. Tree 491

491	Blue Spruce	<i>Picea pungens</i>	34	-	G	FG	F	20	2	2.4	Deadwood (L)	Subject Site	Preserve	-
492	Yew species	<i>Taxus sp.</i>	-6 - 10	-	F	F	G		3	1.5	Average DBH = 6cm, broken branches (L), lean (L-H)	Subject Site	Preserve	-
493	Yew species	<i>Taxus sp.</i>	-18, 10	-20.5	FG	FG	G		3	1.5	V-union at base	Subject Site	Preserve	-
494	Weeping White Mulberry	<i>Morus alba</i> 'Pendula'	25	-	P	PF	PF	30	2	1.8	Decay (H) in trunk, cavities (H), deadwood (M), lean (H), poor form (M)	Subject Site	Remove (TIPP - Condition)	2
495	Siberian Elm	<i>Ulmus pumila</i>	81	-	FG	F	F	20	7	5.4	Epicormic branching (M), broken branches (M), pruning wounds (L), deadwood (L), bow (L)	Subject Site	Injure (TIPP - Development)	-
496	Eastern Red Cedar (Juniper)	<i>Juniperus virginiana</i>	25.5	-	F	G	FG		4	1.8	Lean (L), vine competition (M)	Subject Site	Preserve	-
497	Eastern Red Cedar (Juniper)	<i>Juniperus virginiana</i>	24	-	G	G	FG		3	1.8	Vine competition (M)	Subject Site	Preserve	-

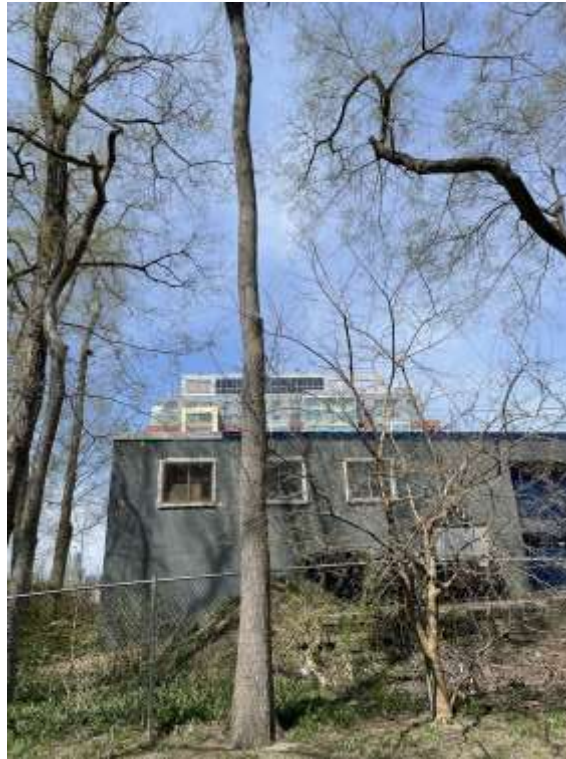
Image 12. Trees 1353 (right) and 1354 (left)

1353	White Mulberry	<i>Morus alba</i>	11.5, 11	16	PF	F	F	10	2	1.5	V-union at 1m with included bark, stem wounds (L), decay (L) in trunk, stem wounds (L)	Shared (Subject Site / Neighbour)	Preserve	-

1354	Siberian Elm	<i>Ulmus pumila</i>	37	-	G	FG	F	10	5	2.4	Deadwood (L)	Shared (Subject Site / Neighbour)	Preserve	-
1355	Siberian Elm	<i>Ulmus pumila</i>	-16	-	F	F	F	10	2	1.5	Included (M) fence, epicormic branching (M), deadwood (L)	Shared (Subject Site / Neighbour)	Preserve	-
1356	Siberian Elm	<i>Ulmus pumila</i>	-32, 20	-37.5	PF	F	F	20	4	2.4	V-union at 0.5m with included bark, included (H) fence, deadwood (L), epicormic branching (L)	Shared (Subject Site / Neighbour)	Preserve	-
1357	Siberian Elm	<i>Ulmus pumila</i>	73	-	F	F	F	10	8	4.8	Deadwood (L), lean (M), epicormic branching (L), broken branches (H)	Subject Site	Injure (TIPP - Development)	-
1358	Siberian Elm	<i>Ulmus pumila</i>	77	-	F	F	F	10	8	4.8	Deadwood (L), lean (M), epicormic branching (L)	Subject Site	Injure (TIPP - Development)	-
1359	Siberian Elm	<i>Ulmus pumila</i>	57	-	PF	F	F	20	5	3.6	Deadwood (L), lean (L), epicormic branching (M), decay (M) in trunk	Subject Site	Remove (TIPP - Development)	4

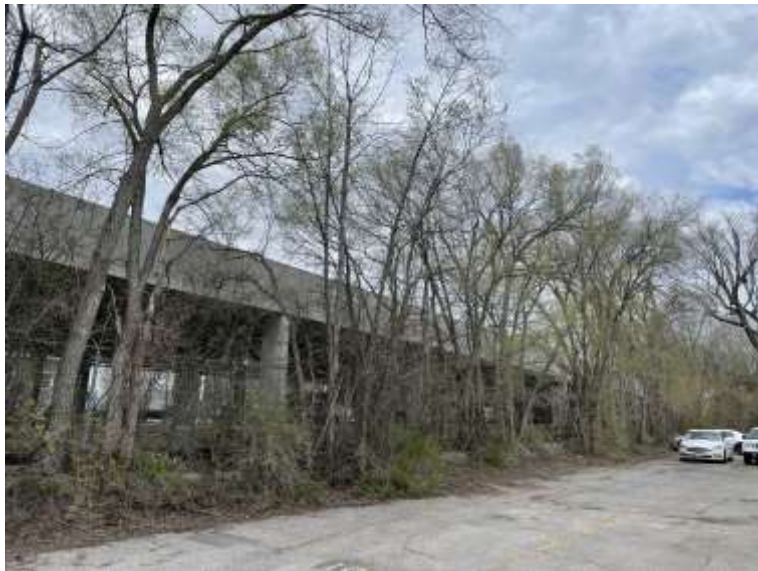
Image 16. Polygon P1360

P1360	See Table 2											Subject Site	Remove (TIPP - Development)	
1361	Siberian Elm	<i>Ulmus pumila</i>	53	-	F	FG	F	10	5	3.6	Lean (L), deadwood (L), stem wounds (L), epicormic branching (M), union at 1.5m and 2.5m	Subject Site	Injure (TIPP - Development)	-
1362	Bur Oak	<i>Quercus macrocarpa</i>	56, 58	80.5	F	F	FG		7	4.8	V-union at 1.2m with included bark (co-dominance), one stem broken in canopy, epicormic branching (L)	Subject Site	Preserve	-
1363	Siberian Elm	<i>Ulmus pumila</i>	41, 36.5	55	PF	F	F	15	6	3.6	Union at 1m, two stems pruned at 1m, one stem remaining, poor form (L), bow (M), deadwood (L)	Subject Site	Injure (TIPP - Development)	-
1364	Norway Maple	<i>Acer platanoides</i>	23	-	G	G	G		3	1.8		Subject Site	Remove (RRSP - Invasive)	-
1365	White Mulberry	<i>Morus alba</i>	-6 - 22	-	PF	F	F	10	3	1.8	Average DBH = 8cm, union at base, included (H) fence, v-union at 1.5m, epicormic branching (M), deadwood (L)	Shared (Subject Site / Neighbour)	Remove (TIPP - Development)	2

The removal of 29 trees and one polygon is required to accommodate the proposed development. Trees / polygons identified for removal include Trees 120, 121, 126, 481 – 483, 488, 489, 1359, 1365 – 1379, 1381, 1382, 1389, J, and K, and Polygon P1360.

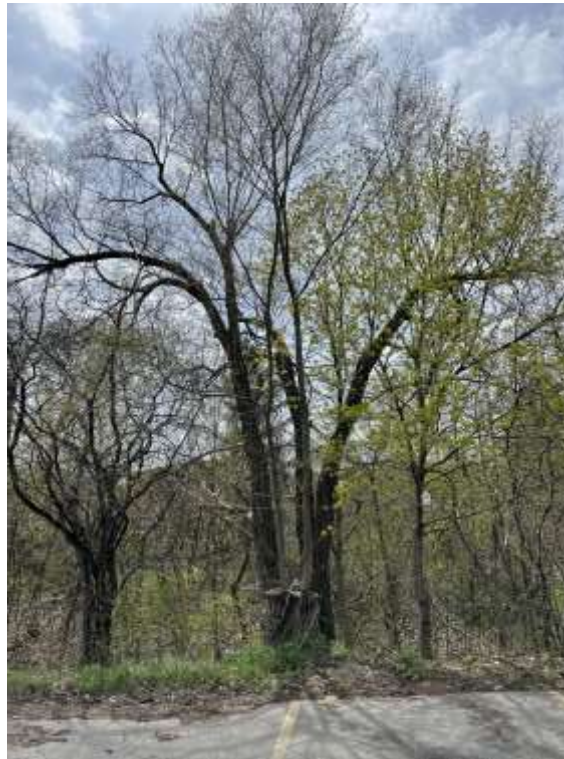
Image 19. Tree 1363

Encroachment into the mTPZ of Tree 1363 will be required to install the proposed stormwater pipe within the ravine area. The excavation to occur within the mTPZ of this tree should occur under the supervision of a Certified Arborist. Any roots exposed during the excavation process are to be pruned by a Certified Arborist in accordance with Good Arboricultural Standards.

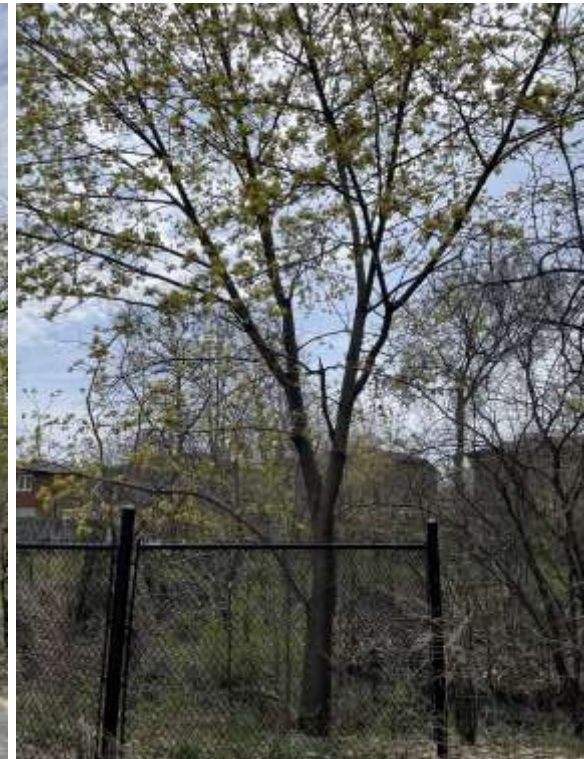
Image 20. Tree 1364

A total of ten trees / shrubs and six polygons are considered invasive species and as such, their removal is recommended as part of the ravine rehabilitation stewardship efforts. The recommended removals include Trees 104, 105, 115, 117, 118, 122 – 125, and 1364, and Polygons P102, P103, P107, P129, P131, and P134.

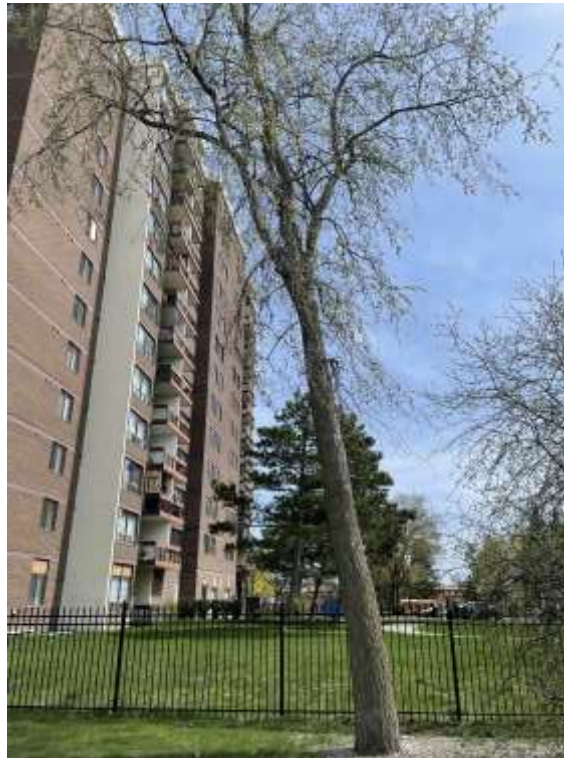
Image 22. Tree 1366

1366	White Elm	<i>Ulmus americana</i>	46	-	FG	F	F	10	4	3.0	Lean (L), epicormic branching (M), deadwood (L)	Subject Site	Remove (TIPP - Development)	4
1367	Siberian Elm	<i>Ulmus pumila</i>	-18, 16	-24	FG	FG	F		2	1.8	Union at 1m, included (L) fence	Subject Site	Remove (TIPP - Development)	2
1368	Siberian Elm	<i>Ulmus pumila</i>	78	-	PF	F	PF		7	4.8	Pruning wounds (M), epicormic branching (M), broken branches (M), decay (M) in trunk	Subject Site	Remove (TIPP - Development)	6
1369	Siberian Elm	<i>Ulmus pumila</i>	84	-	PF	FG	F		8	5.4	Cavities (M), damaged root (H), epicormic branching (M), lean (L), growth deficit (M)	Subject Site	Remove (TIPP - Development)	6
1370	White Mulberry	<i>Morus alba</i>	-12, 12, 10, 10, 8	-23.5	F	F	F		3	1.8	V-unions at base and 1m with included bark, epicormic branching (L)	Subject Site	Remove (TIPP - Development)	2
1371	Eastern Red Cedar (Juniper)	<i>Juniperus virginiana</i>	-6 - 14	-	F	F	FG		2	1.5	Average DBH = 8cm, union at base, lean (L-H)	Subject Site	Remove (TIPP - Development)	1

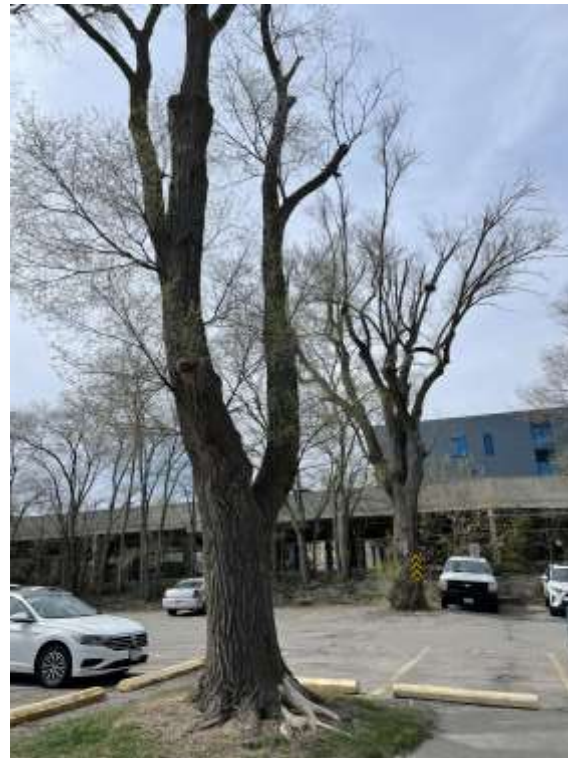
Image 27. Trees 1372 (near) and 1373 (far)

1372	Siberian Elm	<i>Ulmus pumila</i>	87	-	PF	OF	P	40	5	5.4	Decay (M) in trunk, v-union at 2m, pruning wounds (M), epicormic branching (M), deadwood (M)	Subject Site	Remove (TIPP - Development)	6
1373	Siberian Elm	<i>Ulmus pumila</i>	-94	-	PF	OF	P	70	5	6.0	Deadwood (H), epicormic branching (M), pruning wounds (M), burls (H), cavities (M)	Subject Site	Remove (TIPP - Development)	7
1374	Austrian Pine	<i>Pinus nigra</i>	39.5	-	G	F	F	10	3	2.4	Asymmetrical crown (M), deadwood (L)	Subject Site	Remove (TIPP - Development)	3
1375	Austrian Pine	<i>Pinus nigra</i>	16	-	F	FG	FG		1	1.5	Crook (M)	Subject Site	Remove (TIPP - Development)	2
1376	White Elm	<i>Ulmus americana</i>	22.5, 12	25.5	PF	PF	F		3	1.8	Fused to Tree 1377 at base, poor form (L), crook (M), suppressed by Tree 1378, v-union at 0.5m with included bark, decay (M) in smaller stem	Neighbour	Remove (TIPP - Development)	2
1377	Norway Maple	<i>Acer platanoides</i>	20.5	-	F	PF	F		3	1.5	Fused to Tree 1377 at base, poor form (L), crook (L), suppressed by Tree 1378	Neighbour	Remove (TIPP - Development)	2

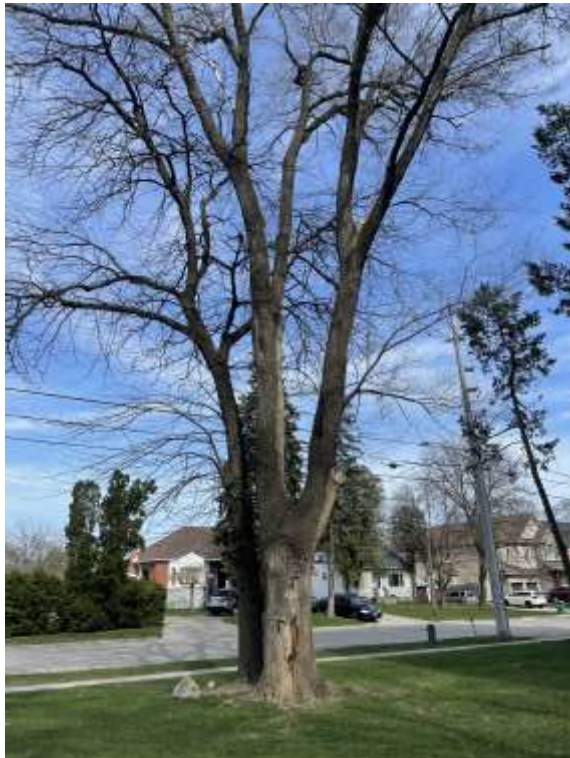
Image 33. Trees 1394 (left) and 1395 (right)

1395	Siberian Elm	<i>Ulmus pumila</i>	84.5	-	PF	F	F	20	5	5.4	Stem wounds (H), pruning wounds (M), deadwood (L), epicormic branching (L)	Subject Site	Preserve	-
1396	Siberian Elm	<i>Ulmus pumila</i>	45	-	G	F	F	20	4	3.0	Deadwood (L), epicormic branching (M)	Subject Site	Injure (TIPP - Development)	-
1397	Norway Spruce	<i>Picea abies</i>	45	-	PF	G	F		3	3.0	Decay (M) in trunk, lean (L), growth deficit (M)	Subject Site	Preserve	-
1398	Siberian Elm	<i>Ulmus pumila</i>	49, 47	68	PF	F	F	30	7	4.2	V-union at 0.5m with included bark, epicormic branching (M), deadwood (M), lean (L), growth deficit (M)	Subject Site	Injure (TIPP - Development)	-
A	Apple species	<i>Malus sp.</i>	23	-	P	F	PF	30	2	1.8	Decay (H) in trunk, epicormic branching (L), deadwood (M)	City (Right-of Way)	Preserve	-
B	Siberian Elm	<i>Ulmus pumila</i>	29	-	PF	PF	F		3	1.8	Sweep (M), epicormic branching (M), pruning wounds (M), sustained pruning for hydro line clearing	City (Right-of Way)	Preserve	-

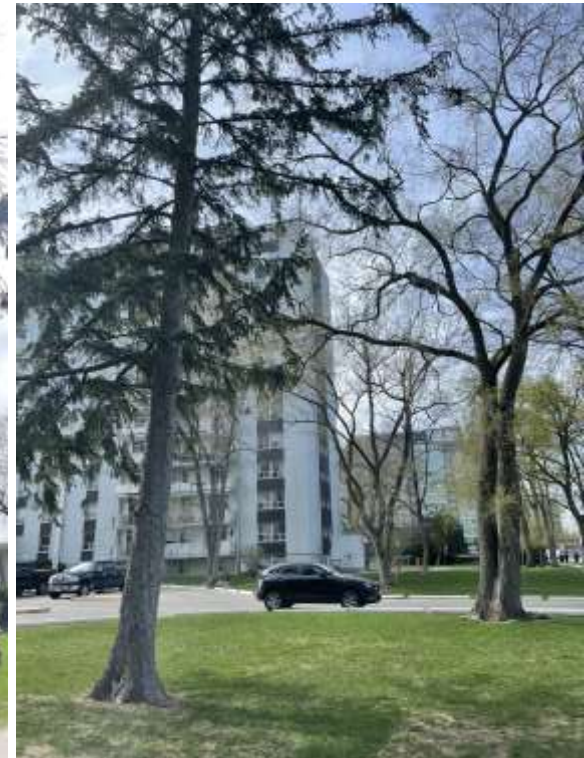
Image 35. Trees 1397 (left) and 1398 (right)

Encroachment into the mTPZs of Tree 1398 and Polygon PL will be required to accommodate alterations in grading. If the following mitigation measures are employed, long-term adverse effects are not anticipated for this tree and polygon.

1. Prior to the commencement of the proposed works, tree preservation fencing is to be installed as depicted in Figure 1. During the final grading stage, the prescribed tree protection fencing may be temporarily adjusted to accommodate the required grading alterations but must be reinstalled as depicted in Figure 1 immediately after the completion of the grading within the mTPZs of this tree and polygon.
2. The addition of fill within the mTPZs of this tree and polygon should occur by hand.
3. Any softscaping within the mTPZs of this tree and polygon should occur by hand.
4. Branches that extend into the proposed development and require pruning should be pruned by a Certified Arborist or other tree professional in accordance with Good Arboricultural Standards.
