June 23, 2022 [*Revised August 7, 2024*]

ARBORIST REPORT

1225 Dundas Street East, Mississauga, Ontario

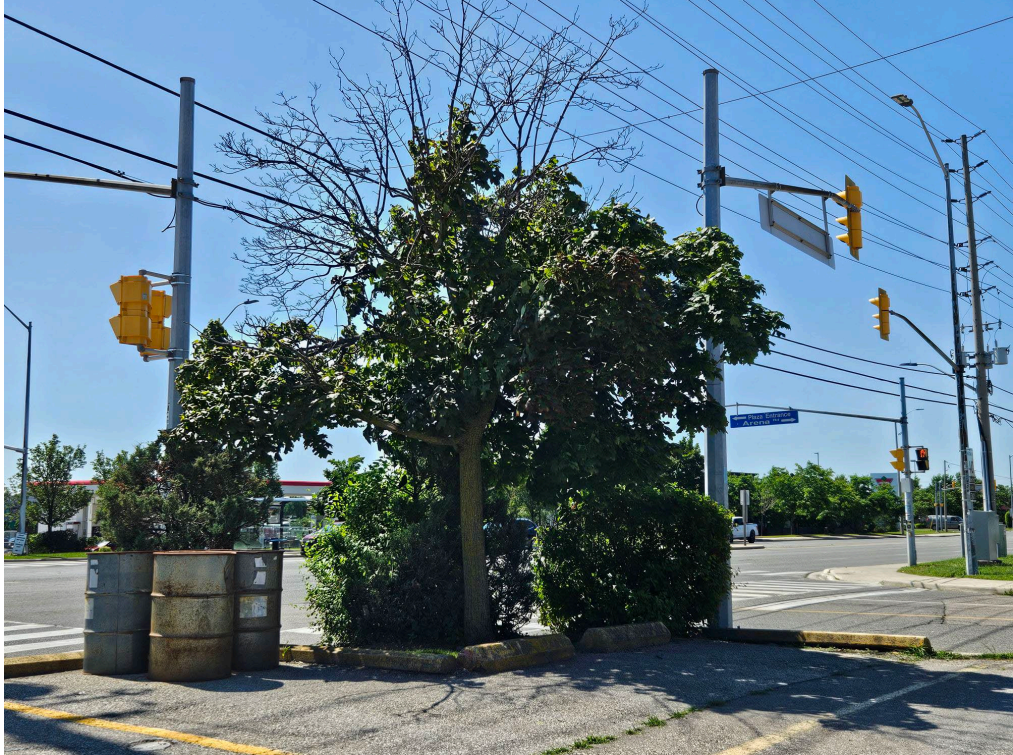
Tree 411

Tree #	Common Name	Botanical Name	DBH (CM)	Condition	Comments	Recommendation
411	Norway Maple	Acer platanoides	20	P	Significant crown die-back and leader die-back	Retain
412	Manitoba Maple	Acer negundo	37	P	Single stem of co-dominant pair remains, moderate to significant deadwood in canopy, signs of rot at base, epicormics throughout	Retain
413	Slippery Elm	Ulmus rubra	23	F/G	Evidence of leaf miner	Retain
414	Slippery Elm	Ulmus rubra	20	F	Evidence of leaf miner	Retain
415	Slippery Elm	Ulmus rubra	21	F	Evidence of leaf miner, slightly imbalanced crown	Retain
416	Slippery Elm	Ulmus rubra	21	F/P	Evidence of leaf miner, moderate/significant die-back on north side of crown	Retain
417	Slippery Elm	Ulmus rubra	24	F/G	Evidence of leaf miner	Retain
418	Slippery Elm	Ulmus rubra	23	F	Evidence of leaf miner	Retain
419	Slippery Elm	Ulmus rubra	24	F/G	Evidence of leaf miner	Remove due to construction
420	Slippery Elm	Ulmus rubra	23	F/G	Evidence of leaf miner	Retain

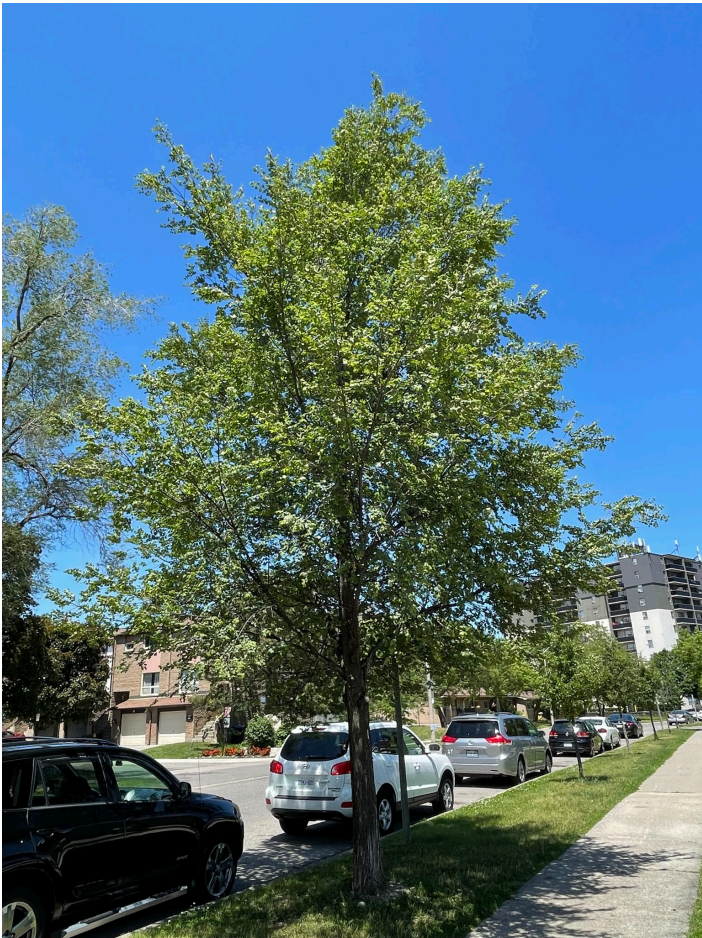
Tree 421

421	Slippery Elm	Ulmus rubra	26	F/G	Evidence of leaf miner	Retain
446	Honey Locust	Gleditsia triacanthos	16	F/G	Wound at trunk at 1.2 metres	Retain
447	Honey Locust	Gleditsia triacanthos	5	F/G	Newly planted, minor deadwood in canopy	Retain
448	Honey Locust	Gleditsia triacanthos	18	G	Good form, full canopy	Remove due to construction
449	Bradford Pear	Pyrus calleryana	8	F/G		Retain
450	Bradford Pear	Pyrus calleryana	9	F/G	Mild lean	Retain

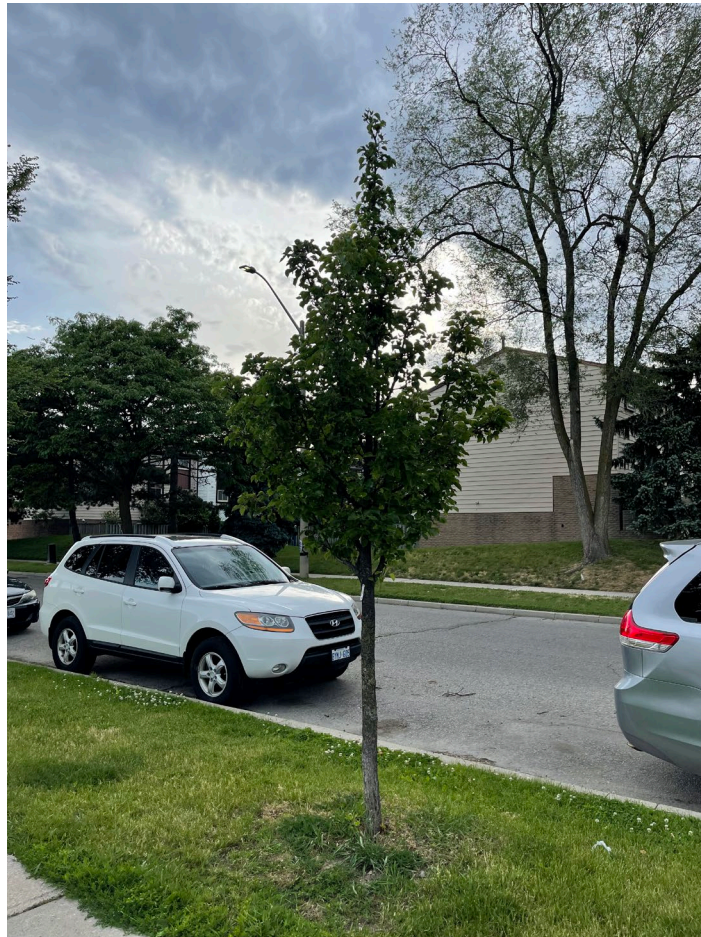
Tree 451

451	Bradford Pear	Pyrus calleryana	10	F/G	Slight bow in trunk	Retain
453	Bradford Pear	Pyrus calleryana	6	D	Tree 100% dead	Remove due to condition
O1	White Mulberry	Morus alba	35	F	Growing between fences, self-seeded, multi-stemmed	Retain
O2	Manitoba Maple	Acer negundo	~27	F	Growing between fences, multi-stemmed, self-seeded	Retain
O3	Manitoba Maple	Acer negundo	~29	F	Growing between fences, multi-stemmed, self-seeded	Retain
O4	Colorado Spruce	Picea pungens	27	F	Top of tree crowded and stunted due to adjacent tree cover	Retain
O5	Austrian Pine	Pinus nigra	25	F	Leader growing at severe angle due to adjacent tree cover	Retain
O6	Manitoba Maple	Acer negundo	48	F	Two stems at base, minor deadwood in canopy	Retain
O7	White Mulberry	Morus alba	39	F	Poor form, moderate deadwood in canopy, twisted main limbs with included bark	Retain
A	White Mulberry	Morus alba	~10	F - F/P	4 separate stems, grown into fence	Retain
