**Tree Inventory and Preservation Plan Report  
3115 Hurontario Street  
Mississauga, Ontario**

11 July 2022, revised 18 June 2024

KUNTZ FORESTRY CONSULTING Inc. Project P3292

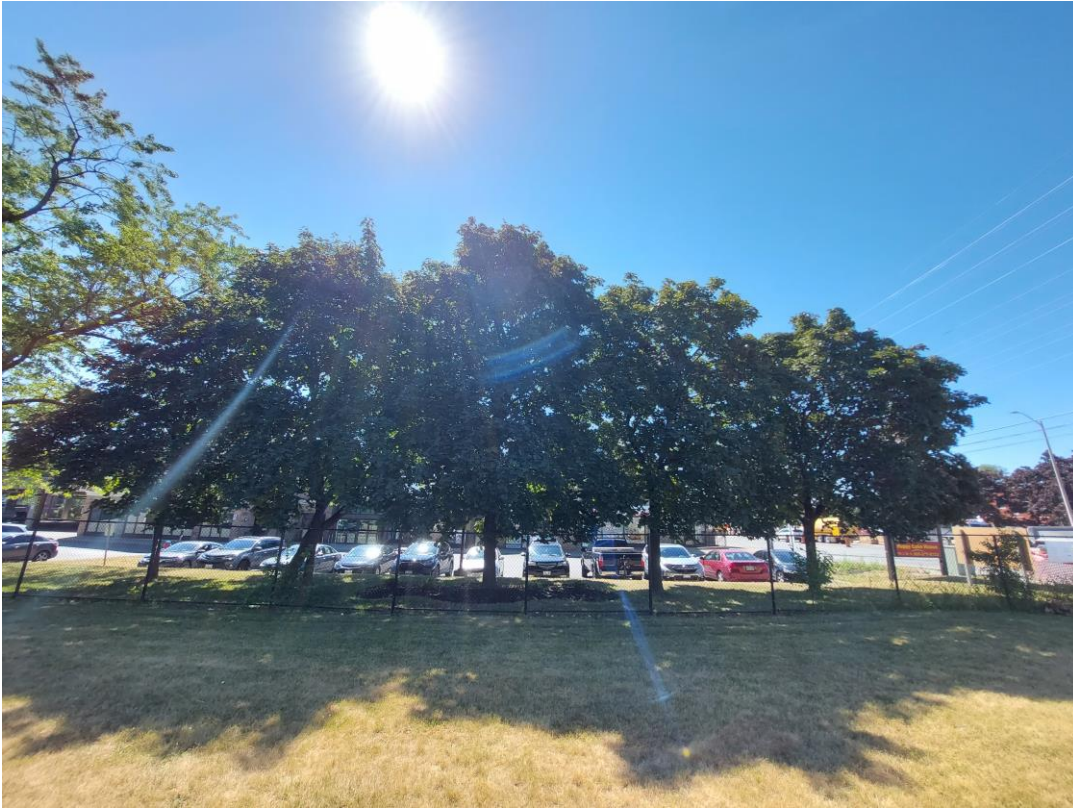
Image 1. Trees 1-6 (from right)

Tree #	Common Name	Scientific Name	DBH	TI	CS	CV	CDB	DL	mTPZ	Ownership	DL in SP	Comments	Action	Comp.
1	Norway Maple	<i>Acer platanoides</i>	30	G	G	G		4	1.8	Neighbour	0.5m	Exposed roots (L), growth deficit (L), pruning wounds (L), epicormic branches (L)	Preserve	
2	Norway Maple	<i>Acer platanoides</i>	31	FG	G	FG		4	2.4	Neighbour	1m	Co-dominance at 2.5m with included bark (L), exposed roots (L), pruning wounds (L), exposed roots (L)	Preserve	
3	Norway Maple	<i>Acer platanoides</i>	35	FG	G	FG		4.5	2.4	Neighbour	1.5m	Previously tagged 469, co-dominance in crown, pruning wounds (L), exposed roots (L), epicormic branches (L)	Preserve	
4	Norway Maple	<i>Acer platanoides</i>	25	FG	G	FG		3.5	1.8	Neighbour	1.5m	Co-dominance at 3.5m, pruning wounds (L), sweep (L)	Preserve	
5	Manitoba Maple	<i>Acer negundo</i>	36	F	G	FG		3.5	2.4	Neighbour	None	Co-dominance at 1.8m, lean (M) to southwest, pruning wounds (M), epicormic branches (M)	Preserve

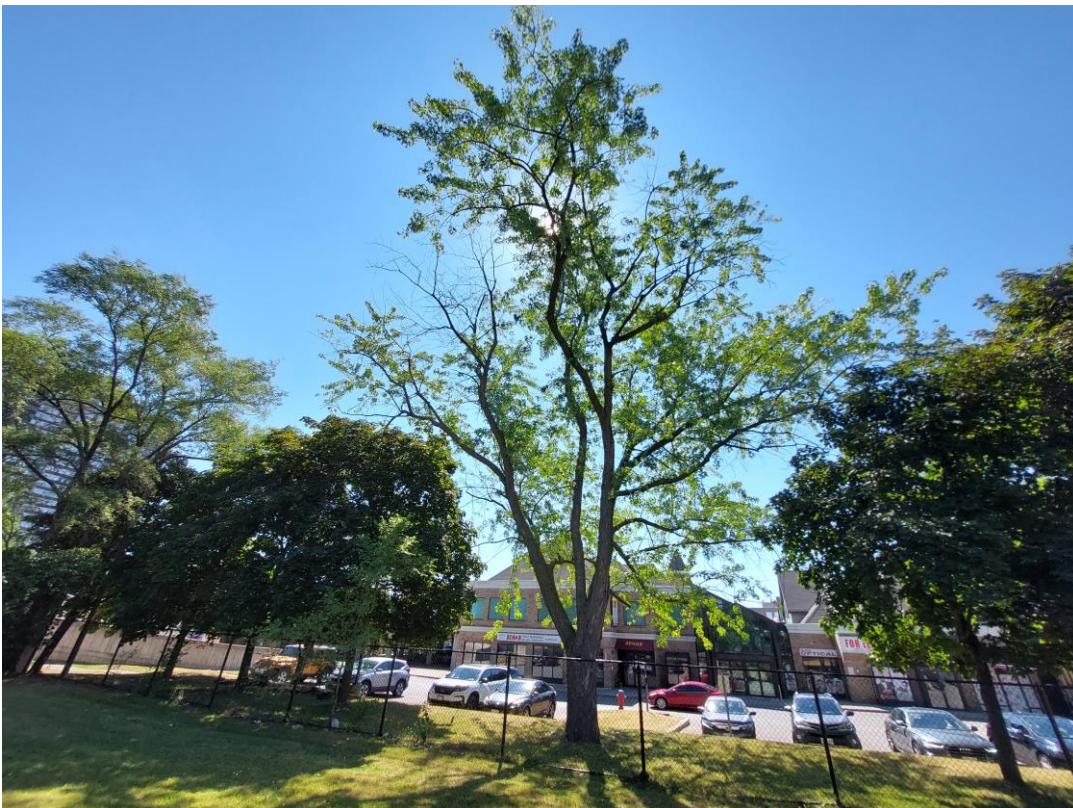
Image 2. Tree 7

6	Norway Maple	<i>Acer platanoides</i>	23	F	G	FG		3	1.8	Neighbour	None	Co-dominance at 4m, sweep (L), pruning wounds (M) with cavity	Preserve	
7	Silver Maple	<i>Acer saccharinum</i>	78.5	F	PF	PF	40	8	4.8	Neighbour	6m	Cavity at 1.6m, union at 2m, 3.5m, and 4m with 4 stems, deadwood, dead branches (M), epicormic branches (M), 1 stem has dead leader	Remove	5
8	Norway Maple	<i>Acer platanoides</i>	28	G	G	G		4	1.8	Neighbour	0.5m	Previously tagged 474, pruning wounds (L), exposed roots (L)	Preserve	
9	Norway Maple	<i>Acer platanoides</i>	27.5	FG	G	G		4	1.8	Neighbour	1m	Previously tagged 475, exposed roots (M), crook (L), growth deficit (L)	Preserve	
10	Siberian Elm	<i>Ulmus pumila</i>	15.5, 15, 14, 11.5, 9.5	F	F	PF	29	3	1.5	Neighbour	None	Previously tagged 476, union at 1m, bow (L) to south, chlorosis (M), pruning wounds (L)	Preserve	
11	Norway Maple	<i>Acer platanoides</i>	23.5	G	G	G		3.5	1.8	Neighbour	None		Preserve

The removal of 23 trees is required to accommodate the proposed development. Required tree removals include Trees 7, 13-16, 18-29, and 31-36. All trees that require removal are greater than 15cm DBH and protected by the City of Mississauga Private Tree By-law; a permit will be required prior to their removal. Trees 7, 13-16, and 18 are located on the adjacent properties; written consent from the respective property owners is required prior to their removal. Refer to Figure 1 for the required tree removals.

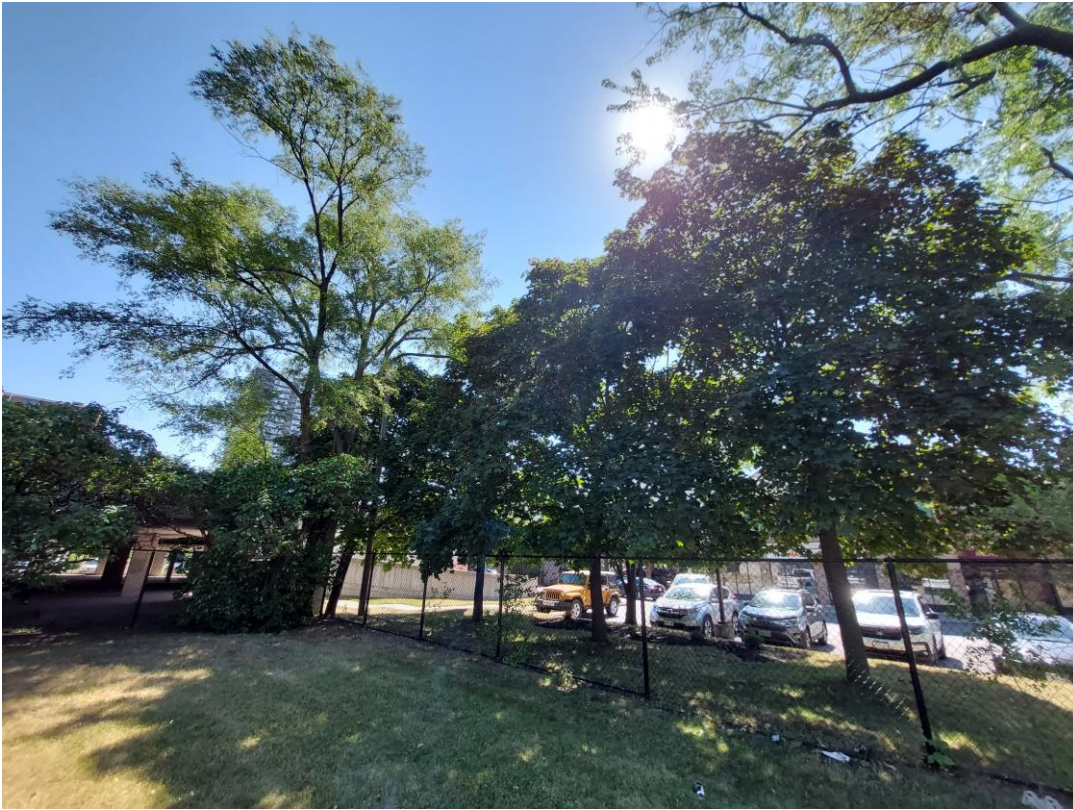
Image 3. Trees 8-12 and 18 (from right)

Minor encroachment into the minimum Tree Protection Zone (mTPZ) of Tree 12 is required to accommodate the proposed development. Given that encroachment is limited to outer edge of the mTPZ, long-term adverse impacts are not anticipated to the tree.

12	Norway Maple	<i>Acer platanoides</i>	29.5	F	FG	FG		4	1.8	Neighbour	1m	Seam (L) - closed, spiral stem, lean (L) to south, crook (M)	Preserve	
13	Norway Maple	<i>Acer platanoides</i>	46.5	P	G	G		5	3	Neighbour	4m	<b>Hazard</b> , co-dominance at 3m with split from union to 0.5m from ground	Remove	3
14	Norway Maple	<i>Acer platanoides</i>	33.5	FG	FG	PF	20	5	2.4	Neighbour	4m	Previously tagged 480, exposed roots (L), co-dominance at 3.5m, broken branches (L)	Remove	2
15	Norway Maple	<i>Acer platanoides</i>	26.5	FG	FG	FG		4	1.8	Neighbour	4m	Previously tagged 481, co-dominance at 4m, asymmetrical crown (M)	Remove	1
16	Norway Maple	<i>Acer platanoides</i>	41	FG	G	FG		6	3	Neighbour	5m	Previously tagged 482, co-dominance at 4m	Remove	2
17	Norway Maple	<i>Acer platanoides</i>	28	PF	FG	FG		3.5	1.8	Neighbour	None	Stem wound (H) from failed stem at 3m, deadwood, asymmetrical crown (M), overhead utility wires in crown	Preserve

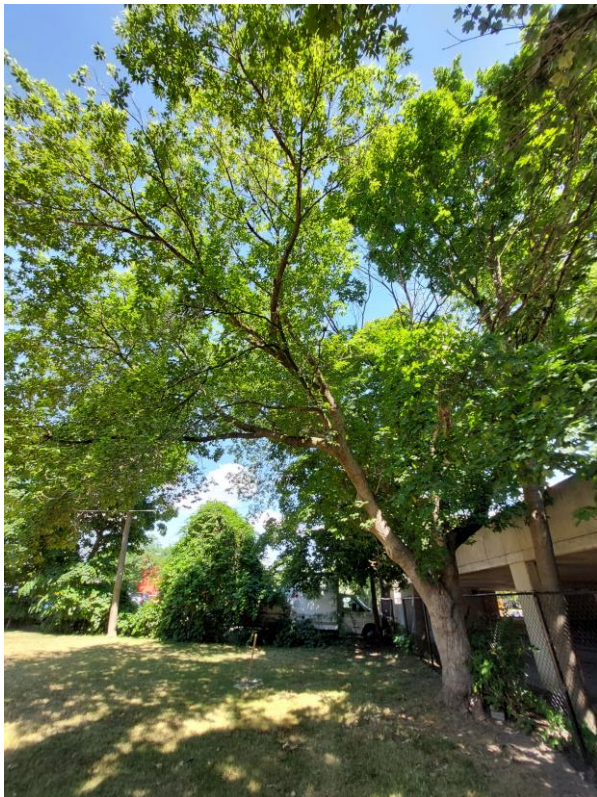
Image 7. Trees 15 (right) and 19

18	Siberian Elm	<i>Ulmus pumila</i>	47	F	F	F	20	5	3	Neighbour	5m	Union at 1m with included bark (M), broken branches (M), dead branches (L), epicormic branches (H)	Remove	3
19	Manitoba Maple	<i>Acer negundo</i>	62	P	PF	PF	30	7	4.2	Private	-	Co-dominance at 2m, included fence (L) at base, stem wound (L), deadwood, pruning wounds (M), dead branches (M), sweep (L), lean (L) to west, dead leader, epicormic branches (M)	Remove	4
20	Norway Maple	<i>Acer platanoides</i>	28.5	F	F	FG		3	1.8	Private	-	Lean (L) to south, sweep (L), crook (M), asymmetrical crown (H)	Remove	1
21	Norway Maple	<i>Acer platanoides</i>	28	G	G	G		3.5	1.8	Private	-	Grape vine competition (L)	Remove	1
22	Norway Maple	<i>Acer platanoides</i>	21.5, 21	FG	G	G		3.5	1.8	Private	-	Co-dominance at base, bow (L)	Remove	1
23	Norway Maple	<i>Acer platanoides</i>	18, 14, 11.5	F	G	G		4	1.5	Private	-	Union at base and 0.3m with included bark (M), sweep (M), lean (M)	Remove	1

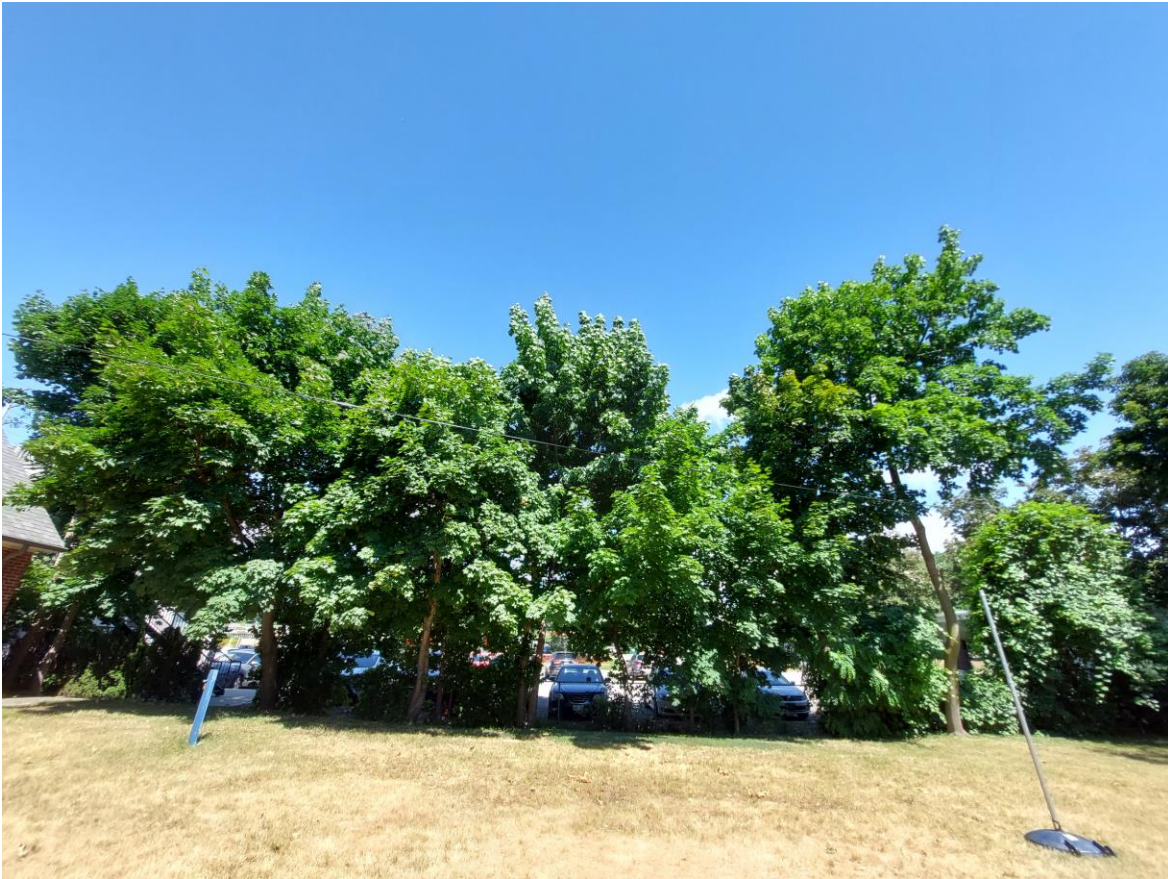
Image 8. Trees 20-25 (from right)

24	Norway Maple	<i>Acer platanoides</i>	18	FG	FG	G		2.5	1.5	Private	-	Crook (M), asymmetrical crown (M)	Remove	1
25	Norway Maple	<i>Acer platanoides</i>	33.5	F	FG	G		3.5	2.4	Private	-	Bow (L) to southwest, co-dominance at 2m with included bark (M), crook (L), asymmetrical crown (M), sweep (L)	Remove	2
26	Norway Maple	<i>Acer platanoides</i>	17.5	G	G	G		3	1.5	Private	-		Remove	1
27	Norway Maple	<i>Acer platanoides</i>	20	G	G	G		3	1.5	Private	-		Remove	1
28	Norway Maple	<i>Acer platanoides</i>	18.5	G	G	G		3	1.5	Private	-		Remove	1
29	Eastern White Cedar	<i>Thuja occidentalis</i>	19	G	P	P	90	1	1.5	Private	-		Remove	1
30	Honey Locust (shademaster)	<i>Gleditsia triacanthos 'inermis'</i>	10	G	G	G		2	1.5	Neighbour	None		Preserve	
31	Blue Spruce	<i>Picea pungens</i>	33	G	F	F	15	1.5	2.4	Private	-		Remove	2
32	Norway Spruce	<i>Picea abies</i>	29	G	F	F	20	2	1.8	Private	-	Asymmetrical crown (M)	Remove	1
33	Blue Spruce	<i>Picea pungens</i>	30	G	P	P	85	1.5	1.8	Private	-		Remove	1

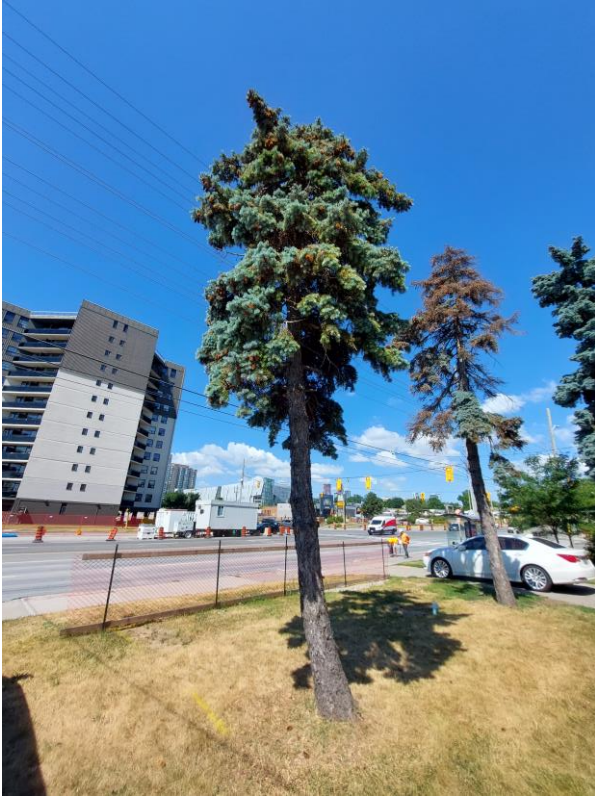
Image 15. Tree 34

34	Blue Spruce	<i>Picea pungens</i>	26	FG	F	PF	35	1.5	1.8	Private	-	Lost leader, sweep (L)	Remove	1
35	Manitoba Maple	<i>Acer negundo</i>	63	PF	PF	PF	20	7	4.2	Private	-	Coppice growth (M) at base, union at base with 3 stems, dead branches (L), sparse leader, epicormic branches (H), lean (M) to south, sweep (L)	Remove	4
36	Eastern Red Cedar (Juniper)	<i>Juniperus virginiana</i>	30	F	F	F		2.5	1.8	Private	-	Frost crack (M), lean (L) to east, asymmetrical crown (M)	Remove	2
													TOTAL	42
