Project Title 10 WEST GO GP INC.

17 & 19 Ann St.; 84 & 90 High St. Mississauga, ON

TREE INVENTORY & PRESERVATION PLAN

Date August 2020	ssued
Job Number	Drawn By
BTI-1490	KC
Scale	Checked By
As Shown	JW/TT
Sheet Number TS.1	File Number

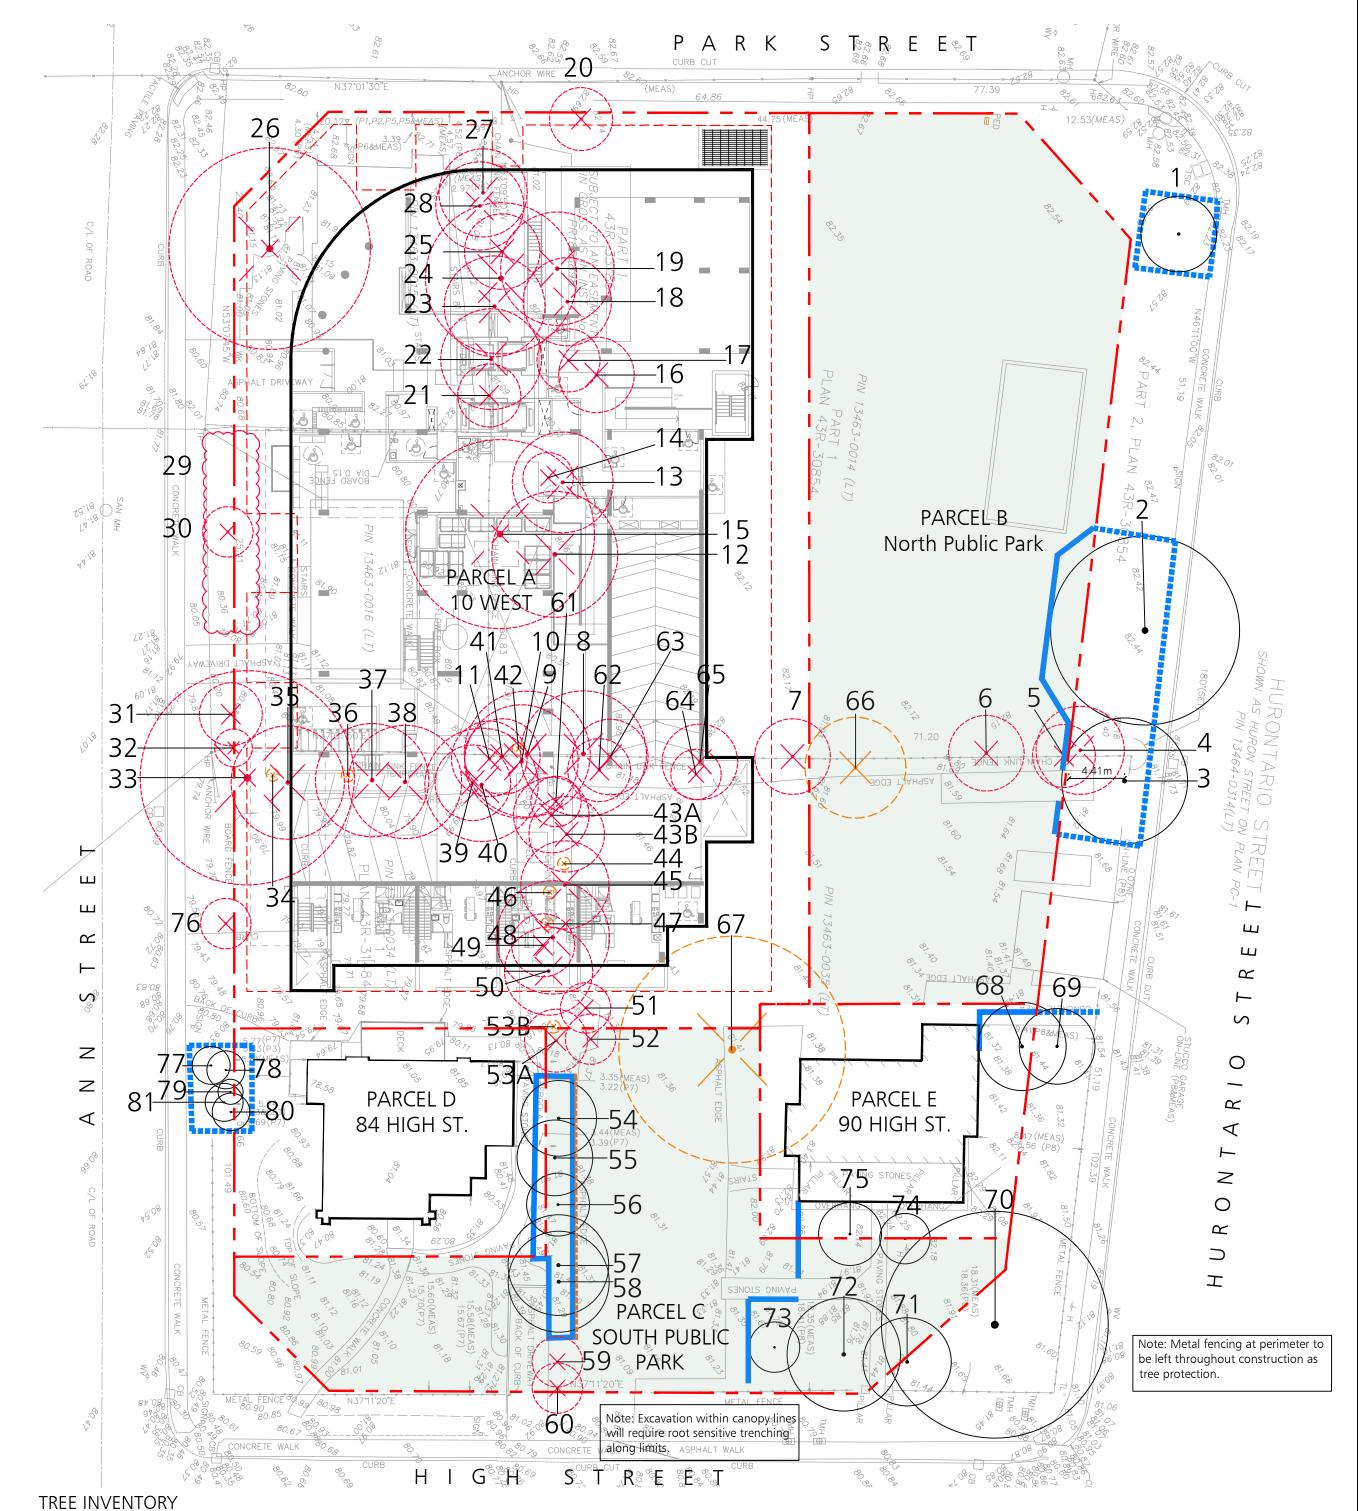
5	Aesculus hippocastanum	35	5	ML	ML	RC	Growing through fence and vine covers 70% of canopy.	Р	Р
6	Acer platanoides	22, 11	6	ML	ML	RC	Vine covers 70% of canopy and one medsized dead branch.	Р	Р
7	Acer platanoides	31	6	М	М	RC	Growing through fence mesh and has thicket creeper in canopy.	Р	S
8	Acer saccharinum	32, 44.5	10	МН	М	RC	Co-dominant leaders, two large dead branches, growing through fence mesh.	Р	S
9	Acer platanoides	~32	10	М	М	RC	Growing through fence mesh, leans 10° to north east.	Р	S

1.0	A1	24 4==	~			D	Co-dominant leaders with included bark	-	
10	Acer platanoides	31, 46.5	9	М	М	RC	at base to 30cm ht. Leans 10° to north west. Has girdling root at base.	Р	S
11	Acer platanoides	22	6	М	ML	RC	Grows through fence mesh, suppressed, and leans 10° to north west.	Р	S
		14, 15x2,					Multistem tree with included bark between all trunks. Girdling roots across		
12	Acer platanoides	18x2, 19x2, 15, 26.5	10	М	ML	RC	the base. Three large injuries from fuse branches.	Р	S
13	Acer platanoides	25, 33	8	М	М	RC	Included bark at base, leans 10° to east and a girdling root.	Р	S
14	Acer platanoides	16	4	М	М	RC	Girdling root with tree #13 and has a small canopy.	Р	S
15	Acer platanoides	91.5	15	М	ML	RC	Girdling root across 50% of base and over 15 medium-sized dead branches.	Р	S
16	Acer platanoides	15.5	6	М	М	RC	45°L to east, slight canopy with 50% of	Р	S
17	Acer negundo	19.5	5	ML	ML	RC	branches with tip dieback.	Р	S

18	Acer negundo	22.5	7	М	М	RC	Fused with another small tree at base to 1m ht.	Р	S
19	Acer negundo	35.5, 40	9	М	М	RC	Co-dominant leader with one leader leaning 45° to north east. Some grape vine covers 5% of canopy.		S
20	Fraxinus pennsylvanicus	14	5	MH	М	RC	Grape covers the lower 25% of canopy, but no EAB obvious yet.	Р	S
21	Acer platanoides	17	5	М	ML	RC	Supporting tree #22 and grows through a fence mesh.	Р	S
22	Acer negundo Acer platanoides	27.5	8	M	ML ML	RC RC	45°L to south on tree #21. Large central leader cut at 1.7m ht. an and wound from cut on remaining leader. Has included bark from 0.5 to 1.7m ht. One leader leans 30° to south. Has several small dead branches.		S
24	Acer platanoides	35, 41	12	М	М	RC	Included bark from 1m to 1.7m, tight branching causing injury from fusing trunk.	Р	S
25	Acer negundo	23	6	M	ML	RC	Leans 45° to north east and has a sparse	Р	S
26	Gleditsia tricanthos var.	62	16	Ĥ	Н	RC	canopy.	5	5

inermis Acer negundo	35	7	M	M	RC	Many 10 small dead branches. Large pruned limb at 4m, medium-sized	S	S
	Acer negundo	32	7	M	M	RC	wound at base of 3% trunk damage. Medium-size wound from cut co- dominant leader covering 15% trunk		5
20	TI :	25x 2,	5			D.C.	damage. Girdling root also present.	-	
29 30	Thuja occidentalis (Hedge) Acer negundo	30x5, 15x2	4	MH	M H	RC RC	All multi-stem from 0.5m height. Leans 15° to west.	S	В
31	Thuja occidentalis	20.5	5	M	M	RC	45oL to south west and 20% trunk wounded.	С	С
32	Thuja occidentalis	16	3	ML	M	RC	Suppressed.	C	В
33	Acer negundo	78	17	М	ML	RC	45oL, with more than 6 large branches cut of over 15cm dia. Also 2 large cuts of	S	S
34	Fraxinus pennsylvanicus	25, 25				R	30cm dia. DEAD	S	S
	Acer negundo	44	9	М	М	RC	Tip dieback of 10% and 2 large dead branches.	S	S
	Fraxinus pennsylvanicus	14	-			R	DEAD tip dieback of 10% and 2 large dead	S	5
37 38	Acer platanoides Acer platanoides	28, 38	9	MH	M	RC RC	branches. Large prune cut of 15cm at 2m	S	S

Acer platanoides	22	6	МН	M	RC	Large wound at 30% trunk damage at root crown.	S	S
40	Acer platanoides	32	9	MH	М	RC		S	S
	Acer platanoides Fraxinus pennsylvanicus	23 ~30	6	MH	MH	RC R	Small dead branches and small cuts at base. DEAD	S S	S S
13A	Acer platanoides	~15	6	MH	MH	RC	45° lean to south, branch fused creating wound at 43A.	S	S
	Acer platanoides Fraxinus pennsylvanicus	~25 ~30	6	MH	MH	RC R	10°L to west.	S	S
45	Acer platanoides	20	7	MH	MH	RC	Hanging branch in canopy.	S	S
	Fraxinus pennsylvanicus Fraxinus pennsylvanicus	~30 ~35				R R	DEAD DEAD	S S	S
	Acer platanoides	29	9	MH	MH	RC	Backfilled and unbalanced canopy to east.	S	S
	Acer platanoides Acer platanoides	17 31	5 7	H MH	MH M	RC RC	Crack from 0.5m to 2m, unbalanced canopy to west and second crack from	S	S
	Picea pungens	39	4	М	М	RC	2m to 4m ht. Backfilled.	S	S
	Picea pungens	46	4	М	ML	RC	Large wound of 15% of trunk diameter at base with sawdust and backfill over base.	S	Р

53A	Morus alba	18	5	М	М	RC	slight canopy and unbalanced crown to	S	Р
	Fraxinus pennsylvanicus	14	100.0			R	south. DEAD crack from 1m to 1.5m ht.	S	В
	Acer platanoides	21	6	MH	MH	Р	4 5 1	S	P

Tree No.	Species	DBH (cm)	Canopy diameter (m)	Bioglogical Health	Structural Condition	Recommended Action	Comments	Existing Location Designation	Future Location Designation	Tree No.		
57	Ailanthus altissima	51	8	Н	МН	Р	large pruned limb with ripping wound and two other medium-sized broken branch wounds.	S	Р	70		
58	Morus alba	35	8	M	M	Р	leans 30° to south.	S	Р		70	
59	Ailanthus altissima	17	4	H	Н	RC	unbalanced canopy to south.	S	Р	71	71	
60	Acer platanoides	16	4	М	M	RC	backfilled, has 5 small prune cuts and a thin wound from 30cm to 1m ht.	S	Р	7.1	71	
61	Acer platanoides	20.5	4	MH	MH	RC		S	S	72	72	
62	Acer negundo	19.5	5	M	M	RC	30° lean to south, one dead trunk fallen.	S	S			
63	Acer platanoides	35	6	MH	MH	RC		S	S	73	\rightarrow	
64	Salix alba 'Tristis'	19	4	М	ML	RC	multibranch node.	S	S	74	\rightarrow	
65	Salix alba 'Tristis'	25	6	MH	M	RC	10°L to north east.	S	S	75		
66	Ulmus americana	44.5	8	L	L	R	50% of canopy is dead. Vine is covering 50% of remaining canopy.		Р	76

67	Gingko biloba	131.5	18	L	L	R	80% of canopy dead. Three leaders and included bark from base to 2m height also at 4 to 8m ht. Large cut at 1m height.	S	Р	77 78 79 80		
68	Malus sp.	29, 17	7	МН	МН	Р	10% trunk damaged at 30cm ht. and greater than 2 medium-sized dead branches.	S	S	81		
69	Malus sp.	10, 10	6	М	ML	Р	Leans 45° to east.	C	C		Tr

Existing Location Designation	Future Location Designation	Tree No.	Species	DВН (ст)	Canopy diameter (m)	Bioglogical Health	Structural Condition	Recommended Action	Comments	Existing Location Designation	Future Location Designation
wound oken	S	P P	70	Acer saccharinum	126.5	18	ML	М	Р	Three of eight leaders showing dieback, central trunk largely dead with tight branches at multibranch nodes, but no included bark	С	С
ts and a	S	Р	71	Prunus avium	29.5	7	M	ML	Р	large prune cut at 1.5m height and 15° lean to south.	С	C
nt. nk fallen.	S S	P S S	72	Prunus avium	22, 23.5, 25, 31	9	МН	ML	Р	Multi-leader with included bark at base of trunk with 2 of 4 limbs leaning 45° to south east and south west.	S	Р
	S	S	73	Picea pungens	24.5	4	Н	Н	Р		S	Р
	S	S	74	Picea pungens	25	4	Н	Н	Р		S	S
	S	S	75	Picea pungens	32	5	Н	Н	Р		S	S
covering	S	Р	76	Acer platanoides	14.5	4	МН	МН	RC	Medium dead branches and small injuries at 6m height.	S	C

ders and			77	Thuja occidentalis	20, 15x3	3	М	МН	Р	tight unions	C	C
height			78	Thuja occidentalis	22	3	M	MH	Р		C	C
1m	S	P	79	Thuja occidentalis	15.5	2	М	МН	Р		C	C
			80	Thuja occidentalis	16,16, 19	3	М	MH	P	tight unions with included bark	C	C

t. and			81	Thuja occidentalis	15, 18	3	М	МН	Р	tight unions with included bark	C	C

TREE PROTECTION RECOMMENDATIONS:

- Install hoarding for subsequent municipal
- Hoarding may be moved temporarily to provide and breaking of roots of trees to remain.
- Pruning, if required, should be done prior to construction and in accordance with current arboricultural practices.
- and disposal of liquids is not permitted within 1m of protected areas.
- Excavation in close proximity to protected areas are
- Roots encountered due to excavation are to be cut with a clean sharp blade. Tearing and ripping of roots is not permitted.
- Exposed roots are to be covered immediately with
- Deep root fertilize (3:1:1) following backfilling. Trees should be re-assessed periodically in order to

- review/approval. access for tree removal only. These trees should be felled away from protected areas to avoid pulling
- Storage of any materials, fill, vehicles/equipment,
- to be undertaken with a certified arborist present.
- Hydrovacing is recommended as the preferred method for excavation. within 1m of protected
- maintain an up to date understanding of health and structure.
