Applicant:
Bousfield Inc.
P. Stewart
DARC 22-255

October 2023

Arborist Report and Tree Protection Plan for 1580 and 1650 Dundas St. E Mississauga, Ontario

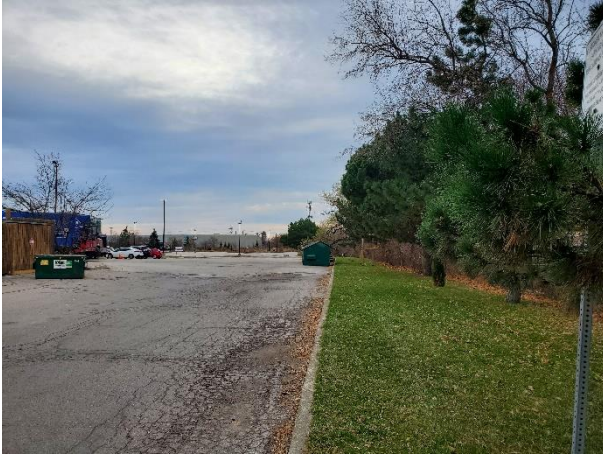
Woodland Dripline looking east (1580 Dundas st. E)

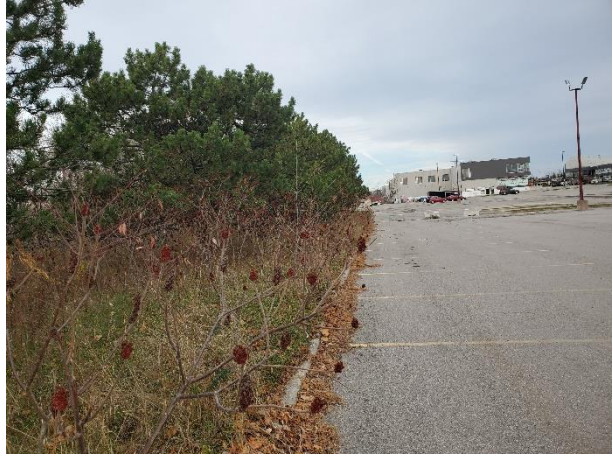
Woodland Dripline looking west (1580 Dundas st. E)

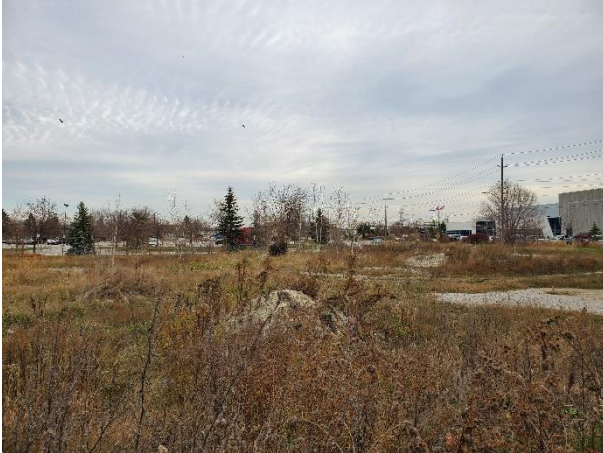
Field east of the parkinglot (1580 Dundas st. E)

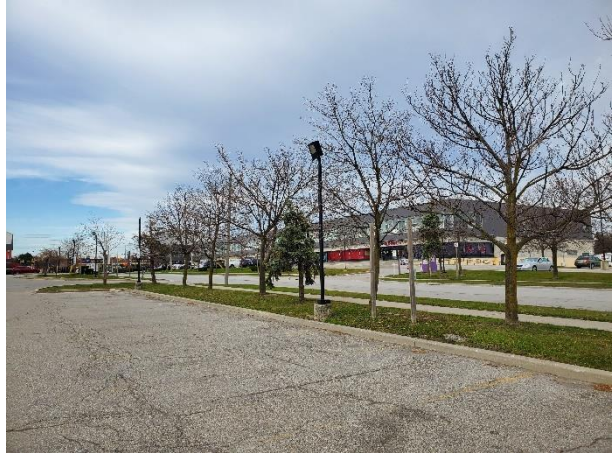
Street trees (1580 Dundas st. E)

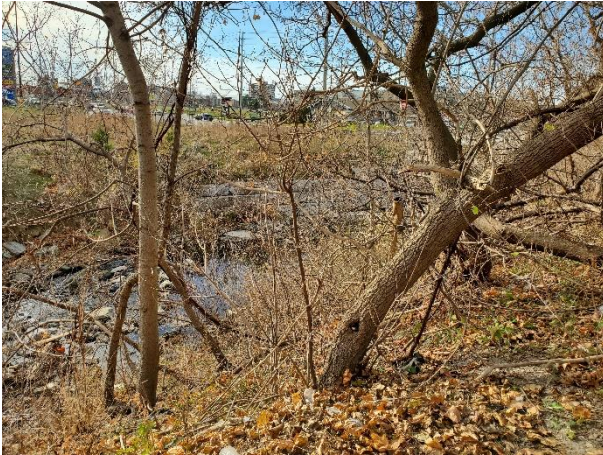
Woodland and creek (1580 Dundas st. E)

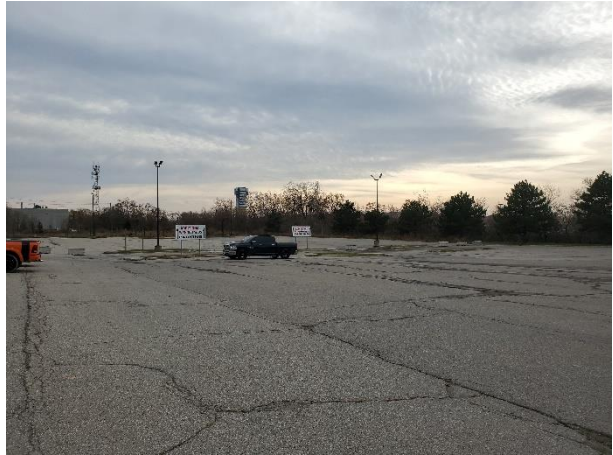
Parking lot (1580 Dundas st. E)

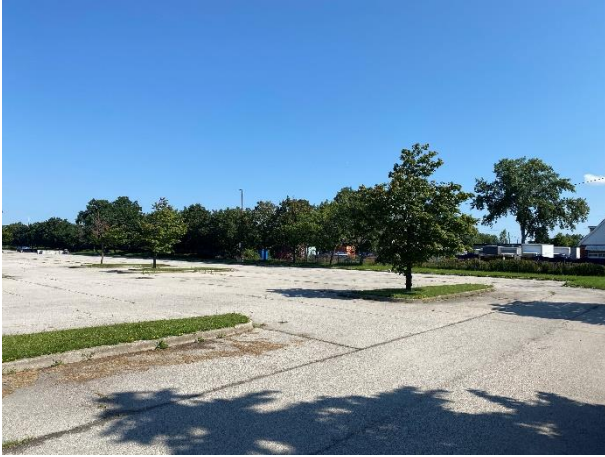
Median trees (1650 Dundas St E)

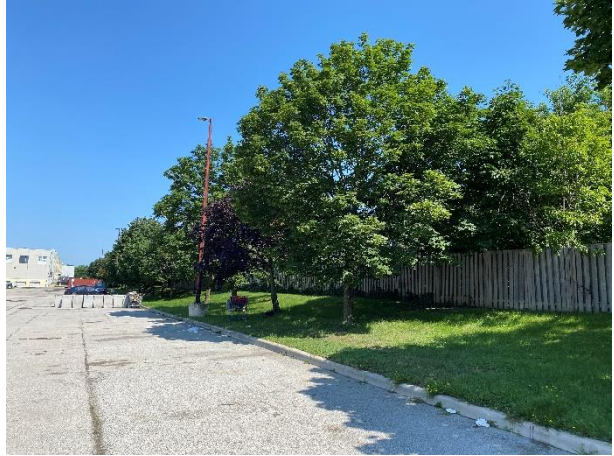
Trees along north edge of parking lot (1650 Dundas St E)

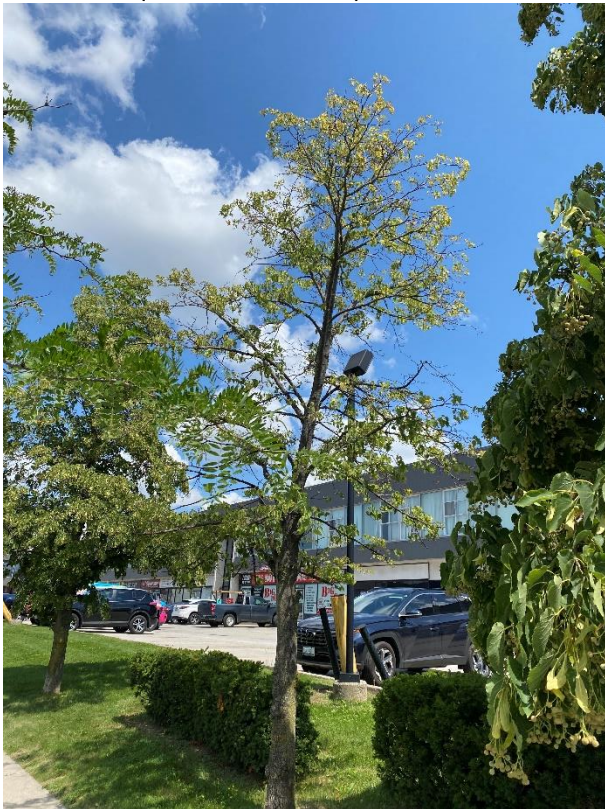
Street tree (1650 Dundas St E)

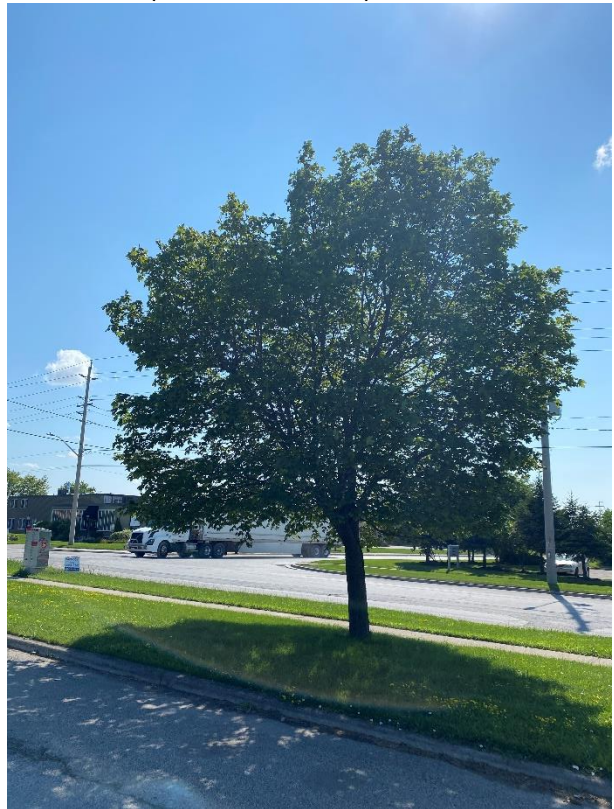
Tree #1746 (1650 Dundas St E)
