**Tree Inventory and Preservation Plan
2620 Chalkwell Close
Mississauga, Ontario**

14 November 2023

KUNTZ FORESTRY CONSULTING INC. Project P3982

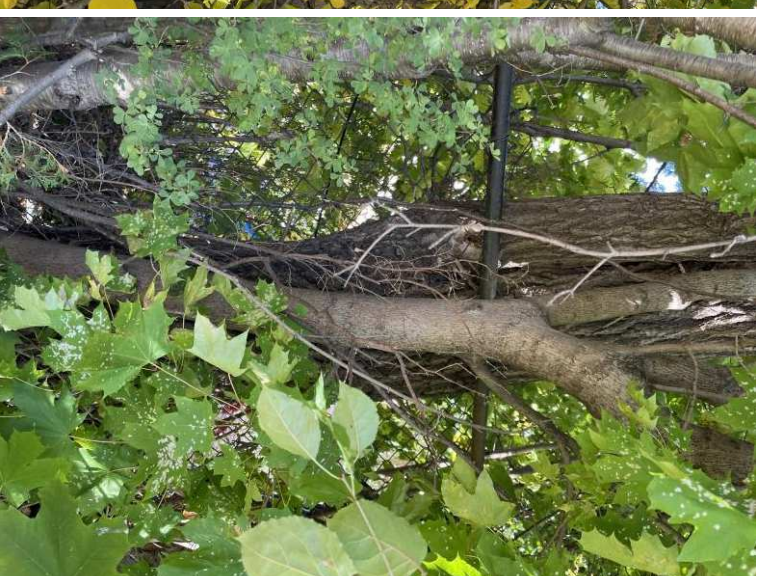
Image 21. Trees K (back) and L (front)

Where the minimum tree protection zone (mTPZ) of a tree cannot be fully respected, including for Trees K, AB, AI, and AM, special mitigation measures have been prescribed and are described below.

Encroachment into the mTPZs of Trees K, AB, and AI will be required to accommodate the construction of proposed sidewalks and / or laneways. Tree preservation fencing has been prescribed within the mTPZs of these trees at the anticipated limits of encroachment. If the following mitigation measures are employed, long-term adverse effects are not anticipated for these trees.

K	Siberian Elm	<i>Ulmus pumila</i>	~54		F	PF	PF	40	7	3.6	V-union at 1.5m with included bark, included fence (L)	Subject Property	Preserve (Injure)	
L	Norway Maple	<i>Acer platanoides</i>	~14		F	F	F		2	1.5	Included fence (L), lean (L), asymmetrical crown (M)	Subject Property	Preserve	
M	Norway Maple	<i>Acer platanoides</i>	12, 9, 8, 8, 6	19.5	P	PF	F		3	1.5	V-union at base and 0.5m with included bark, sweep (H), poor branch unions, included fence (H), asymmetrical crown (H), epicormic branching (L)	Subject Property	Preserve	
N	Siberian Elm	<i>Ulmus pumila</i>	~26		FG	F	F	10	4	1.8	Bow (L), asymmetrical crown (M)	Neighbour Property	Preserve	
O	Siberian Elm	<i>Ulmus pumila</i>	~50		G	PF	PF	40	6	3.0		Neighbour Property	Preserve	
P	Siberian Elm	<i>Ulmus pumila</i>	~28		G	F	F	20	4	1.8	Epicormic branching (L)	Neighbour Property	Preserve	
Q	Siberian Elm	<i>Ulmus pumila</i>	~38, 38, 36, 10, 10	~66	PF	PF	PF	30	7	4.2	V-union at base and 1m with included bark and wetwood, included fence (M), epicormic branching (M), one leader decay (M)	Shared	Remove	5

1. Prior to the commencement of the proposed works, tree preservation fencing must be installed as depicted on Figure 1 and maintained throughout the proposed works.

2. Where indicated on Figure 1 with solid cyan, air-spade or low-pressure hydro-vacuum technology should be used to excavate trenches, under the supervision of a Certified Arborist, at the anticipated limit of disturbance within the mTPZs of these trees.

3. The depth of the trenches will depend on the depth of excavation required to construct the proposed sidewalk or laneway.
4. The roots exposed within the trenches are to be pruned by a Certified Arborist in accordance with Good Arboricultural Standards.

5. The trenches are to be backfilled with clean topsoil.
6. Where softscaping is to occur within the mTPZs of these trees, it should occur by-hand.
7. Any branches that extend into the proposed development and require pruning should be pruned by a Certified Arborist or other tree professional in accordance with Good Arboricultural Standards.

A permit to injure Trees K, AB, and AI will be required.

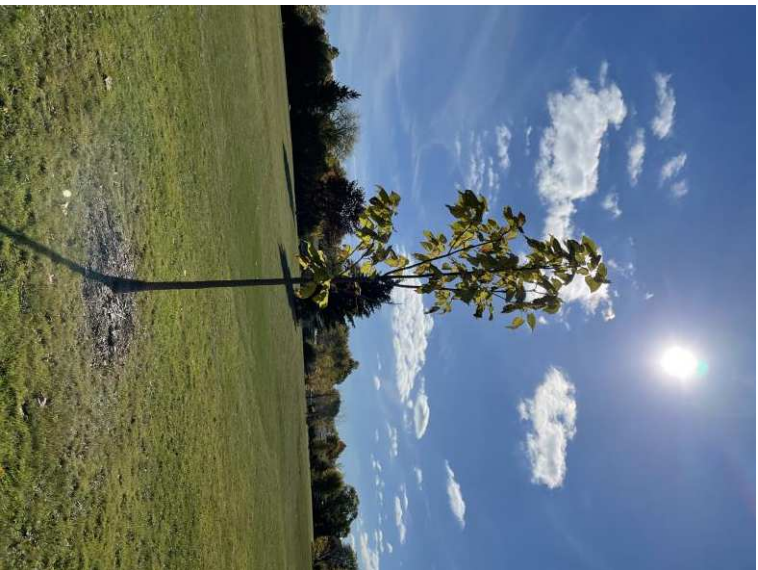
Image 25. Tree T

It should be noted that Tree T is a parkland tree that appears to have been mistakenly planted within the subject property.

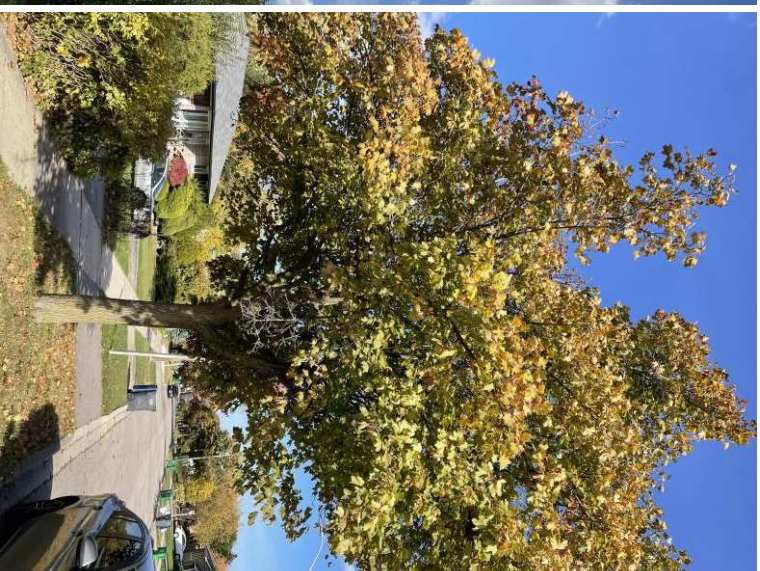
Image 42. Tree AM

Encroachment into the mTPZ of Tree AM will be required to accommodate the removal of the existing sidewalk and curb. Tree preservation fencing has been prescribed within the mTPZ of this tree at the anticipated limit of encroachment. If the following mitigation measures are employed, long-term adverse effects are not anticipated for this tree.

AM	Norway Maple	<i>Acer platanoides</i>	31		F	F	PF	10	3	2.4	Multiple branch attachments, poor branch unions, lean (L)	City (Right-of-Way)	Preserve

1. Prior to the commencement of the proposed works, tree preservation fencing must be installed as depicted on Figure 1 and maintained throughout the proposed works.
2. The existing sidewalk and curb should be removed carefully, using small machinery (i.e. a skidsteer).
3. Any roots encountered within the subsurface material are to be left intact.
4. Once the sidewalk has been removed, no machinery use will be permitted within the exposed area of mTPZ from which the sidewalk was removed.
5. Where softscaping is to occur within the mTPZ of Tree AM, it should occur by-hand.

A permit to injure Tree AM will be required.

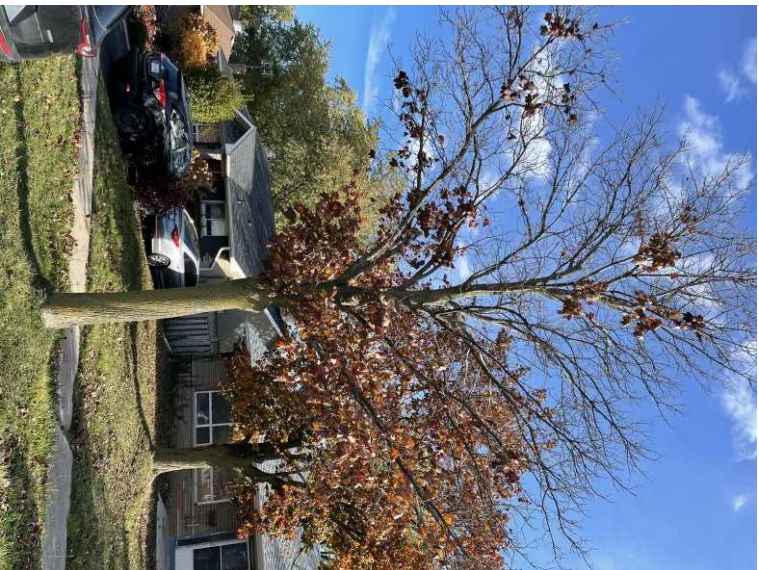
Image 43. Tree AN

Trees 1376 – 1379, 1381, 1385, 1386, 1388 – 1390, 1392, A, B, Q, R, and V are located on private property and are 15cm DBH and greater. As such, these trees will require a permit prior to their removal. Tree AN is located within the Chalkwell Close right-of-way and as such, permission from the City of Mississauga will be required prior to the removal of this tree.

AN	Species	Scientific Name	28.5		PF	P	P	60	3	1.8	Epicoemic branching (M), frost rib (M), cavities (L)	City (Right-of-Way)	Remove	2
P-1	Eastern White Cedar	<i>Thuja occidentalis</i>	~10 - 22		FG	FG	FG	10	2	1.8	Approximately ten trees, average DBH = ~14cm, most trees lean (L)	Neighbour Property	Preserve	
P-2	Eastern White Cedar	<i>Thuja occidentalis</i>	~10 - 12		FG	FG	F	10	2	1.5	Approximately nine trees, average DBH = ~10cm, most trees lean (L)	Shared	Preserve	
P-3	Eastern White Cedar	<i>Thuja occidentalis</i>	~10 - 12		FG	FG	FG		2	1.5	Approximately six trees, average DBH = ~10cm, one tree sweep (M)	Neighbour Property	Preserve	
P-4	Eastern White Cedar	<i>Thuja occidentalis</i>	~10 - 26		G	G	G		2	1.8	Approximately 16 trees, average DBH = ~16cm	Neighbour Property	Preserve	
P-5	Norway Maple	<i>Acer platanoides</i>	~10 - 30		F	F	FG		3	1.8	Approximately 15 trees, average DBH = ~12cm	Shared	Preserve

To compensate for the removal of trees on the subject property, 54 replacement plantings will be required within the boundaries of the subject property. To compensate for the removal of Tree AN, a public tree, two replacement plantings will be required within the Chalkwell Close right-of-way.
