Tree Preservation Plan for
120 Fairview Road West (Ward 7)

Date: August 23, 2023
Revised : November 13, 2023

Site Visits : July 10, 2023
November 10, 2023
January 4, 2024

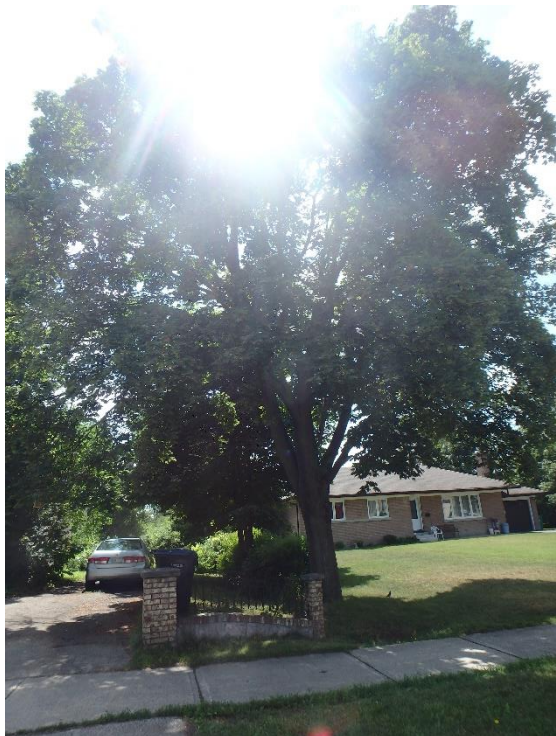
I have estimated that ~9% of the roots located within the TPZ of tree T1 may be impacted by excavations. As the tree is in fair health, and as the species is highly tolerant of root injury, it is my opinion that T1 will remain viable following the completion of construction activities. Note however that an existing structural issue with this tree requires attention by the owner.

Excavations are proposed within the TPZ of tree T1. The following measures will be implemented to limit potential injuries while excavating within TPZs to within tolerable levels:

1. Excavations will be supervised by a Certified Arborist.
2. Excavations will be conducted by hand or via HVAC method (water pressure to <125 psi) along the tree side edge to a maximum depth of 1 meter. No heavy equipment will be used for these excavations.
3. In the event that roots less than 5 cm diameter are encountered during excavations, such roots will be cleanly cut by a Certified Arborist.

4. In the event roots 5 cm or larger diameter are encountered during excavations, or an abundance of smaller roots, activities near the tree will cease and the Certified Arborist will contact Mississauga Forestry.
5. Exposed roots will be kept damp at all times.

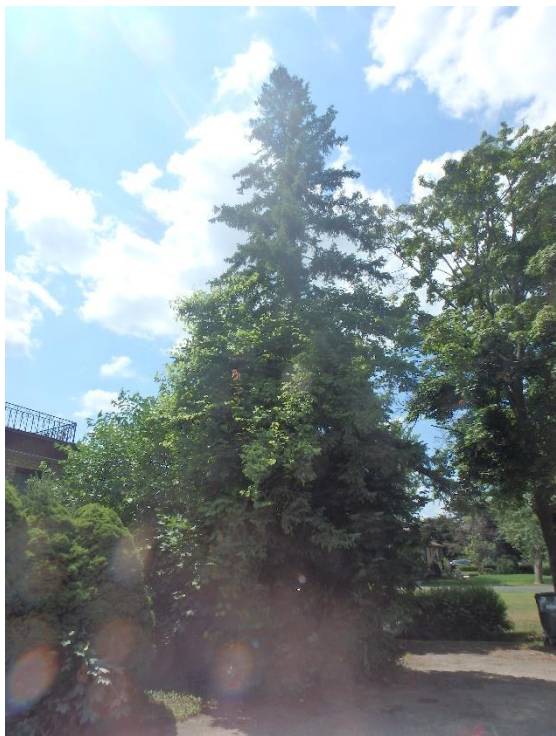
Tree #	Common Name <i>Botanical Name</i>	DBH (cm)	Crown diameter (m)	Health	Structure	Condition Notes (Defect code-Detail code-Severity code)	Category	Proposal	Reason to injure or remove	Minimum Required TPZ	TPZ provided	Hoarding type	Protection notes/comments	City tree appraisals
T1	Norway maple Acer platanoides	60	12.0	f	p	6AI, 3BIII	2	retain, injure	excavations for driveway & foundation	3.6	3	solid	Arborist to supervise excavations	
T2	Norway maple Acer platanoides	18	6.0	g	g		2	remove	too close to foundation excavations	2.4				
T3	Norway maple Acer platanoides	18	3.0	g	g		2	remove	too close to foundation excavations	2.4				
T4	Norway maple Acer platanoides	22	7.0	g	g		2	remove	too close to foundation excavations	2.4				
T5	White spruce Picea glauca	27	4.0	g	g		1	remove	within footprint of house	2.4

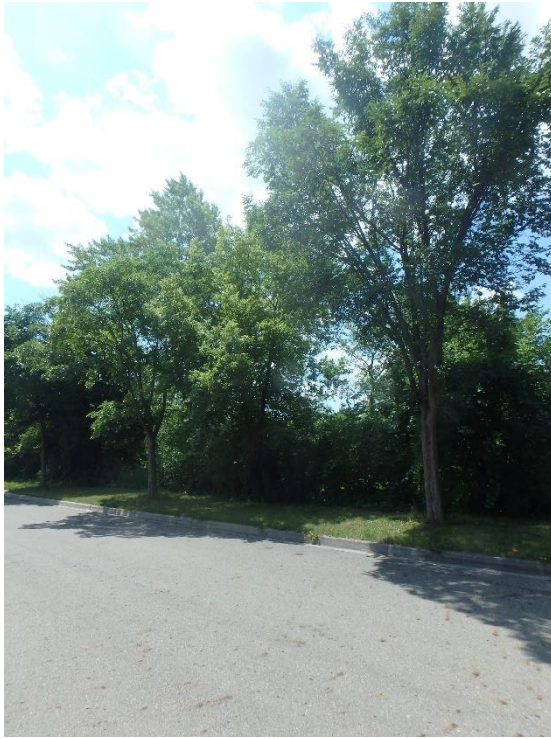
T11 (right background), T12 (right)

Tree #	Common Name <i>Botanical Name</i>	DBH (cm)	Crown diameter (m)	Health	Structure	Condition Notes (Defect code-Detail code- Severity code)	Category	Proposal	Reason to injure or remove	Minimum Required TPZ	TPZ provided	Hoarding type	Protection notes/comments	City tree appraisals
T6	Accolade elm <i>Ulmus japonica x wilsoniana</i>	27	6.5	g	g		3	retain		2.4	2.4	plastic		\$2,130.00
T7	Accolade elm <i>Ulmus japonica x wilsoniana</i>	27	7.0	g	g		3	retain		2.4	2.4	plastic		\$2,130.00
T8	Accolade elm <i>Ulmus japonica x wilsoniana</i>	27	7.0	g	g		3	retain		2.4	2.4	plastic		\$2,130.00
T9	Accolade elm <i>Ulmus japonica x wilsoniana</i>	27	7.0	f	g	6C1	3	remove	within footprint of driveway	2.4				\$1,655.00
T10	Accolade elm <i>Ulmus japonica x wilsoniana</i>	26	5.5	g	g		3	remove	within footprint of driveway	2.4				\$1,975.00
T11	Manitoba maple <i>Acer negundo</i>	29	5.0	g	p	3BII	1	remove	within footprint of driveway	2.4

T12	Accolade elm <i>Ulmus japonica x wilsoniana</i>	22	5.0	g	g		3	remove	within footprint of driveway	2.4				\$1,415.00

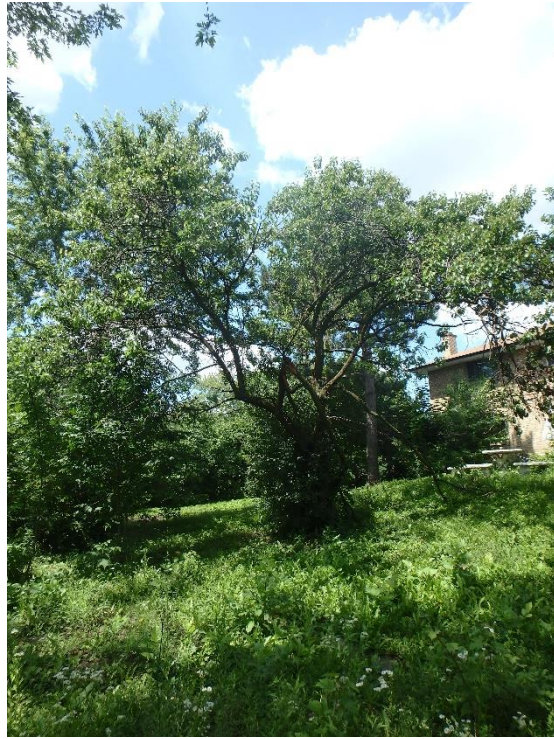
Tree #	Common Name <i>Botanical Name</i>	DBH (cm)	Crown diameter (m)	Health	Structure	Condition Notes (Defect code-Detail code- Severity code)	Category	Proposal	Reason to injure or remove	Minimum Required TPZ	TPZ provided	Hoarding type	Protection notes/comments	City tree appraisals
T13	Accolade elm <i>Ulmus japonica x wilsoniana</i>	20	6.0	g	g		3	remove	within footprint of driveway	2.4				\$1,170.00
T14	Norway maple <i>Acer platanoides</i>	22	5.5	g	g		1	remove	within footprint of driveway	2.4				
T15	Japanese maple <i>Acer palmatum, var.</i>	8	3.0	g	g		1	remove	too close to excavations for road	1.8				\$95.00
T16	Common plum <i>Prunus domestica</i>	15	5.0	p	p	6BIII	1	remove	condition, too close to excavations for driveway & foundation	2.4				
T17	Common plum <i>Prunus domestica</i>	16	5.0	g	g		1	remove	too close to excavations for driveway & foundation	2.4				
T18	Apricot <i>Prunus armeniaca</i>	24	8.0	p	p	6CII, 3BIII	1	remove	within footprint of house	2.4

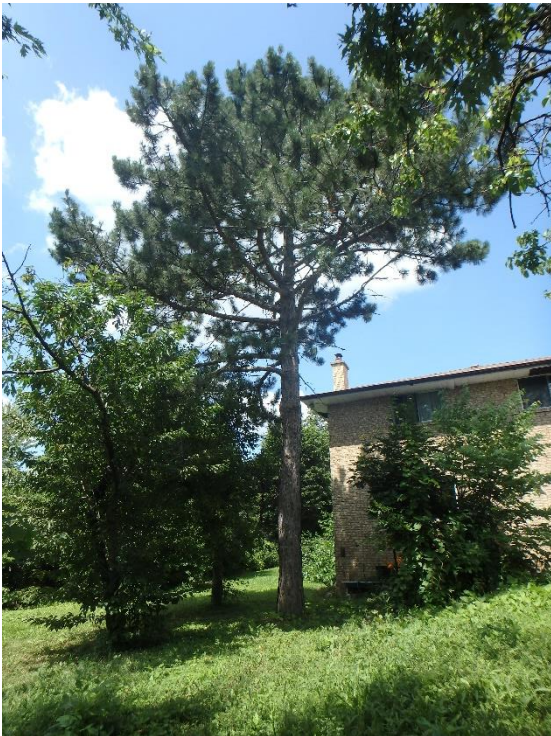
T19 (centre)

T19	Austrian pine <i>Pinus nigra</i>	49	6.5	g	g		1	remove	too close to excavations for foundation	3

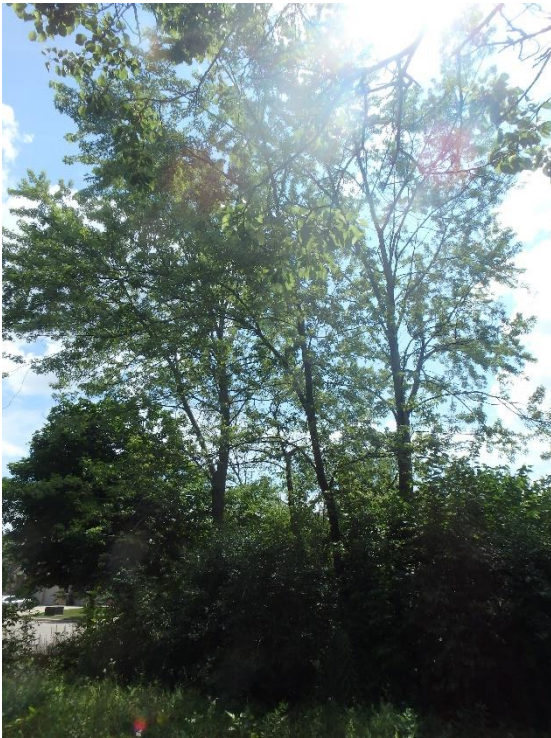
T25, T26, T27, T28 (right to left)

Tree #	Common Name <i>Botanical Name</i>	DBH (cm)	Crown diameter (m)	Health	Structure	Condition Notes (Defect code-Detail code- Severity code)	Category	Proposal	Reason to injure or remove	Minimum Required TPZ	TPZ provided	Hoarding type	Protection notes/comments	City tree appraisals
T20	Common apple <i>Malus domestica</i>	25	3.0	p	p	6AII, 18AIII (canker)	1	remove	within footprint of house	2.4				
T21	Norway maple <i>Acer platanoides</i>	18	3.5	g	g		2	remove	grading	2.4				
T22	Norway maple <i>Acer platanoides</i>	19	3.5	g	g		2	remove	grading	2.4				
T23	Norway maple <i>Acer platanoides</i>	16	4.0	g	g		2	remove	grading	2.4				
T24	Silver maple <i>Acer saccharinum</i>	22	6.0	g	g		1	remove	within footprint of house	2.4				
T25	Silver maple <i>Acer saccharinum</i>	44	7.0	g	g		1	remove	within footprint of house	3				
T26	Silver maple <i>Acer saccharinum</i>	28	5.5	g	f	10CII	1	remove	within footprint of house	2.4

T27	Silver maple <i>Acer saccharinum</i>	23	4.0	p	g	6AI, 6CII	1	remove	within footprint of driveway	2.4

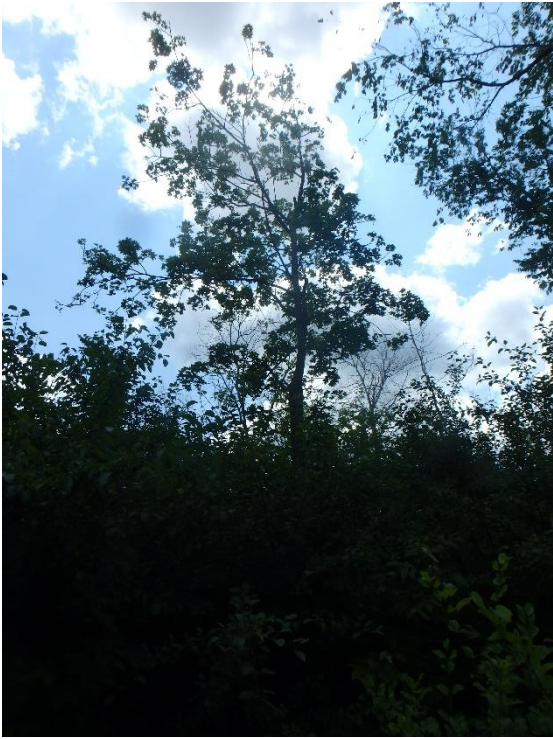
Tree #	Common Name <i>Botanical Name</i>	DBH (cm)	Crown diameter (m)	Health	Structure	Condition Notes (Defect code-Detail code- Severity code)	Category	Proposal	Reason to injure or remove	Minimum Required TPZ	TPZ provided	Hoarding type	Protection notes/comments	City tree appraisals
T28	Silver maple Acer saccharinum	41	7.0	g	g		1	remove	within footprint of driveway	3				
T29	Norway maple Acer platanoides	28	6.0	g	g		1	remove	within footprint of road	2.4				
T30	Norway maple Acer platanoides	19	4.0	g	g		1	remove	lot to be paved	2.4				
T31	White elm Ulmus americana	23	6.0	g	g		1	remove	lot to be paved	2.4				
T32	Common apple Malus domestica	15	4.0	g	g		1	remove	within footprint of road	2.4				
T33	White elm Ulmus americana	30	6.0	f	g	13ACII (DED)	1	remove	within footprint of house	2.4				
T34	White elm Ulmus americana	26	4.0	f	g	6AII	1	remove	within footprint of house	2.4				
T35	Red maple Acer rubrum	17	3.5	f	g	6ACII	1	remove	within footprint of house	2.4

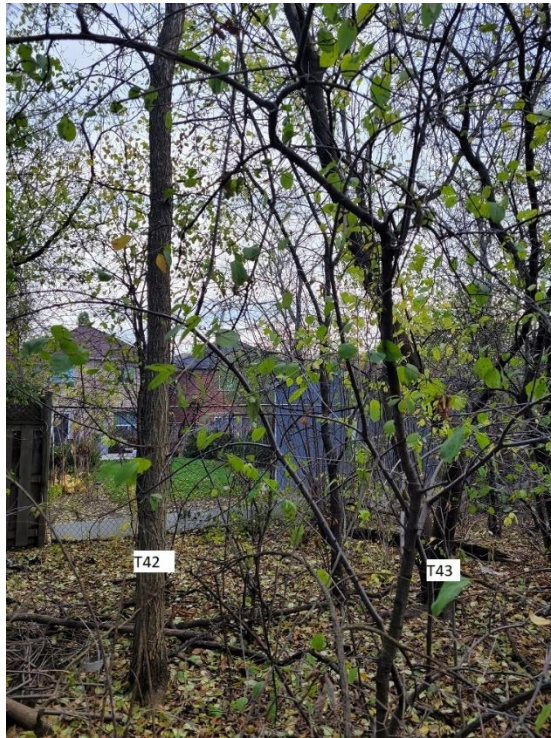
T42, T43

Tree #	Common Name <i>Botanical Name</i>	DBH (cm)	Crown diameter (m)	Health	Structure	Condition Notes (Defect code-Detail code- Severity code)	Category	Proposal	Reason to injure or remove	Minimum Required TPZ	TPZ provided	Hoarding type	Protection notes/comments	City tree appraisals
T36	White elm <i>Ulmus americana</i>	15	2.0	p	g	13ACIII (DED)	1	remove	lot to be paved	2.4				
T37	White elm <i>Ulmus americana</i>	18	4.0	g	g		1	remove	lot to be paved	2.4				
T38	Sour cherry <i>Prunus cerasus</i>	14	3.0	p	p	6AIII, 3BII	1	remove	within footprint of house	2.4				
T39	Silver maple <i>Acer saccharinum</i>	11	3.0	g	g		1	remove	grading	2.4				
T40	Bur oak <i>Quercus macrocarpa</i>	17	3.0	g	g		1	remove	lot to be paved	2.4				
T41	Manitoba maple <i>Acer negundo</i>	22	4.0	g	p	10CII	1	remove	lot to be paved	2.4				
T42	White elm <i>Ulmus americana</i>	12	5.0	g	g		1	remove	lot to be paved	2.4				
T43	Manitoba maple <i>Acer negundo</i>	20	6.0	g	p	3BII	1	remove	lot to be paved	2.4

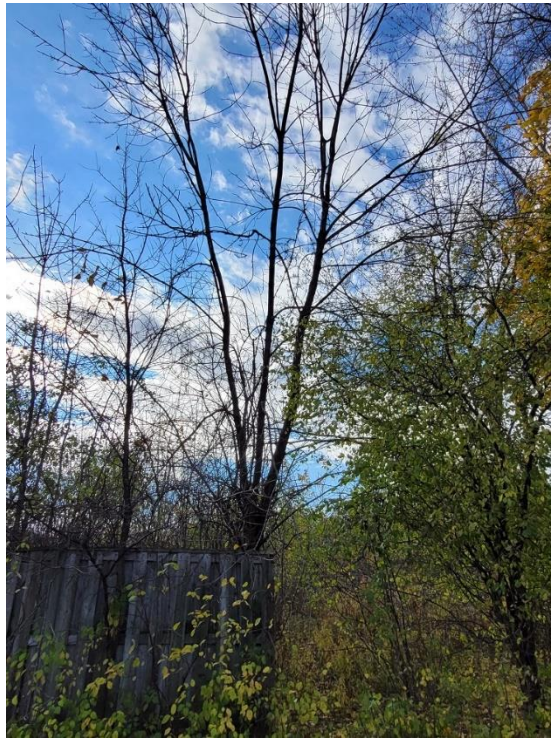
Tree #	Common Name <i>Botanical Name</i>	DBH (cm)	Crown diameter (m)	Health	Structure	Condition Notes (Defect code-Detail code- Severity code)	Category	Proposal	Reason to injure or remove	Minimum Required TPZ	TPZ provided	Hoarding type	Protection notes/comments	City tree appraisals
T44	Norway maple Acer platanoides	11	3.0	g	g		1	remove	within footprint of driveway	2.4	4.8			
T45	Red mulberry Morus rubra	14	3.0	g	g		1	remove	too close to proposed road	2.4	4.8			
T46	White elm Ulmus americana	13	2.0	g	g		1	remove	within footprint of proposed road	2.4	4.8			
T47	Common buckthorn Rhamnus cathartica	11	4.0	g	g		1	remove	within footprint of driveway	2.4	4.8			
T48	Green ash Fraxinus pennsylvanica	21	1.0	p	p	9AIII, 13ACIII	1	remove	grading, hazard tree	2.4	4.8
