Arborist Report

2463, 2469 Mimosa Row, Mississauga, Ontario, Canada

Prepared by Serg V. Litvinov, B. Sc, ISA Certification ON-2281A

November 10, 2023

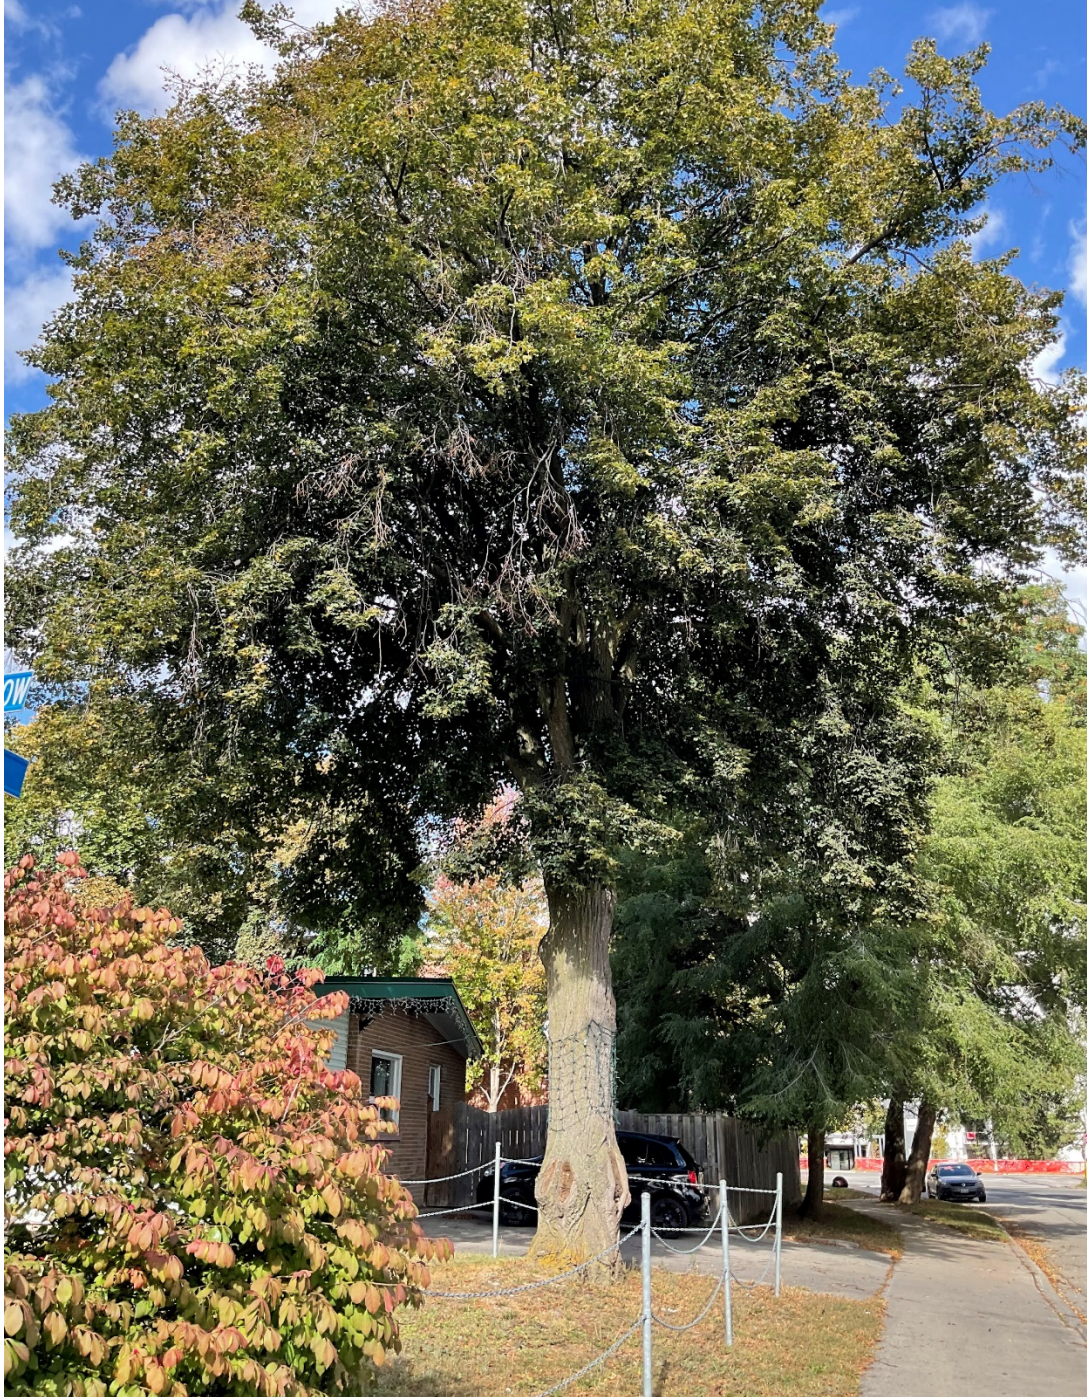
Tree 1:

Tree #1 is a 68cm mature Littleleaf Linden in City ownership, located in front yard of the property. The tree is in Good botanical and structural condition, with no significant flaws noted during the latest site visit. There is a minor amount of small diameter deadwood present in the crown and a pruning wound however, these flaws are not of immediate concern and do not affect tree's overall well-being and longevity.

Injury source	Closest point of impact	Max Depth	Impact
Driveway Removal	1.3m	6"	Minor
Veranda Construction	3m	15"	Minor
Walkway Construction	1.3m	6"	Minor/None

The tree in question will require minor to moderate TPZ trespass and root injuries in order to allow for removal of the existing driveway, installation of the interlock walkway and construction of the covered veranda.

Footprints of the proposed walkway overlap with TPZ area of the tree in approximately 5%, and at the given distance it is likely that roots small and medium in size will be discovered at the depth of 6". Discovering moderate amount of such roots is expected, and they will be sharply cut at the face of the trench. Removal of roots larger than 5cm in diameter is forbidden, and if such root is uncovered, the envelope should be immediately back filled, and the footprints of the walkway reduced. Finding and pruning of minor to moderate amount of small diameter roots is expected to have no effect on the structural integrity of the tree and its botanical condition

Footprints of the proposed veranda overlap with TPZ area of the tree in less than 5%, and at the 3m distance it is likely that only minor amount of small diameter roots will be discovered at the depth of 15".

Prior to any work on the driveway location and depth of any utility lines running below the driveway should be marked on the driveway surface. Removal of the existing driveway surface should be done by hand within the TPZ of the tree, using only non-vibrating hand tools. Other tools (such as a jackhammer) can be used outside of the TPZ to break the concrete up into small chunks. All driveway parts should be picked up using shovel and removed from the property. No debris should end up within the TPZ of the tree or be stored on any softscaping surface.

When existing asphalt driveway is removed, the footprints should be cleaned, and the ground pressed before walkway base is installed. The area that will be converted to landscaping should be aerated, covered in high quality soil and sodded/planted as per clients wishes. The base of the new interlock walkway should be made out of gravel- no thicker than 3cm. Such base should be sufficient for installation of 3cm thick layer of interlock pavers.

The walkway will be constructed as a semi-permeable surface and will require 6 inches deep excavation to allow for 1inch deep decomposed granite (or equivalent) base of the walkway and 3 inches thick solid concrete pavers. Excavation deeper than 6 inches is not allowed.

Finding larger roots is not very likely, however if such roots are discovered, they should be retained. Removal of roots larger than 5cm in diameter is forbidden, and if such root is uncovered, the envelope should be immediately back filled, and the footprints of the veranda reduced. Finding and pruning of minor to moderate amount of small diameter roots is expected to have no effect on the structural integrity of the tree and its botanical condition.

The tree will remain safe for retention and its long-term survival is not likely to be compromised by proposed work. No other disturbances of the TPZ should occur during the time of construction. All excavation should be done by hand, following Root Sensitive Excavation principles and using RSE technology.

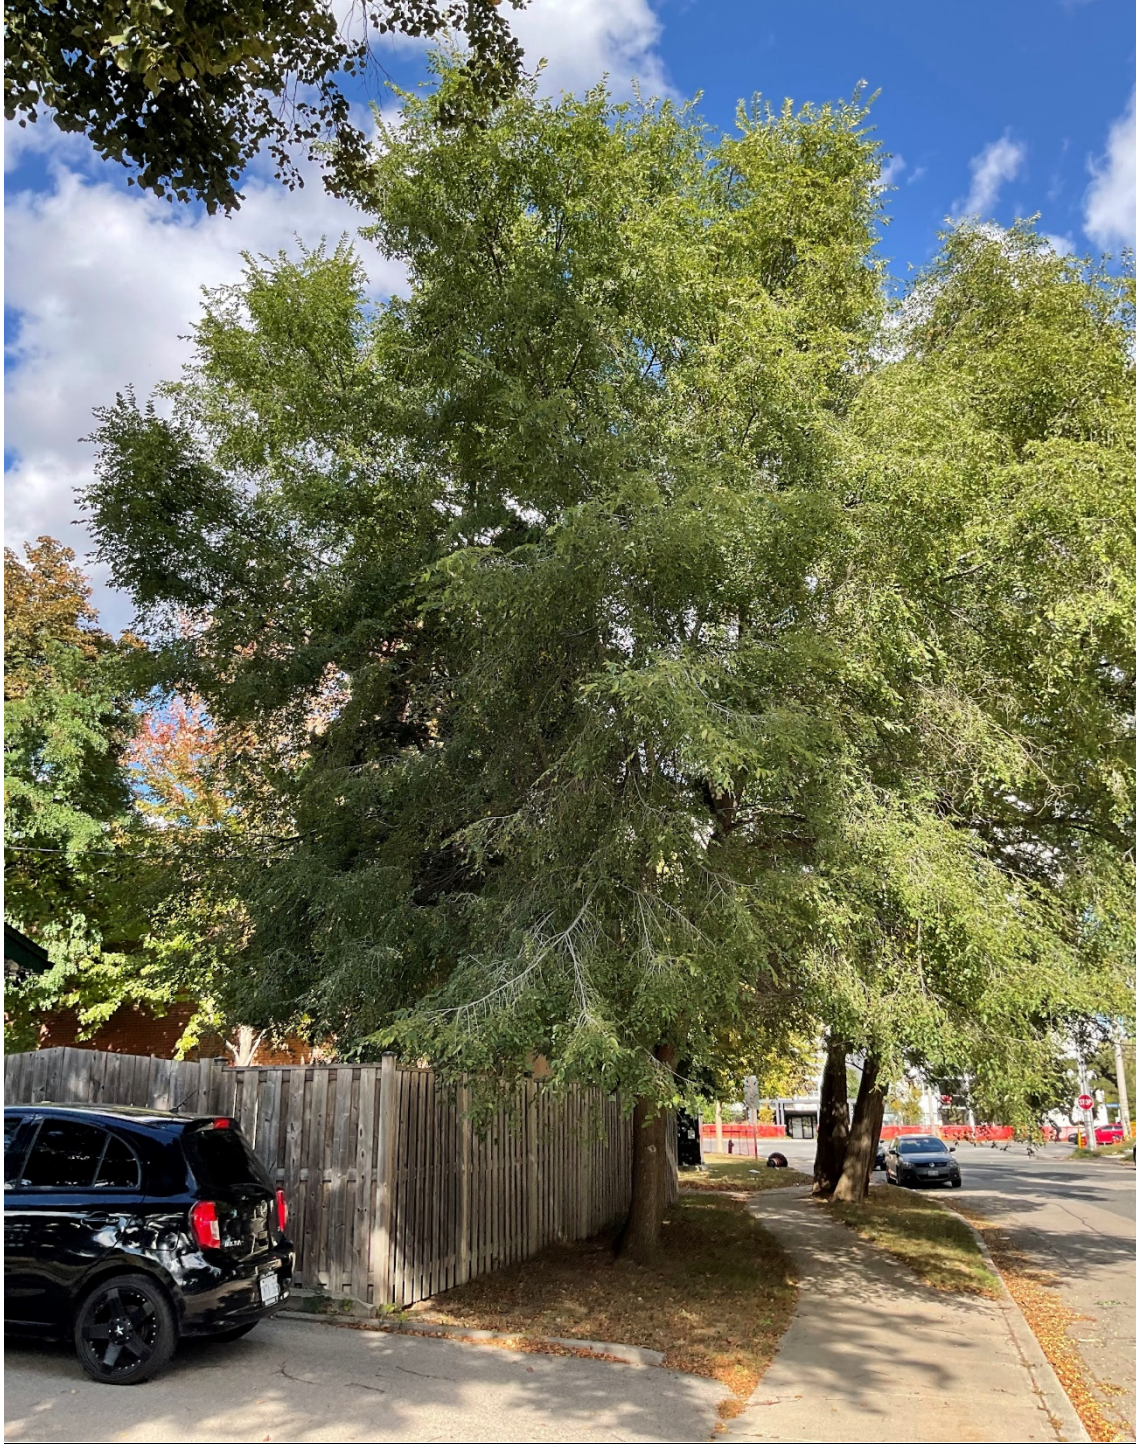
Tree 2:

Tree #2 is a 25,29cm semi-mature Siberian Elm in City ownership, located in front yard of the property. The tree is in Good botanical and structural condition, with no significant flaws noted during the latest site visit. There is a minor amount of small diameter deadwood present in the crown however, this flaw is not of immediate concern and do not affect tree's overall well-being and longevity.

Injury source	Closest point of impact	Max Depth	Impact
Fence Installation	1.6m	48"	Minor

The tree in question will require minor TPZ trespass and root injuries in order to allow for construction of the proposed property fence. The tree in question is located approximately 1.6m

away from the only post that is to be installed within its TPZ. Proposed development will require 2m encroachment on 3.6m TPZ.

The work will likely affect small and medium diameter roots of the tree and will have no significant impact on overall structural integrity of the tree. All excavation within the TPZ of the tree in question should be done by hand and supervised by an ISA certified professional.

The fence that is to be constructed will require installation of 4x4" aluminum posts. The posts are to be placed in 10-inch wide sono-tubes placed every 6 feet. Full depth of the posts will not be greater than 48". All work on digging holes for sono-tubes will be done by hand following Root Sensitive Excavation methodology.

Every effort for preservation as many large diameter roots as possible should be made. Exploratory excavation trench should be opened to assess root distribution and provide clearer picture of the damage that construction will be causing to the roots. It is expected to discover abundance of small diameter roots and only several moderate diameter roots while discovering large diameter roots is not likely.

If, however, such roots are discovered, they should be preserved, and proposed location of sono-tube and aluminum post moved over a few inches in order to allow for their preservation. Finding and pruning some amount of small diameter roots is expected to have no effect on the structural integrity of the tree and its botanical condition. The tree will remain safe for retention and its long-term survival is not likely to be compromised by proposed work.

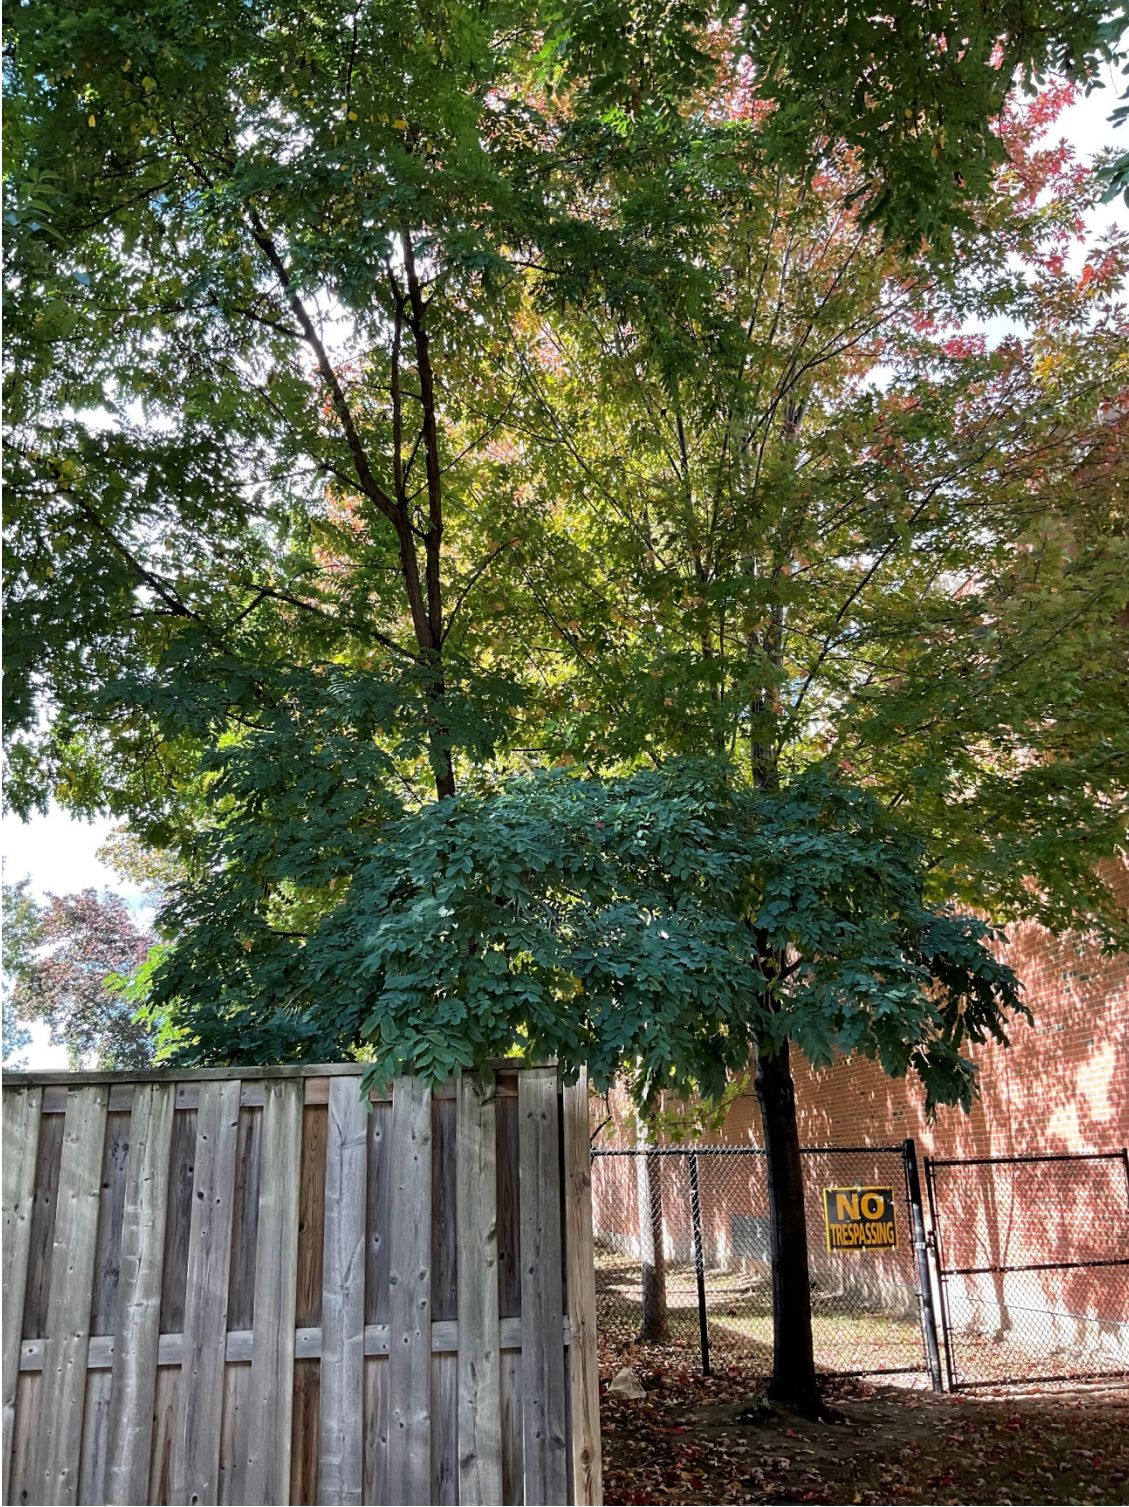
Trees 6-10:

Tree #9 is a 50cm semi-mature Norway Maple in Neighbouringownership, located in back yard of the adjacent property. The tree is in Good botanical and structural condition, with no significant flaws noted during the latest site visit. There is a minor

Injury source	Closest point of impact	Max Depth	Impact
Aluminum Shed Removal	2.3m	6"	Minor

amount of small diameter deadwood present in the crown however, this flaw is not of immediate concern and do not affect tree's overall well-being and longevity.

The tree in question will require minor to moderate TPZ trespass and minor physical root injuries in order to allow for removal of the existing aluminum shed. Existing shed is located approximately 2.3m away from the trunk of the tree at the closest point, necessitating 1.3m encroachment on 3.6m TPZ.

The shed is to be demolished by hand and removed from the property. No debris should be left within the TPZ of the tree in question. The shed was constructed on a concrete pad and after the shed is removed the pad should be carefully broken into smaller chunks using hand tools and removed from the property. Concrete pad braking should be done using only hand tools within the TPZ of the tree.

Other tools (such as a jackhammer) can be used outside of the TPZ to break the concrete up.

Debris should be removed from the property and footprints covered in high quality soil. The area is to be sodded after all other construction work on the property is completed. Excavation should not be deeper than absolutely necessary. All excavation within the TPZ should be done by hand and supervised by certified arborist.

Excavation should not be deeper than absolutely necessary. All excavation within the TPZ should be done by hand and supervised by certified arborist.

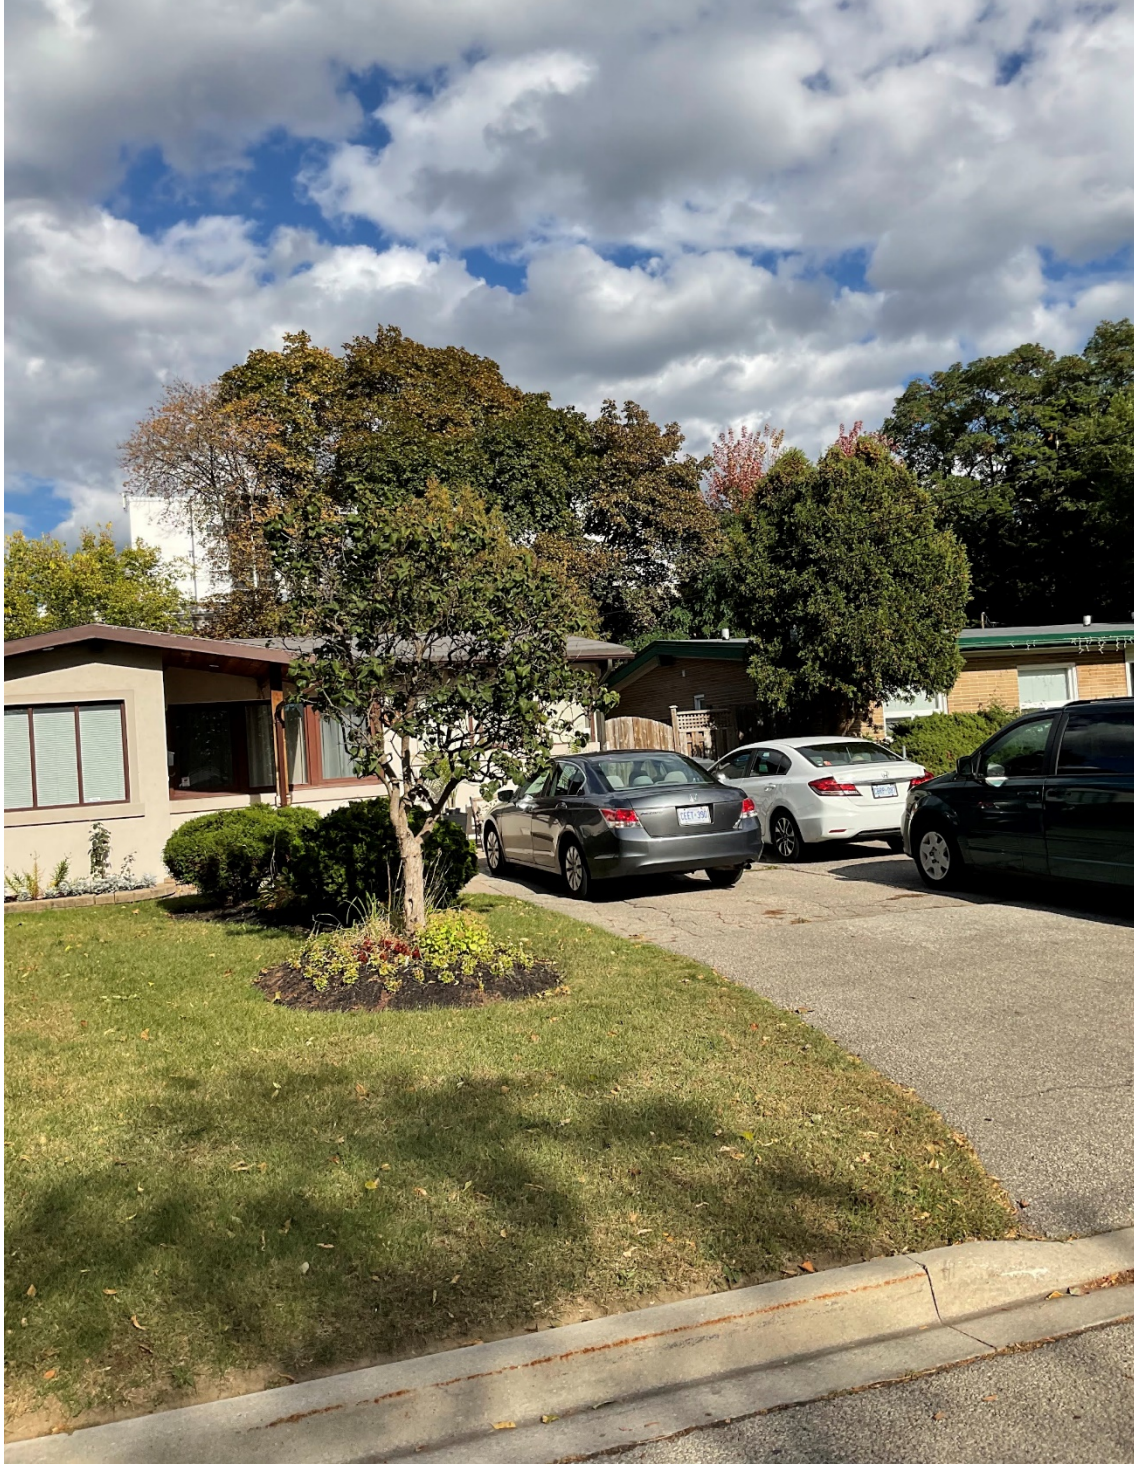
Tree 11:

Tree #11 is a 29cm semi-mature Eastern White Cedar in Private ownership, located in front yard of the property. The tree is in Fair botanical and structural condition, with several flaws noted during the latest site visit. There is a minor amount of small diameter deadwood present in the crown, the tree is leaning and demonstrates fair health and overall form.

The tree in question will require removal in order to allow for construction of the proposed dwellings. It is located directly within the footprints of the proposed houses and is obstructing the space that will require 6' deep foundation excavation.

Due to its location retention is not possible and pre-emptive removal is recommended.

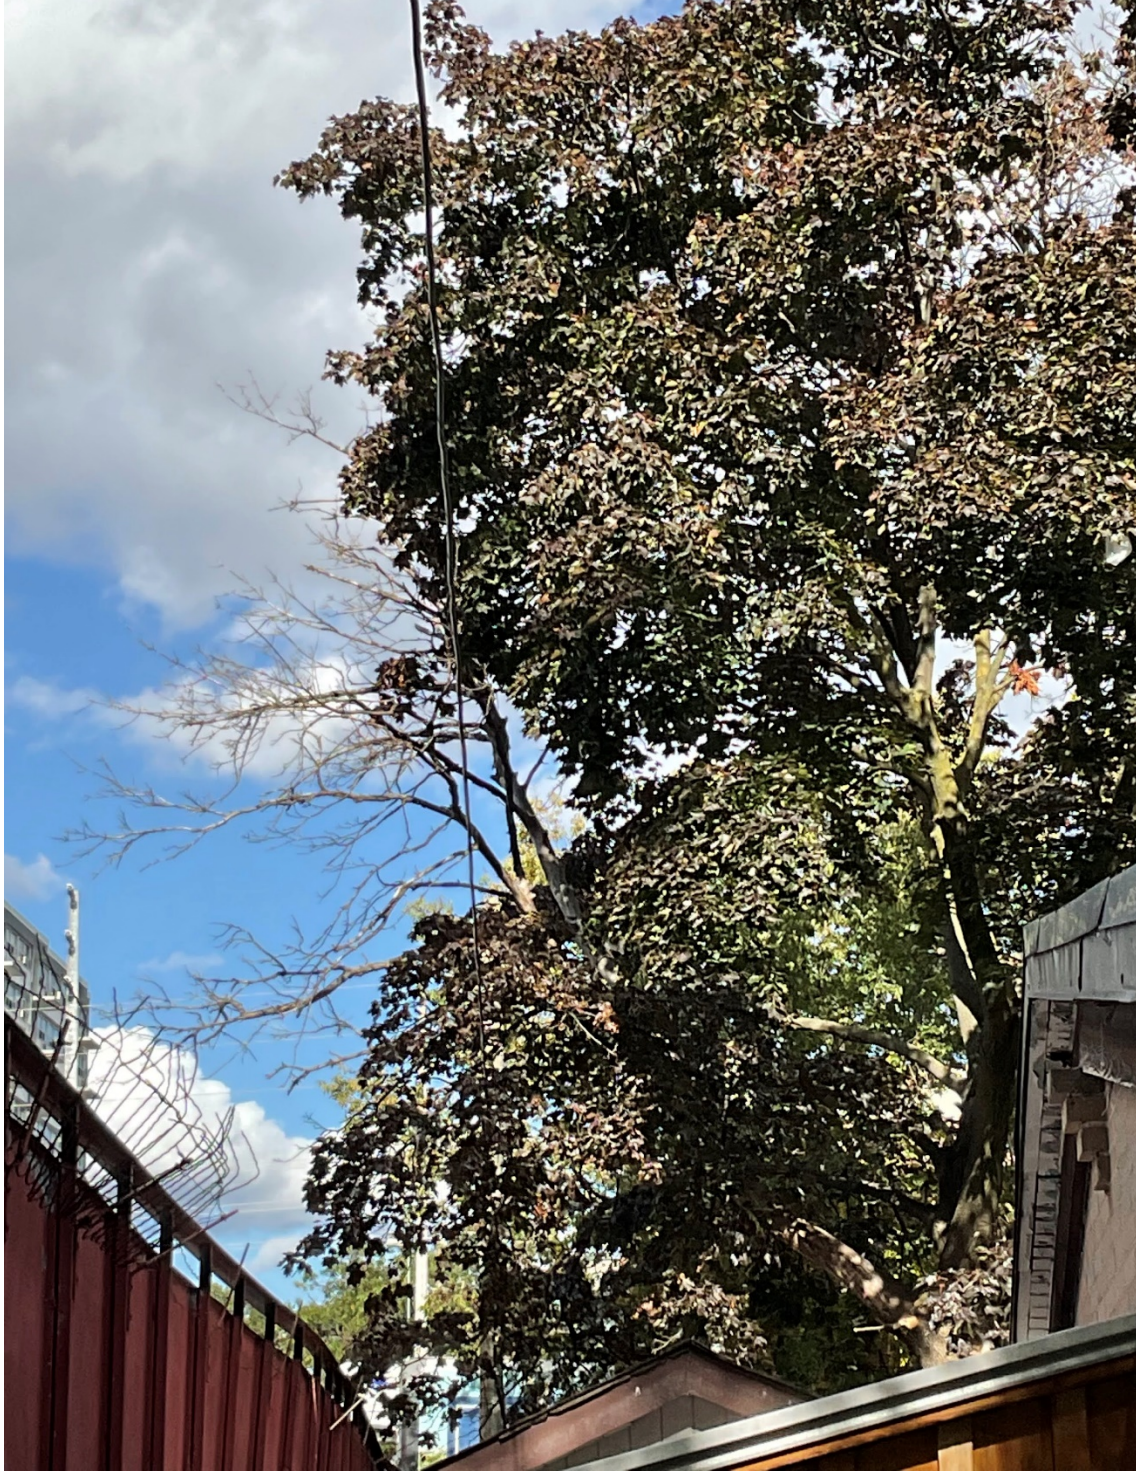
Tree 12:

Tree #12 is a 51cm semi-mature Norway Maple in Private ownership, located in back yard of the property. The tree is in Poor botanical and structural condition, with numerous significant flaws noted during the latest site visit. There is a minor to moderate amount of small diameter deadwood present in the crown, one limb of over 10cm in diameter is dead, the crown is bent and the tree is in overall health decline.

The tree in question will require removal in order to allow for construction of the proposed dwellings. It is located directly adjacent (less than 1.5m away) to the footprints of the proposed houses and will require total root loss of over 50% of its TPZ. The tree is not likely to survive such injuries, nor to retain its structural integrity, and should therefore be removed.

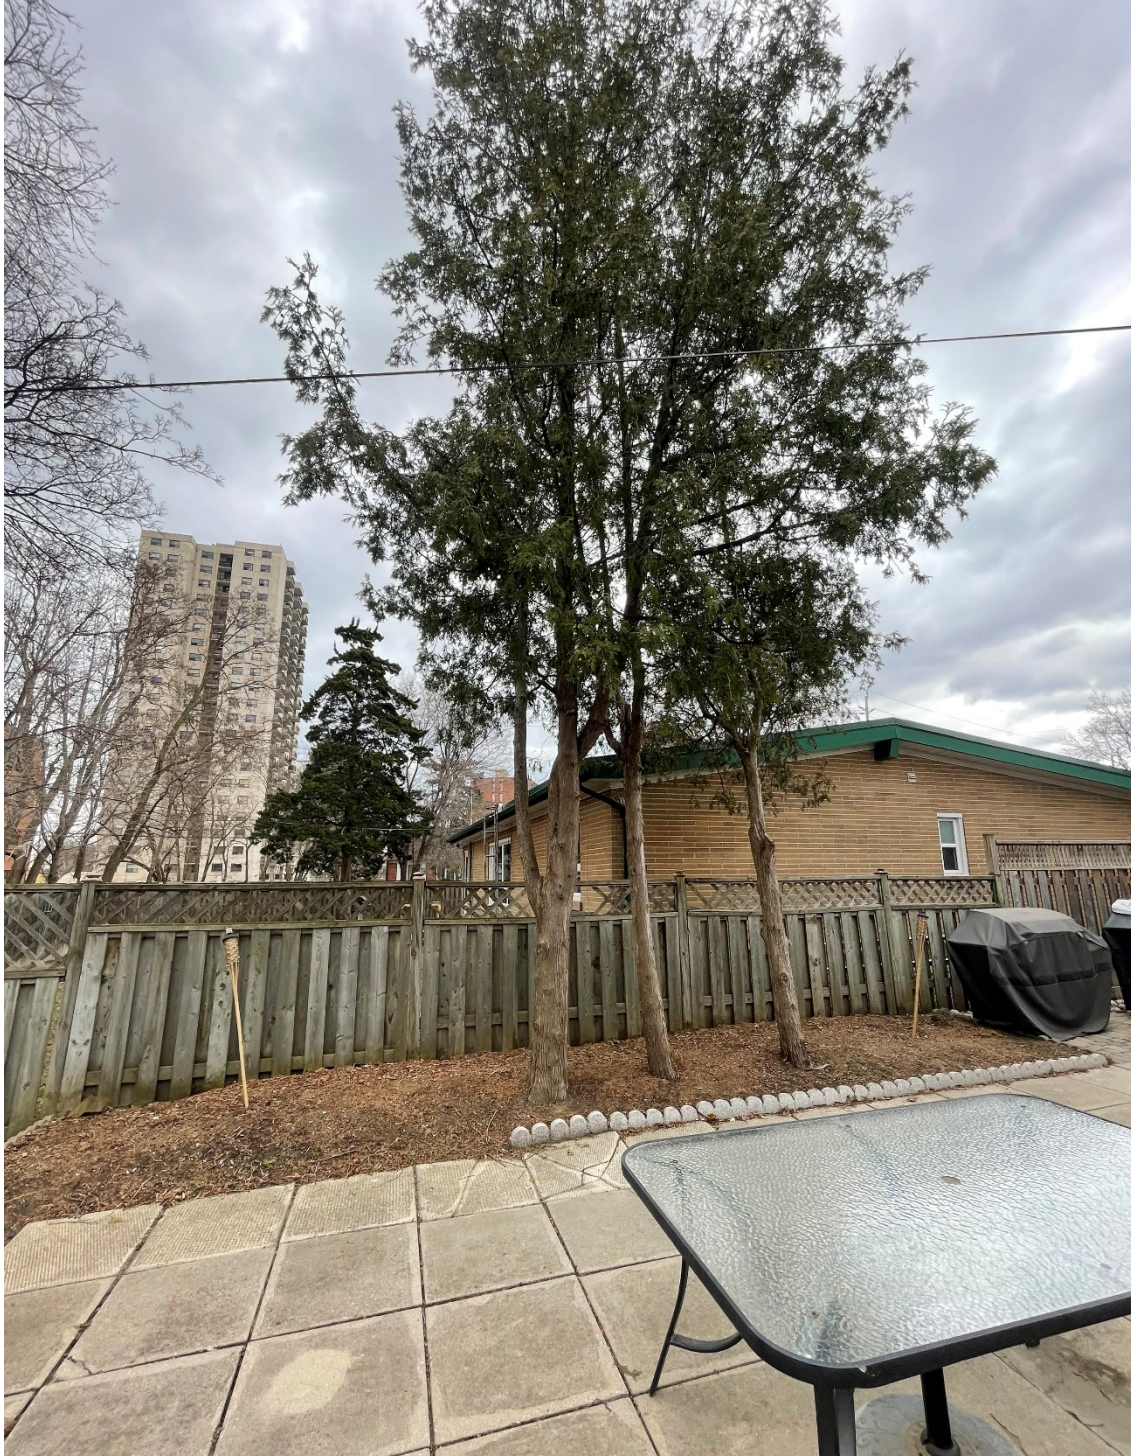
Tree 13:

Tree #13 is a 24cm semi-mature Eastern White Cedar in Private ownership, located in back yard of the property. The tree is in Fair botanical and structural condition, with no significant flaws noted during the latest site visit. There is a minor amount of small diameter deadwood present in the crown however, this flaw is not of immediate concern and do not affect tree's overall well-being and longevity.

The tree in question will require removal in order to allow for construction of the proposed dwelling. It is located directly within the footprints of the proposed house and is obstructing the space that will require 6' deep foundation excavation.

Due to its location retention is not possible and pre-emptive removal is recommended.
