**Arborist Report  
Erin Mills Town Centre – Block 1  
Mississauga, Ontario**

**Studio tla  
20 Champlain Boulevard, Suite 102  
Toronto, Ontario M3H 2Z1**

10 September 2024

KUNTZ FORESTRY CONSULTING Inc. Project P4111

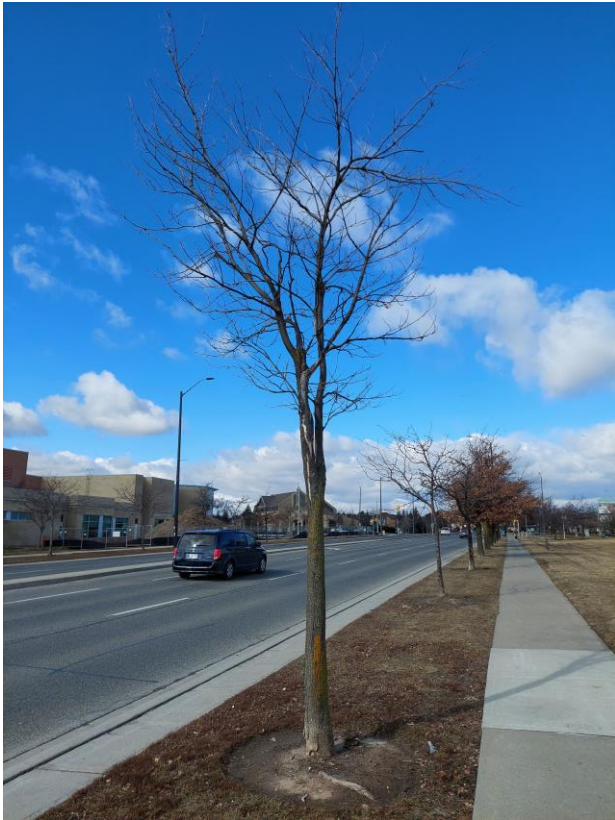
Image 13. Tree 13

Trees 13 and 15, both located within Glen Erin Drive road right-of-way, are completely dead. The removal of these two trees is recommended. Refer to Figure 1 for the location of required tree removals.

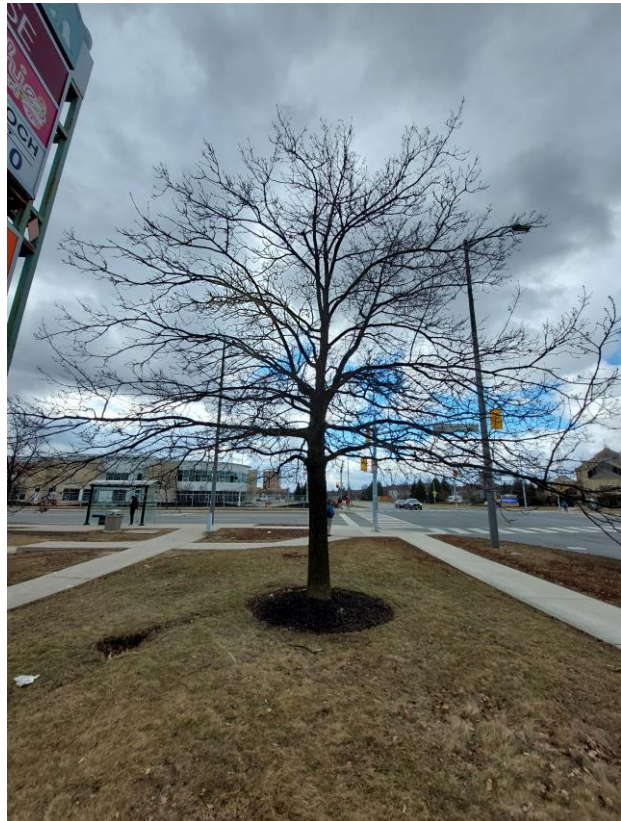
Image 41. Tree 50

The removal of 41 trees is required to accommodate the proposed development. Required tree removals include Trees 1, 6-8, 24-50, and 59-68. Trees 1 and 6-8 have conflicts with the new private roads and turning sight triangles. Tree 50 conflicts with the new Urban Plaza entrance. The remaining trees have direct conflicts with the proposed buildings and landscaping. Trees 6-8 and 50 are located within the city road right-of-way. All other trees that require removal are greater than 15cm DBH on the subject property and protected by the City of Mississauga Tree By-law; a permit will be required prior to their removal.

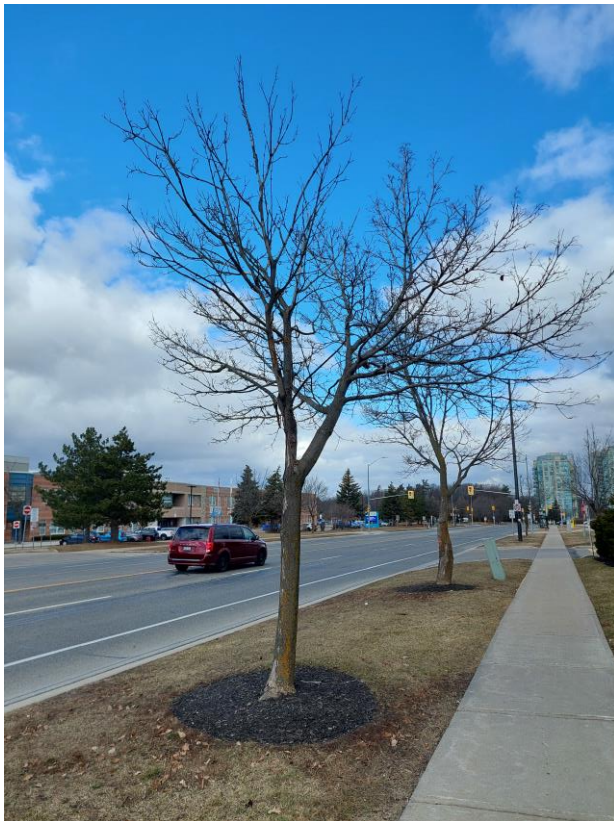
Image 48. Tree 57

Trees 57, 58, and 69 are in hazardous conditions and have orange paint marking, which indicates their removal is proposed by the City Urban Forestry.

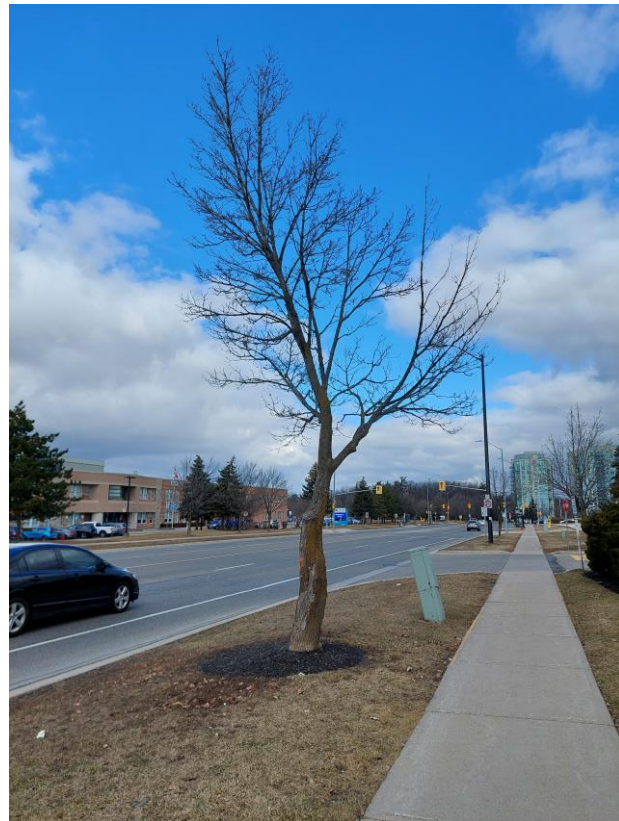
Image 49. Tree 58

58	Norway Maple	<i>Acer platanoides</i>	27	P	P	P		3	1.8	Orange marking -> removal proposed by city, co-dominance at 1.6m but 1 stem cut, canker (H) at base ==> hazard	City	Removal proposed by City	0
59	Serviceberry	<i>Amelanchier spp.</i>	10.5, 9.5, 8, <8	G	G	G		2	1.5	Multi-stemmed, union at base with 7 stems, exposed roots (M)	Private	Remove	1
60	Serviceberry	<i>Amelanchier spp.</i>	8, 7.5, 6, <6	G	G	G		2	1.5	Multi-stemmed, union at base with 8 stems, exposed roots (M)	Private	Remove	1
61	Serviceberry	<i>Amelanchier spp.</i>	9.5, 9.5, 9, <9	G	G	G		2	1.5	Multi-stemmed, union at base with 8 stems, exposed roots (M)	Private	Remove	1
62	Serviceberry	<i>Amelanchier spp.</i>	8, 7, 6.5, <6	G	G	G		2	1.5	Multi-stemmed, union at base with 13 stems, exposed roots (L)	Private	Remove	1
63	Norway Maple	<i>Acer platanoides</i>	19.5	G	G	F-G		2	1.5	Exposed roots (M)	Private	Remove	2
64	Colorado Blue Spruce	<i>Prunus virginiana</i>	~28	G	G	F-G		1.5	1.8		Private	Remove	2
