**Tree Inventory and Preservation Plan Report
1785 Bloor Street
Mississauga, Ontario**

27 May 2022; revised 14 September 2023

KUNTZ FORESTRY CONSULTING INC. Project P2991

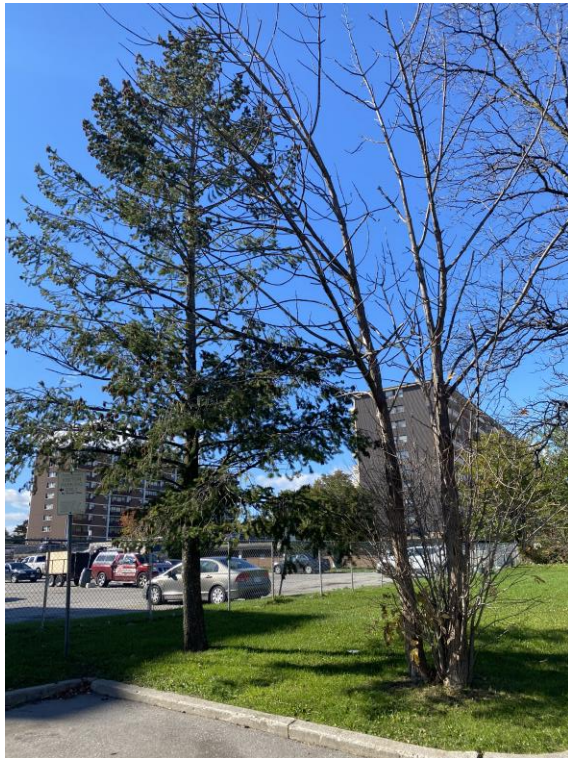
Image 1. Tree 949 (left)

Tree #	Common Name	Scientific Name	DBH	TI	CS	CV	CDB	DL	mTPZ	Comments	Owner	Action	Comp.
949	Douglas Fir	<i>Pseudotsuga menziesii</i>	26	FG	G	G		2	1.8	Sweep (L), broken branches (VL)	Private	Remove	2
950	Shagbark Hickory	<i>Carya ovata</i>	41	P	G	F		3	3	Cavity (H) at 1m and in crown, sloughing bark	Private	Remove	3
951	Sugar Maple	<i>Acer saccharum</i>	58	F	FG	G		4	3.6	Sweep (L), crook (M) in crown	Private	Remove	4
952	Sugar Maple	<i>Acer saccharum</i>	57	FG	F	F	20	5	3.6	Sweep (L), deadwood (L), poor form (L), multiple branch attachments (L)	Private	Remove	4
953	Sugar Maple	<i>Acer saccharum</i>	46.5	FG	FG	FG		5	3	Broken branches (L), asymmetrical crown (L), girdling roots (L)	Private	Remove	4
954	American Beech	<i>Fagus grandifolia</i>	47	PF	F	F		5	3	Bow (M), asymmetrical crown (M), broken branches (L), decay in main leader in crown from a lost leader	Private	Remove	4
955	Shagbark Hickory	<i>Carya ovata</i>	38	G	G	F		5	2.4	Sloughing bark	Private	Remove	3

The removal of 21 trees will be required to accommodate the proposed development. The required tree removals include Trees 949 – 959, 965, 966, 968 – 971, B – D, and K. Trees noted as dead on Figure 1 should also be removed.

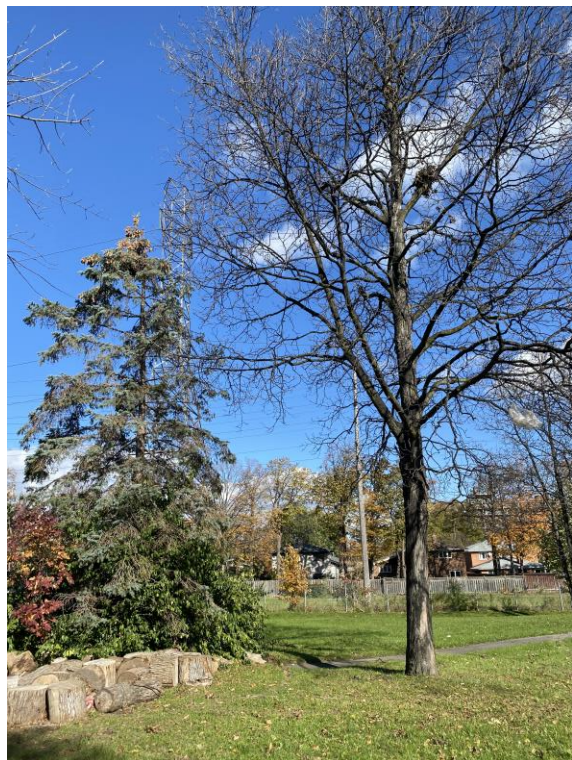
Image 4. Trees 955 (right) and 956 (left)

956	Blue Spruce	<i>Picea pungens</i>	~20	FG	FG	F		2	1.8	Competing with euonymus (climbing) (H), sweep (L)	Private	Remove	2
957	White Ash	<i>Fraxinus americana</i>	60	PF	PF	P	80	6	3.6	Emerald Ash Borer (H), union at 3m, bark sloughing, deadwood (H), cavity (M) in crown	Private	Remove	4
958	American Beech	<i>Fagus grandifolia</i>	56	PF	FG	FG		6	3.6	V-union at 1m and fused to 1.75m, broken branches (L), cavity (L), stem wounds (M) with decay	Private	Remove	4
959	Little-leaf Linden	<i>Tilia cordata</i>	60	F	F	FG		5	3.6	Sweep (L), V-union at 3m, cavity (M) in crown, top of main leader lost	Private	Remove	4
960	Bitternut Hickory	<i>Carya cordiformis</i>	~24	FG	FG	G		3	1.8	Vine competition (M), crook (L) in crown	Private	Preserve	
961	Shagbark Hickory	<i>Carya ovata</i>	29, 27, 23, 20	FG	F	FG		4	1.8	Union at base with four leaders (codominance)	Private	Preserve	
962	Poplar species	<i>Populus spp.</i>	36	F	F	F	15	3	2.4	Cavity (M), deadwood (L), poor form (M), crook (L) in crown, pruning wounds (L), lean (L)	Private	Preserve

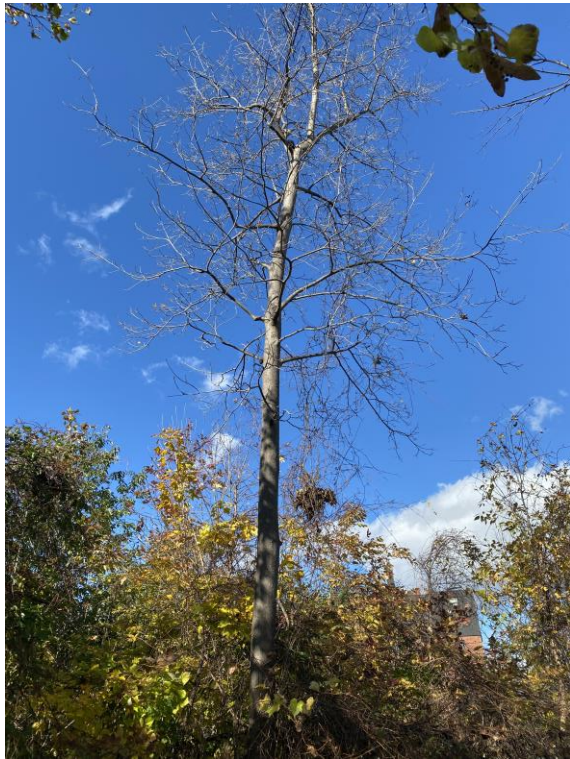
Image 7. Tree 960

The City of Mississauga requires tree protection fencing to be installed at the dripline of a tree. Although this level of protection cannot be respected for Trees 960, 961, and G, these trees are afforded minimum tree protection zones (mTPZs) that are consistent with standards utilized by surrounding municipalities.

The preservation of 14 trees, including Trees 960 – 964, 967, A, E – J, and L, will be possible with the use of appropriate tree protection measures as indicated on Figure 1. Tree protection measures must be implemented prior to the commencement of the proposed works to ensure tree resources designated for retention are not impacted. Refer to Figure 1 for the location of required tree preservation fencing, general Tree Protection Plan Notes, and tree preservation fence details.

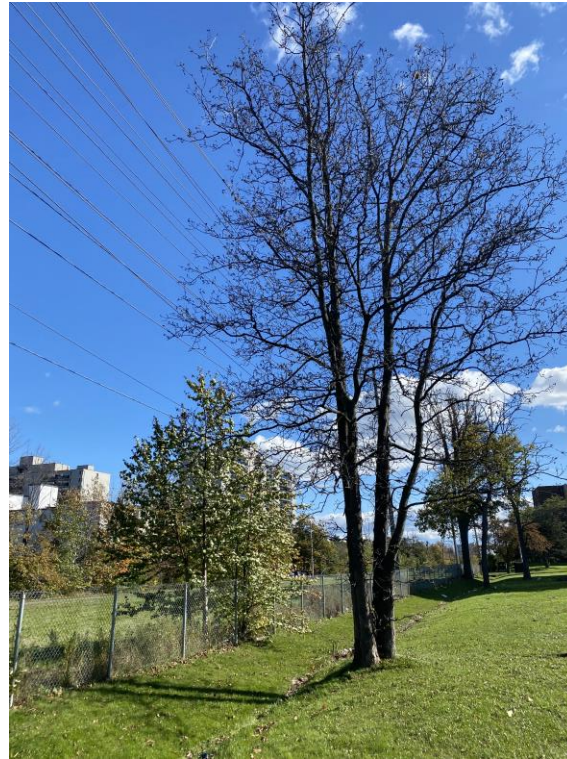
Image 8. Trees 961 (right) and J (left)

H	White Mulberry	<i>Morus alba</i>	~15, 10	FG	FG	FG	15	2	1.8	V-union at 0.1m, deadwood (L)	Shared	Preserve	
I	Bitternut Hickory	<i>Carya cordiformis</i>	~24	G	G	G		2	1.8		Neighbour	Preserve	
J	Cherry species	<i>Prunus sp.</i>	~14, 9	G	G	G		1	1.8	Union at base	Neighbour	Preserve	
K	Elm cultivar	<i>Ulmus x</i>	<5	G	G	G		0.5	1.2		City	Remove	1
L	Ginkgo	<i>Ginkgo biloba</i>	<5	G	G	G		0.5	1.2		City	Preserve

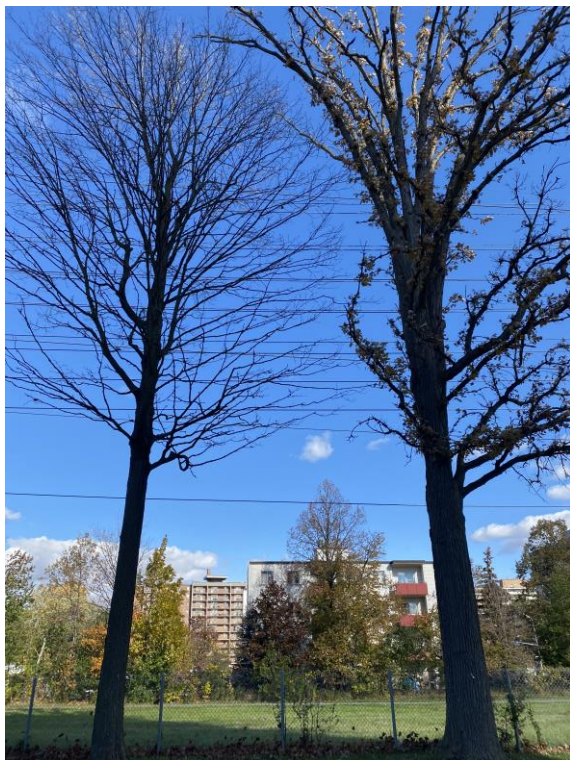
Image 10. Trees 963 (left) and 964 (right)

963	Sugar Maple	<i>Acer saccharum</i>	46	FG	F	F		4	3	Sweep (L), asymmetrical crown (L)	Private	Preserve

964	Bur Oak	<i>Quercus macrocarpa</i>	80	F	PF	F		6	4.8	Epicormic branching (H), deadwood (L), V-union at 6m with three stems, pruning wounds (M), asymmetrical crown (M), broken branches (M)	Private	Preserve	
965	Blue Spruce	<i>Picea pungens</i>	39	FG	G	FG		4	2.4	Lean (L), growth deficit (L)	Private	Remove	3
966	Apple species	<i>Malus sp.</i>	53.5	F	FG	FG		5	3.6	Pruning wounds (M), crook (H) in crown, union at 2m, epicormic branching (M)	City	Remove	4
967	Elm cultivar	<i>Ulmus x</i>	16	G	FG	FG		2	1.8	Pruning wounds (M), epicormic branching (M)	Private	Preserve	
968	Blue Spruce	<i>Picea pungens</i>	28	FG	FG	FG		2	1.8	Bow (L), asymmetrical crown (L)	Private	Remove	2
969	White Mulberry	<i>Morus alba</i>	~22, 18, 10, 10	F	F	G		4	1.8	Union at base with four leaders fused to 1m, poor form (M)	Private	Remove	2
970	Scots Pine	<i>Pinus sylvestris</i>	37	F	FG	G		3	2.4	Sweep (L), lean (L), crook (L) in canopy	Private	Remove	3

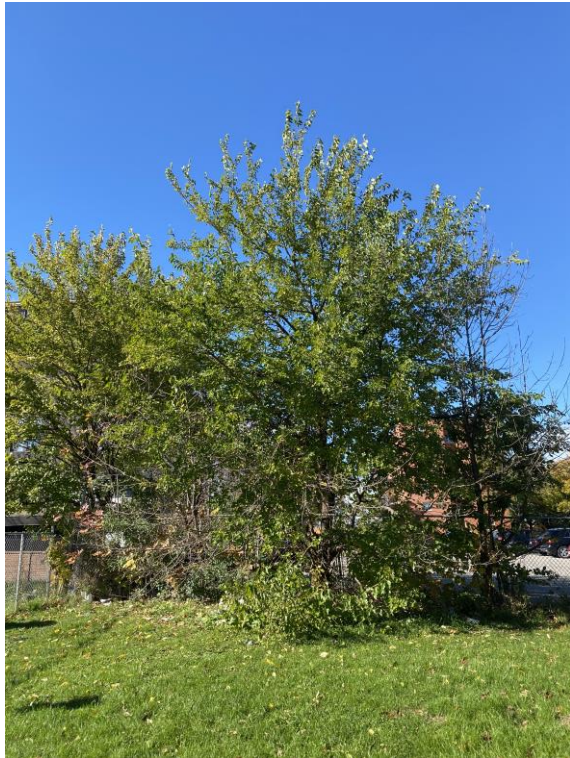
Image 14. From left to right, Trees A – C

971	White Ash	<i>Fraxinus americana</i>	51	PF	F	F	15	4	3.6	Pruning wounds (M), Emerald Ash Borer (H), bark sloughing, V-union at 1.5m, deadwood (L)	Private	Remove	4
A	White Mulberry	<i>Morus alba</i>	~26	FG	FG	G		4	1.8	Union at 1.5m with four leaders	Neighbour	Preserve	
B	White Mulberry	<i>Morus alba</i>	~30	F	F	G		4	2.4	Union at 2m, included fence (M)	Neighbour	Remove	2
C	White Ash	<i>Fraxinus americana</i>	13	P	F	F		3	1.8	Included fence (H), Emerald Ash Borer (H), poor form (L)	Shared	Remove	1
D	White Ash	<i>Fraxinus americana</i>	~20	PF	PF	F		2	1.8	Emerald Ash Borer (H), top of main leader lost, broken branches (M), epicormic branching (H)	Neighbour	Remove	2
E	Norway Maple	<i>Acer platanoides</i>	~18	F	FG	FG		3	1.8	Broken branches (L), stem wounds (H)	Neighbour	Preserve	
F	Little-leaf Linden	<i>Tilia cordata</i>	11	G	G	FG		1	1.8	Epicormic branching (L)	Shared	Preserve	
G	White Mulberry	<i>Morus alba</i>	~22, 20, 20	F	FG	G		4	1.8	Union at 1m and fused to 1.5m	Neighbour	Preserve

Trees 949 – 959, 965, 968 – 971, B, and D are located on private property and are greater than 15cm DBH. Trees B – D are located fully or partially (i.e. shared) on a neighbouring property and as such, permission from the neighbouring property owner will be required prior to the removal of these trees. Trees 966 and K are located within the Bloor Street right-of-way and as such, permission from the City of Mississauga will be required prior to the removal of these trees.
