ARBORIST REPORT AND TREE PRESERVATION PLAN

1148 and 1154 Mona Road
Mississauga, ON

2 August 2024, revised 30 September 2024

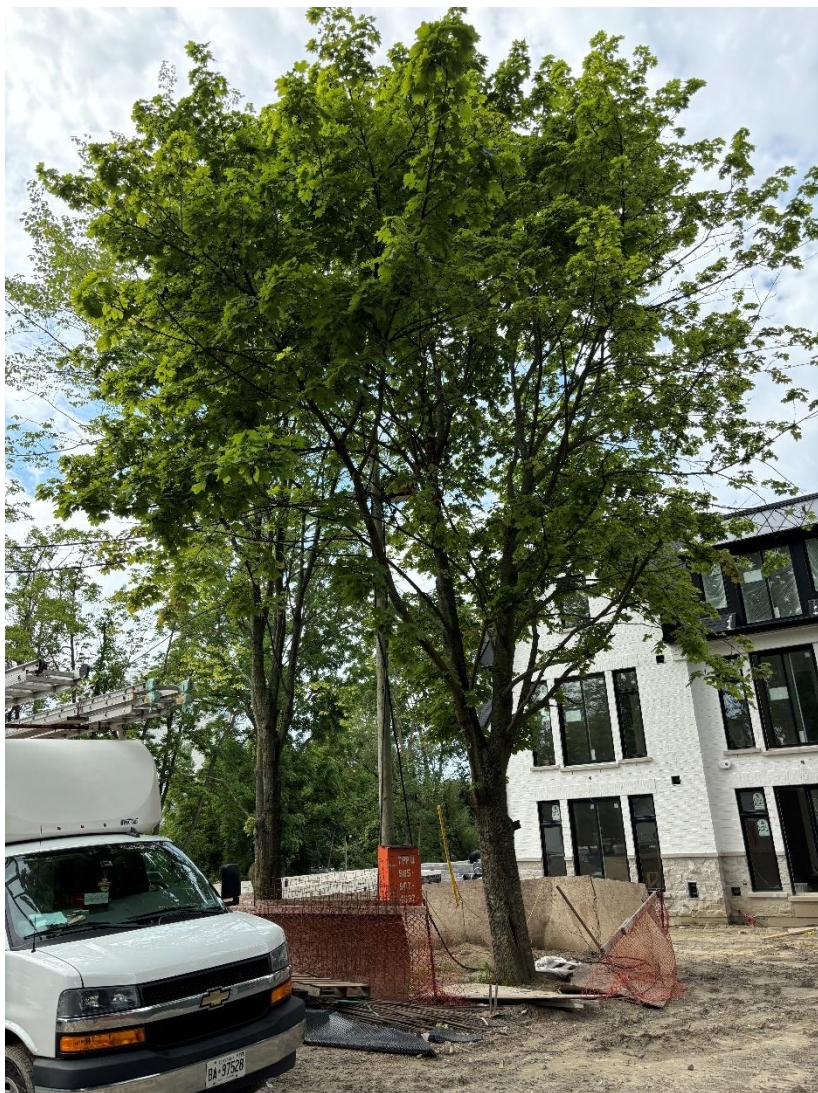
Photo 1. Trees 1 and 2 (left and right), view looking south

4	White Pine	<i>Pinus strobus</i>	78	G	FG	FG		3	4.8	Moderate pruning wounds due to a raised crown, sparse	Preserve - injure		Boundary
5	White Pine	<i>Pinus strobus</i>	56	FG	FG	G		3	3.6	Moderate pruning wounds due to a raised crown, crooks	Preserve - injure		Subject

Trees 1, 2, and 6 to 8 will require removal to accommodate the excavation for the proposed townhouse foundations and/or the acoustic barrier. Trees 11 to 23, 28, 29, 31 and 33 will require removal to accommodate the proposed buildings and/or new paved surfaces (road, driveways, walkways).

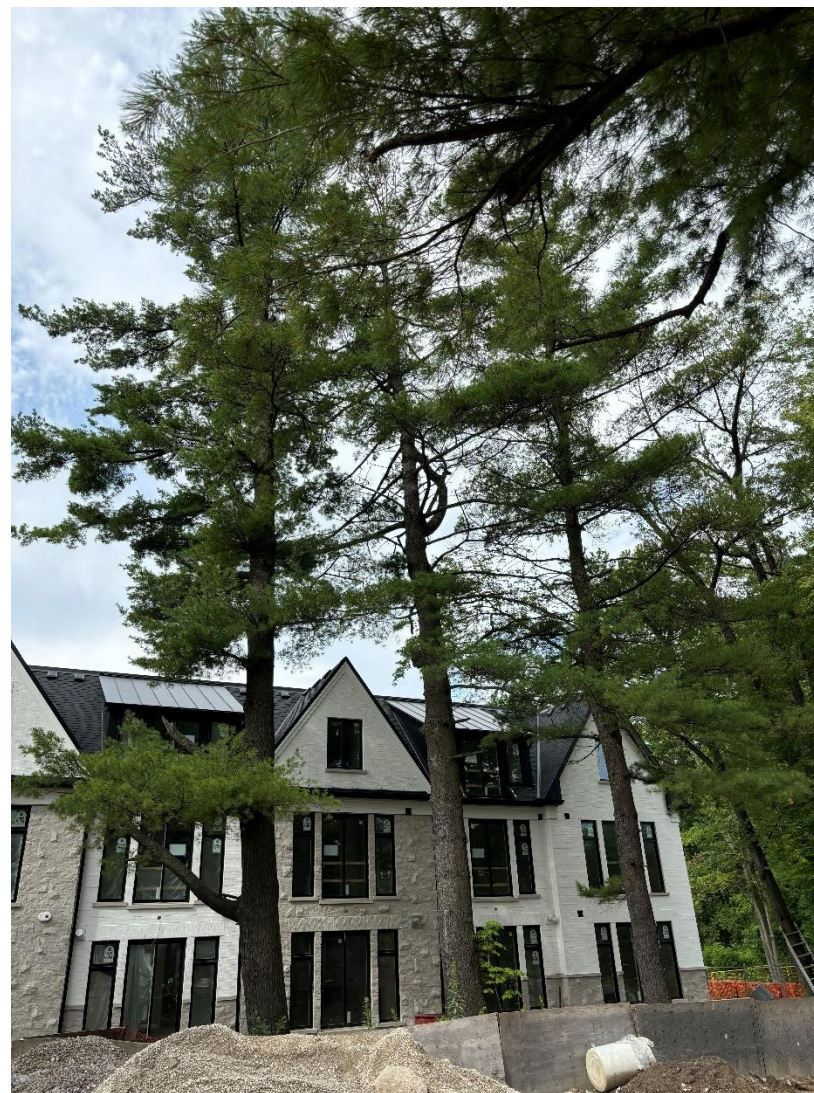
Moderate encroachment into the minimum Tree Protection Zones (mTPZs) of Tree 3 to 5 will be required to for foundation over-dig and to install the proposed fence and for minor grading. Excavation within mTPZs for foundation to be completed using hydro-vac excavation to a minimum depth of 0.5m to exposed roots for pruning according to good arboricultural practices. The privacy fence and grading should be completed in the final landscaping phase of development. Any post holes to be dug using air or hydro vac excavation. Any work within the mTPZs should be supervised by a Certified Arborist. These trees should be monitored closely for changes in health, condition, and structural stability, annually for a minimum of 2 years following construction.

Trees 3 to 5 will be protected by solid board (plywood) framed hoarding. Trees 24 to 27 and 32 will be protected by plastic snow fence framed hoarding within the road allowance and solid board (plywood) framed hoarding within the subject property.

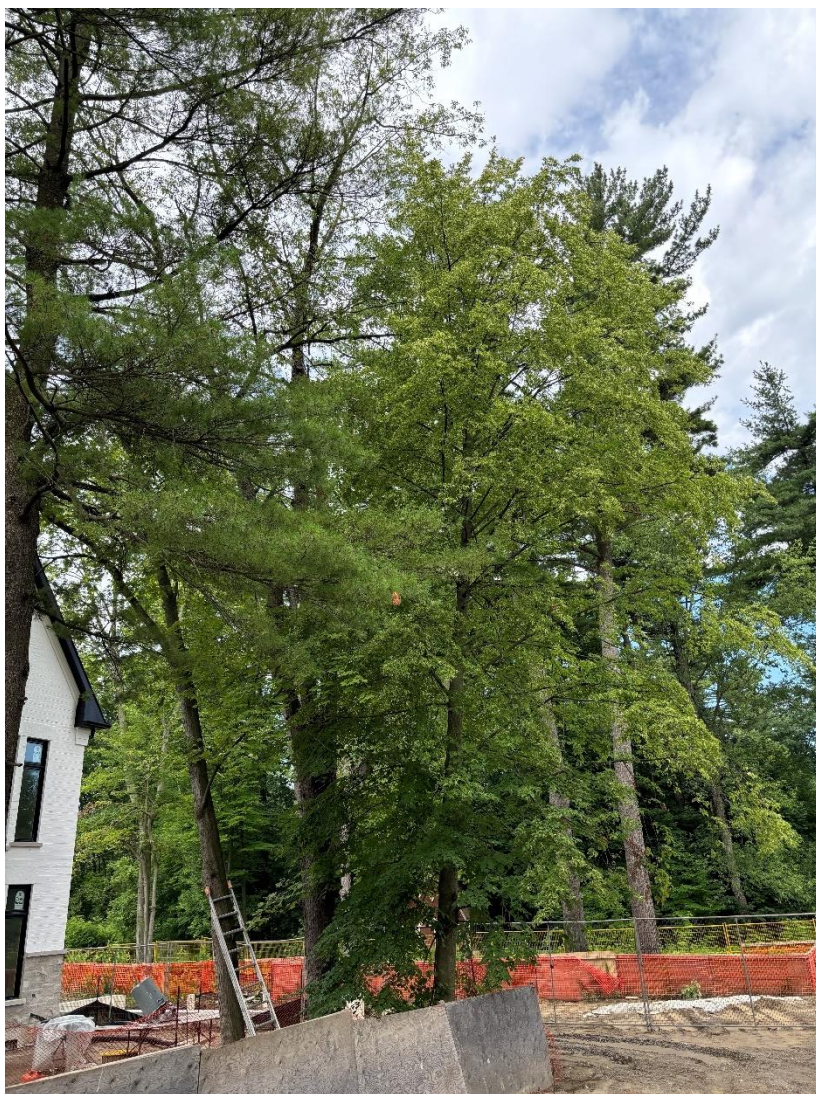
Photo 3. Trees 6 to 8 (centre foreground, left to right), view looking west

Trees 7 and 30 are in declining condition and are recommended for removal regardless of the proposed development. A permit will be required for the removal of trees greater than 15 cm DBH, including the aforementioned trees with the exception of Trees 22 and 33. Permission will be required from the neighbouring property owner(s) prior to the removal of any shared/neighbouring trees.

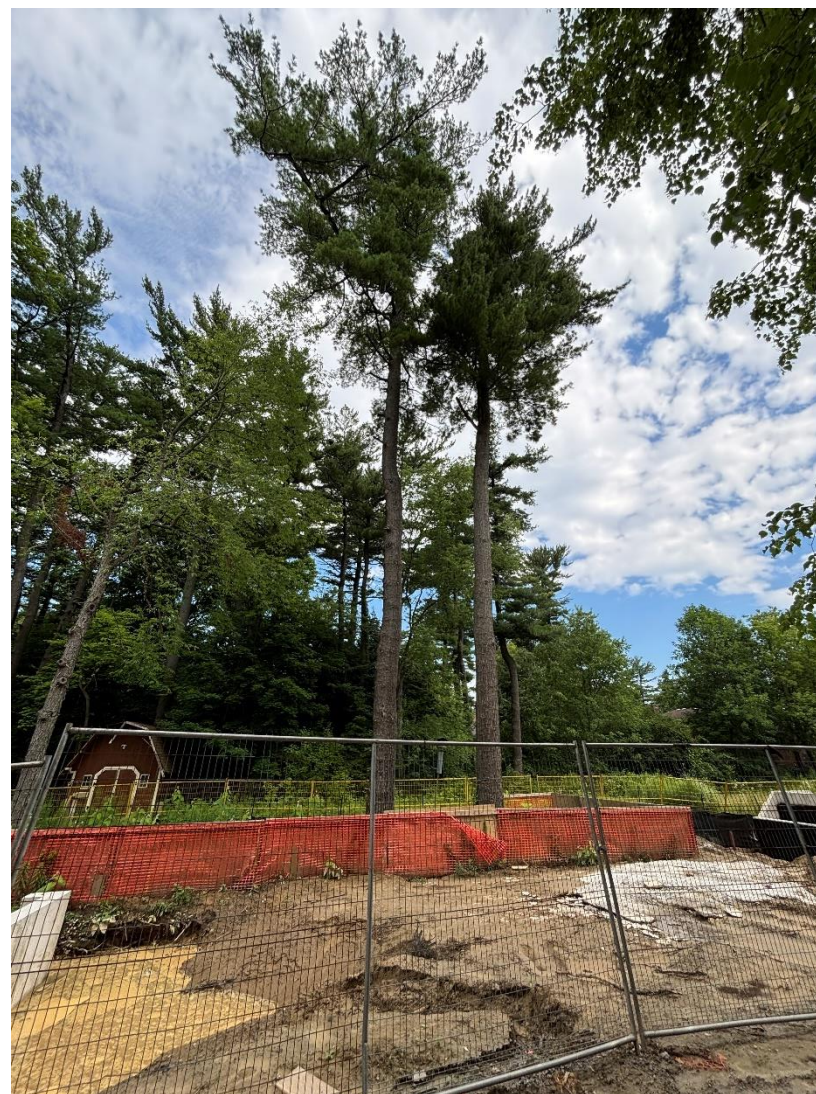
Photo 4. Trees 9 and 10 (left and right), view looking northwest

Trees 9 and 10 are located on neighbouring property and away from the proposed works. Tree preservation hoarding has not been prescribed for these trees. This tree should not be impacted assuming all construction activities, equipment, materials, and/or fill, remain within subject property limits.

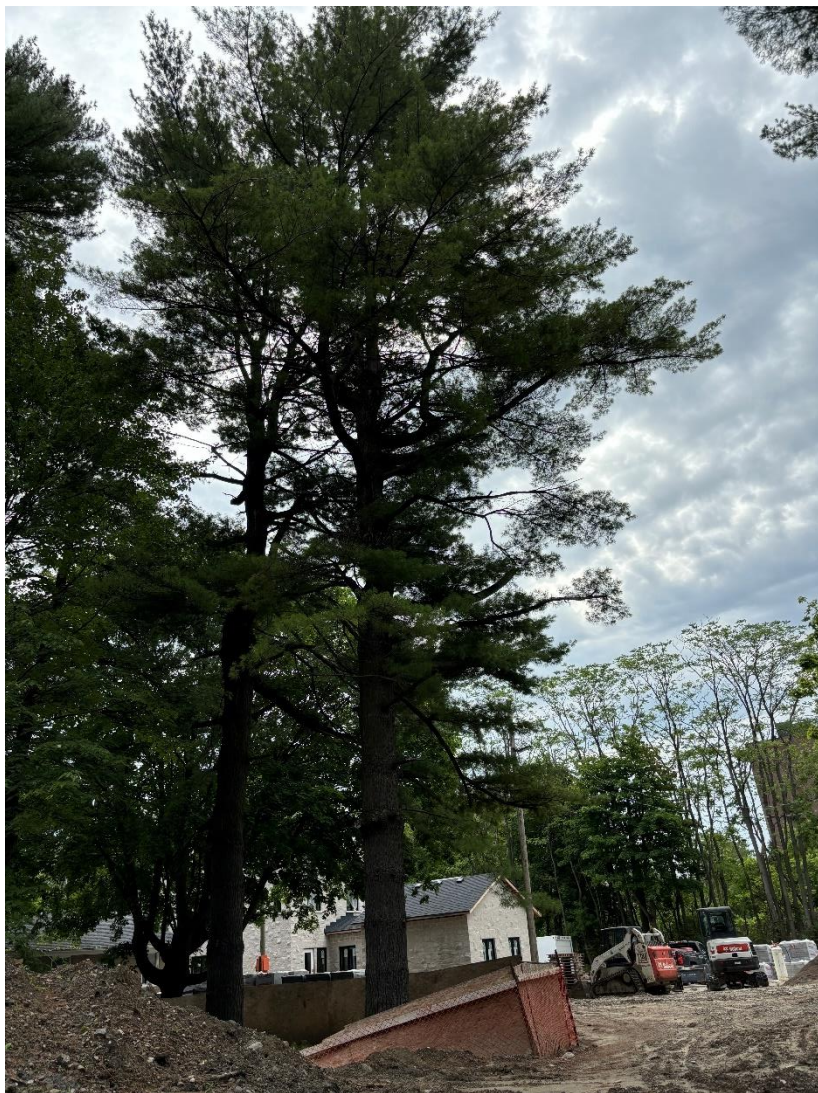
Photo 5. Trees 11 and 12 (right and left), view looking east

11	White Pine	<i>Pinus strobus</i>	72	G	FG	FG		4.5	4.8	minor pruning wounds due to a raised crown, minor broken branches	Remove (development)		Subject
12	White Pine	<i>Pinus strobus</i>	71	FG	FG	FG		5	4.8	minor pruning wounds due to a raised crown, minor broken branches, multiple leaders	Remove (development)		Subject
13	Red Maple	<i>Acer rubrum</i>	27	G	G	G		3.5	1.8	Minor broken branches	Remove (development)		Subject
14	White Pine	<i>Pinus strobus</i>	54	FG	FG	F		3	3.6	Moderate pruning wounds due to a raised crown, minor deadwood, minor broken branches	Remove (development)		Subject

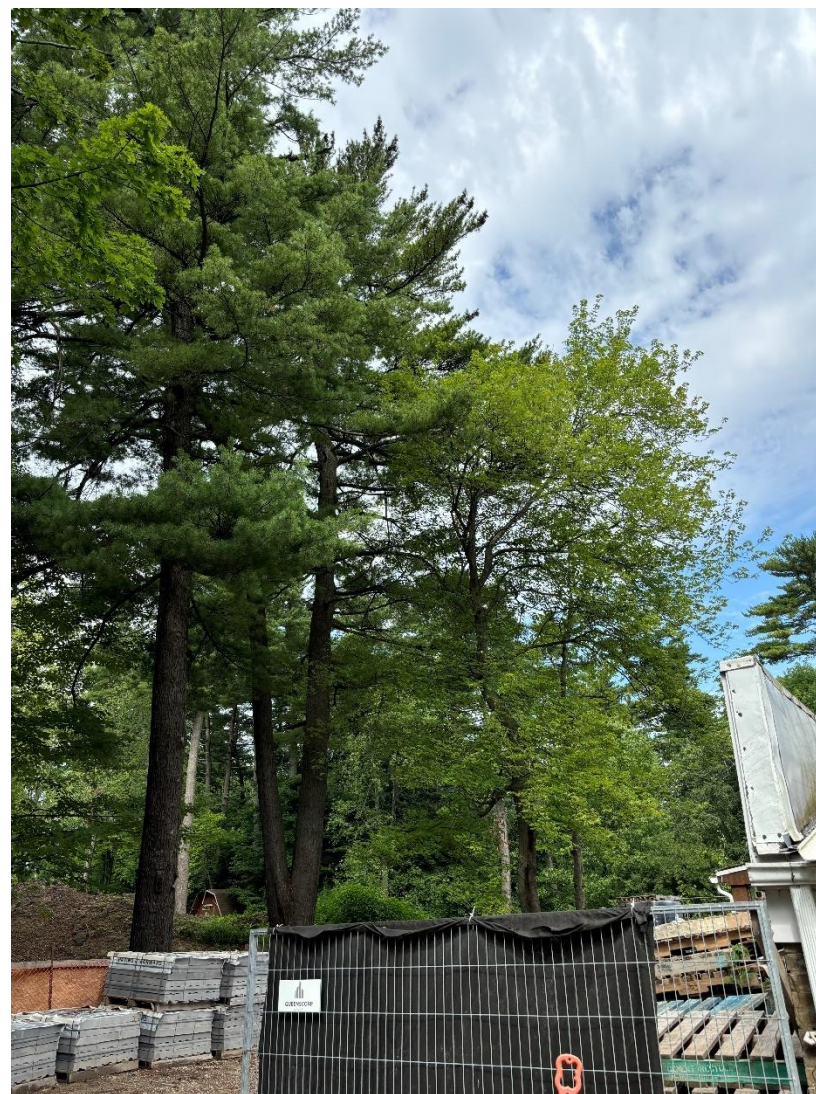
Photo 8. Trees 16 to 19 (left to right), view looking west

19	Red Maple	<i>Acer rubrum</i>	22.5	FG	F	F		2.5	1.8	Root zone excavated, significant pruning wounds due to a raised crown	Remove (development)		Subject
20	Little-leaf Linden	<i>Tilia cordata</i>	21	FG	FG	G		2.5	1.8	Minor pruning wounds, root zone excavated	Remove (development)		Subject
21	Green Ash	<i>Fraxinus pennsylvanica</i>	15	FG	FG	G		2	1.5	Co-dominant at 3.5m, minor pruning wounds, root zone excavated	Remove (development)		Subject
22	Little-leaf Linden	<i>Tilia cordata</i>	12.5	FG	FG	FG		1.5	1.5	Utility lines through crown	Remove (development)		Subject
23	Blue Spruce	<i>Picea pungens</i>	25	G	G	F		2	1.8	Utility lines through crown, minor pruning wounds due to a raised crown, minor asymmetrical crown due to competition	Remove (development)		Subject

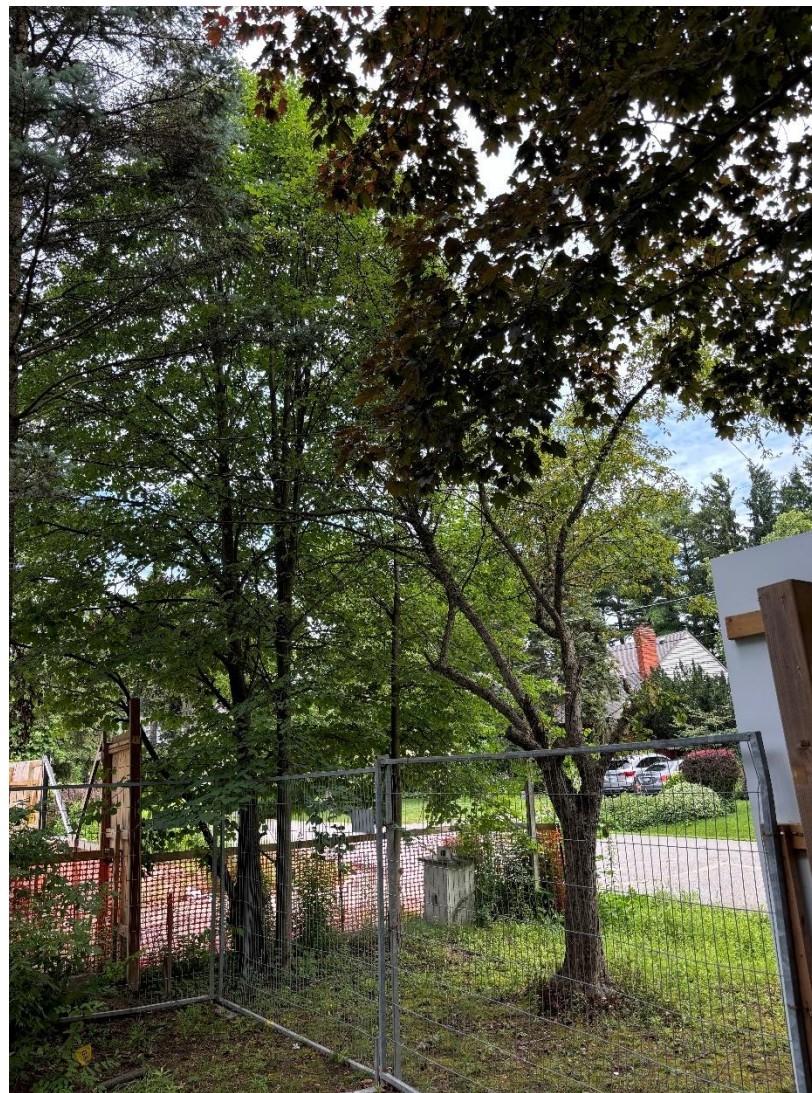
Photo 12. Trees 24 to 27 (left to right), view looking north

Minor to moderate encroachment into the mTPZs of Tree 24 and 25 will be required to install the proposed fence. The fence should be installed during the final landscaping phase of development, under supervision of a Certified Arborist. The post holes should be dug by hand and any exposed roots pruned according to good arboricultural practices. These trees should be monitored annually during the growing season for changes in health and condition for a minimum period of two years following construction completion.

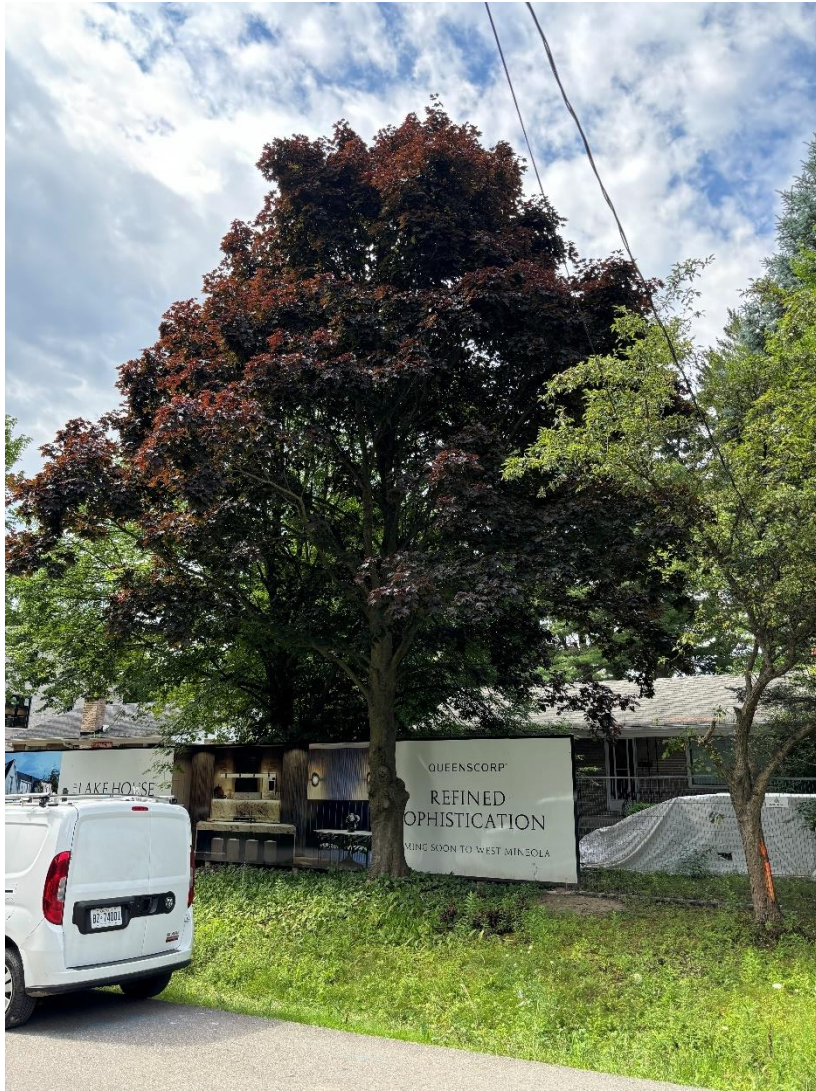
Photo 13. Tree 28 (centre), view looking south

28	Norway Maple	<i>Acer platanoides</i>	63	FG	F	FG		4	4.2	Moderate pruning wounds, vertical scaffold limbs, girdling roots	Remove (development)		City ROW (Boundary)
29	Little-leaf Linden	<i>Tilia cordata</i>	65	FP	F	FG		5	4.2	Narrow branch unions with moderate decay, significant epicormic branches	Remove (development)		Subject
30	Red Maple	<i>Acer rubrum</i>	25,30,39 [55]	FP	FP	F		6	3.6	Multi-stemmed near base, moderate pruning wounds with decay, fruiting bodies, vertical scaffold limbs	Remove (condition)		City ROW
31	Norway Maple	<i>Acer platanoides</i>	56	F	FP	F		6	3.6	Union at 2m, vertical scaffold limbs, minor broken branches with decay	Remove (development)		City ROW
32	Austrian Pine	<i>Pinus nigra</i>	55	FG	F	F		4	3.6	Utility lines through crown, moderate pruning wounds due to a raised crown, sparse	Preserve - injure	Fence to be installed during final landscaping phase of development, under supervision of a Certified Arborist. Post holes to be hand-dug.	City ROW

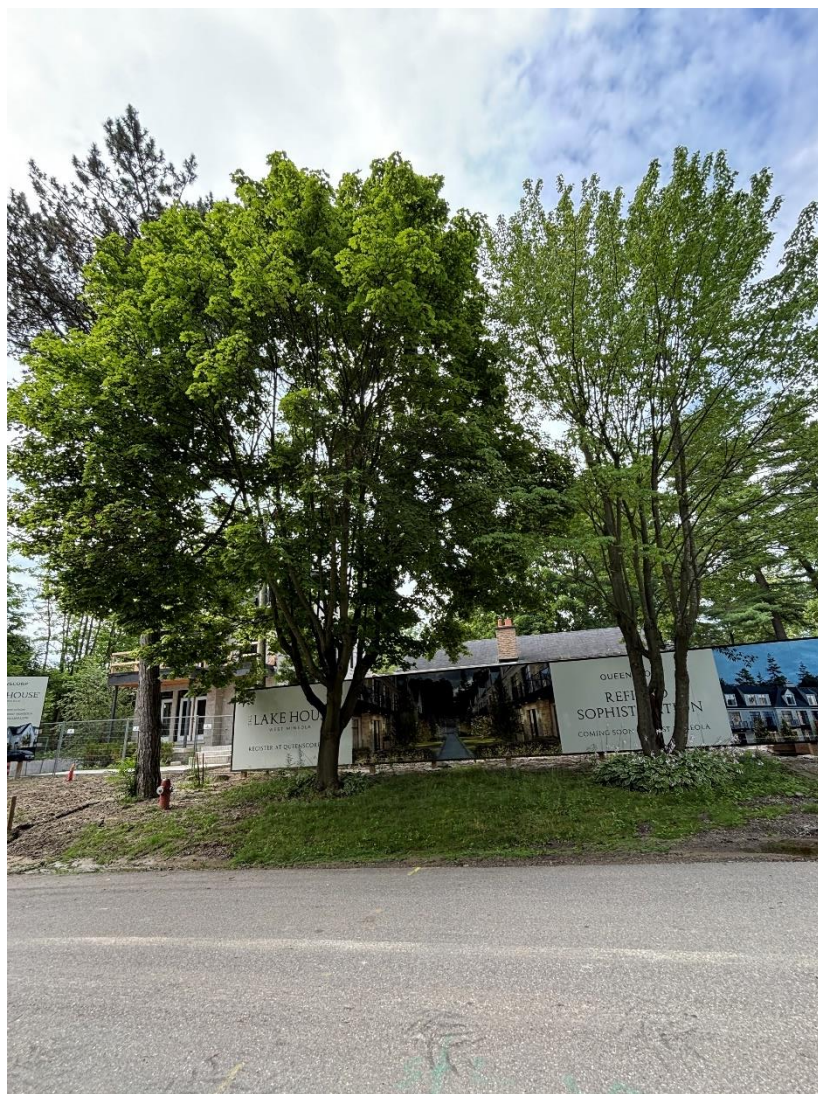
Photo 15. Trees 30 to 32 (right to left), view looking southwest

Minor to moderate encroachment into the mTPZ of Tree 32 will be required to backfill the ditch and to install the proposed fence. The fence should be installed during the final landscaping phase of development, under supervision of a Certified Arborist. The post holes should be dug by hand and any exposed roots pruned according to good arboricultural practices. This tree should be monitored annually during the growing season for changes in health and condition for a minimum period of two years following construction completion. This tree will benefit from watering during and for a minimum period of two years following construction.
