ARBORIST REPORT AND TREE PRESERVATION PLAN

1148 and 1154 Mona Road
Mississauga, ON

2 August 2024, revised 25 March 2025

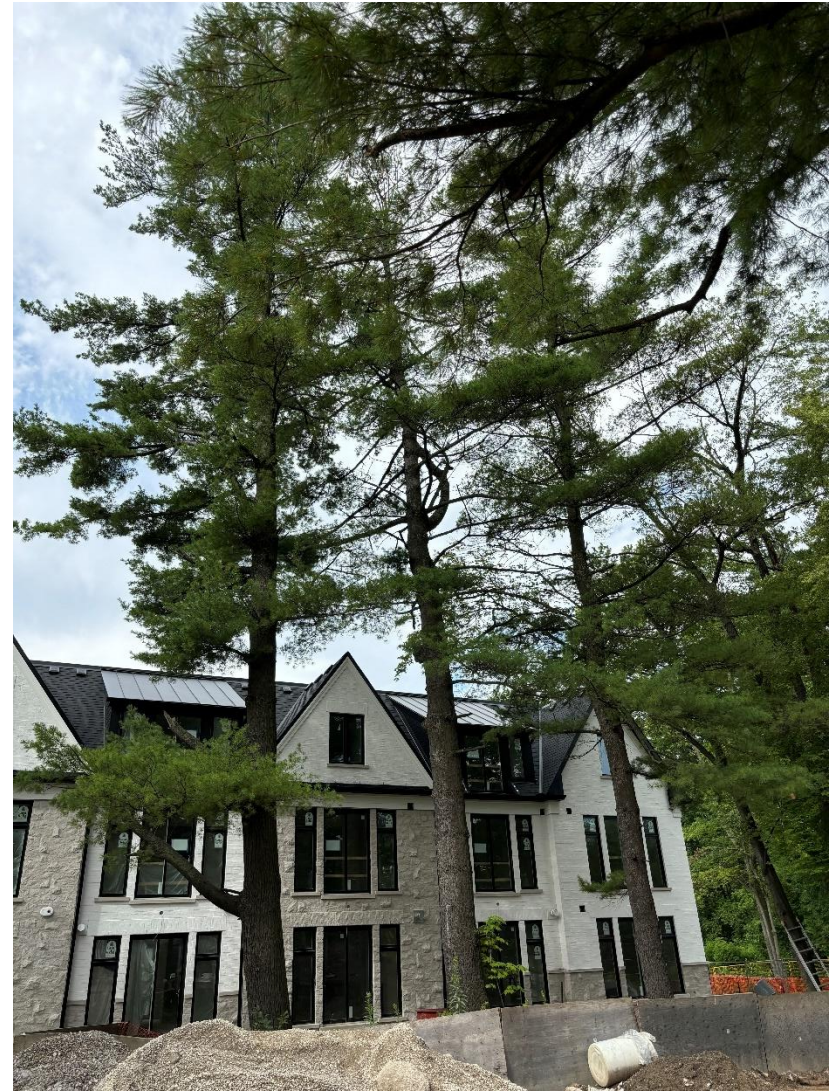
Photo 2. Trees 3 to 5 (left to right), view looking west

4	White Pine	<i>Pinus strobus</i>	78	G	FG	FG		3	4.8	Moderate pruning wounds due to a raised crown, sparse	Preserve - injure		Boundary
5	White Pine	<i>Pinus strobus</i>	56	FG	FG	G		3	3.6	Moderate pruning wounds due to a raised crown, crooks	Preserve - injure		Subject

Trees 3 to 5 will be protected by solid board (plywood) framed hoarding. Trees 24 to 27 and 32 will be protected by plastic snow fence framed hoarding within the road allowance and solid board (plywood) framed hoarding within the subject property.

Moderate encroachment into the minimum Tree Protection Zones (mTPZs) of Tree 3 to 5 will be required to for foundation over-dig and to install the proposed fence and for minor grading. Excavation within mTPZs for foundation to be completed using hydro-vac excavation to a minimum depth of 0.5m to exposed roots for pruning according to good arboricultural practices. The privacy fence and grading should be completed in the final landscaping phase of development. Any post holes to be dug using air or hydro vac excavation. Any work within the mTPZs should be supervised by a Certified Arborist. These trees should be monitored closely for changes in health, condition, and structural stability, annually for a minimum of 2 years following construction.

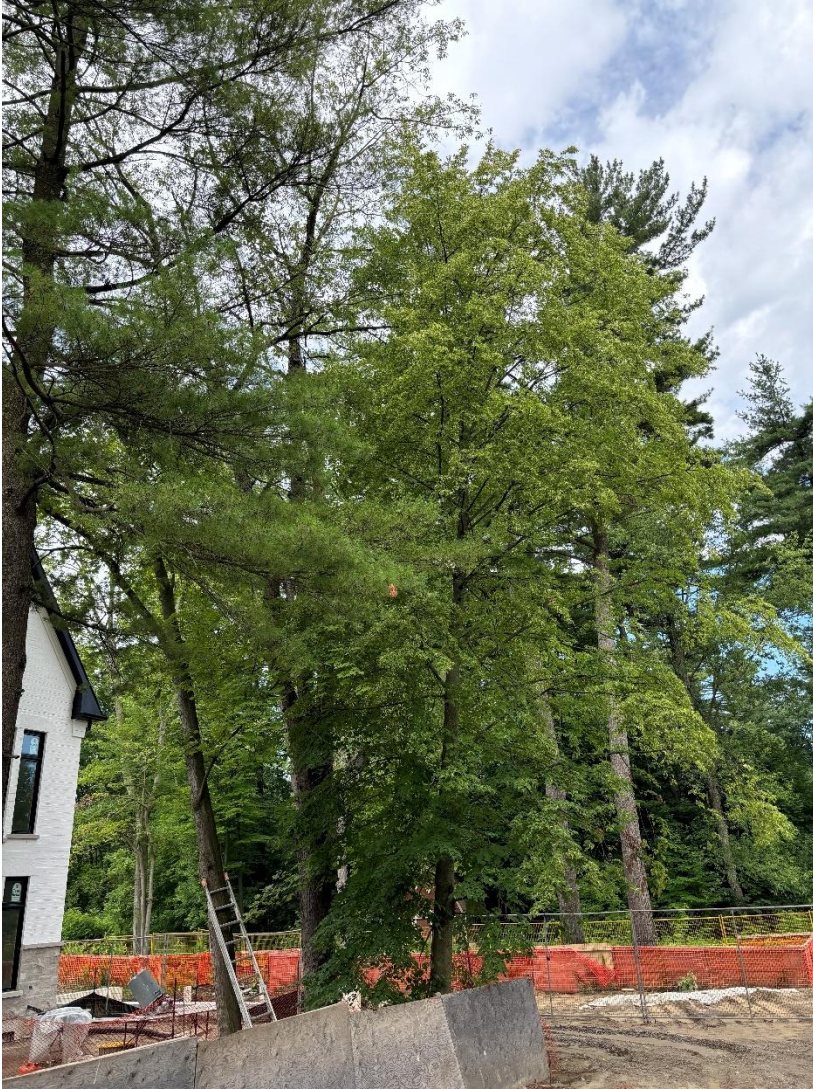
Photo 3. Trees 6 to 8 (centre foreground, left to right), view looking west

Tree #	Common Name	Scientific Name	Diameter at Breast Height (DBH) ¹	Trunk Integrity	Crown Structure	Crown Vigour	Crown Dieback	Dripline (radius)	minimum Tree Protection Zone (mTPZ) (radius) ²	Comments	Proposed Action	Preservation Comments	Ownership
			(cm)	Good (G), Fair (F), Poor (P)		%		(m)	(m)				
6	Red Maple	<i>Acer rubrum</i>	35	FG	FG	FG		3.5	2.4	Moderate lean, minor broken branches, minor pruning wounds	Remove (development)		Neighbouring
7	Black Cherry	<i>Prunus serotina</i>	61	F	FP	F		3.5	4.2	Union at 4.5m, 1 stem dead, significant deadwood	Remove (condition)		Boundary
8	Little-leaf Linden	<i>Tilia cordata</i>	29	G	G	G		3	1.8		Remove (development)		Subject
9	White Pine	<i>Pinus strobus</i>	~60	G	FG	G		2.5	3.6	Moderate pruning wounds due to a raised crown, small live crown ratio	Preserve		Neighbouring
10	White Pine	<i>Pinus strobus</i>	~60	G	FG	G		2.5	3.6	Moderate pruning wounds due to a raised crown, small live crown ratio	Preserve		Neighbouring

Trees 1, 2, and 6 to 8 will require removal to accommodate the excavation for the proposed townhouse foundations and/or the acoustic barrier. Trees 11 to 23, 28, 29, 31 and 33 will require removal to accommodate the proposed buildings and/or new paved surfaces (road, driveways, walkways).

Trees 7 and 30 are in declining condition and are recommended for removal regardless of the proposed development. A permit will be required for the removal of trees greater than 15 cm DBH, including the aforementioned trees with the exception of Trees 22 and 33. Permission will be required from the neighbouring property owner(s) prior to the removal of any shared/neighbouring trees.

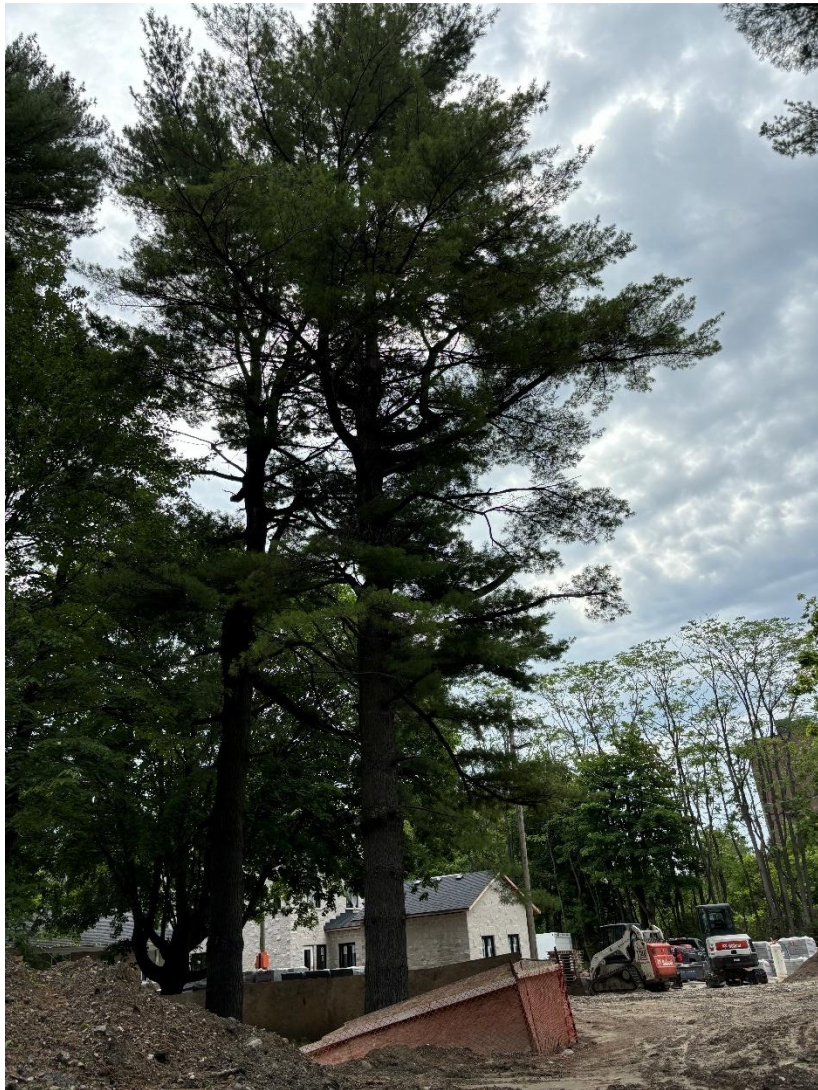
Photo 5. Trees 11 and 12 (right and left), view looking east

11	White Pine	<i>Pinus strobus</i>	72	G	FG	FG		4.5	4.8	minor pruning wounds due to a raised crown, minor broken branches	Remove (development)		Subject
12	White Pine	<i>Pinus strobus</i>	71	FG	FG	FG		5	4.8	minor pruning wounds due to a raised crown, minor broken branches, multiple leaders	Remove (development)		Subject
13	Red Maple	<i>Acer rubrum</i>	27	G	G	G		3.5	1.8	Minor broken branches	Remove (development)		Subject
14	White Pine	<i>Pinus strobus</i>	54	FG	FG	F		3	3.6	Moderate pruning wounds due to a raised crown, minor deadwood, minor broken branches	Remove (development)		Subject

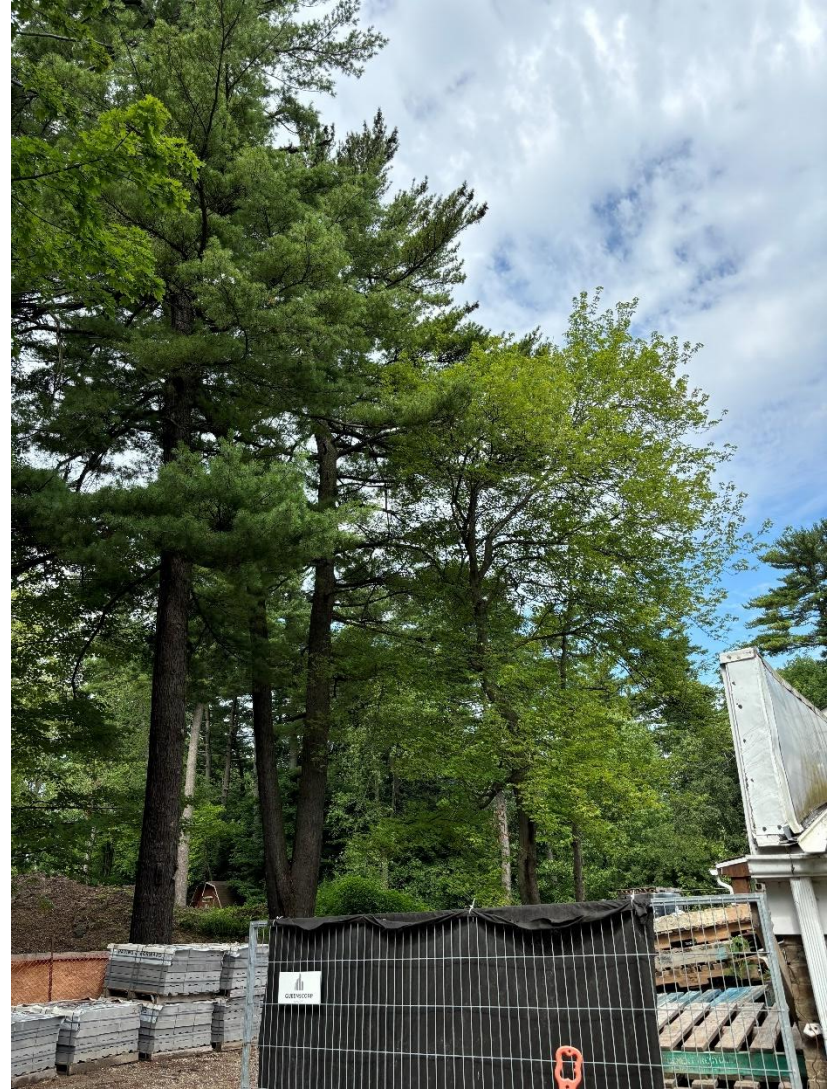
Photo 8. Trees 16 to 19 (left to right), view looking west

19	Red Maple	<i>Acer rubrum</i>	22.5	FG	F	F		2.5	1.8	Root zone excavated, significant pruning wounds due to a raised crown	Remove (development)		Subject
20	Little-leaf Linden	<i>Tilia cordata</i>	21	FG	FG	G		2.5	1.8	Minor pruning wounds, root zone excavated	Remove (development)		Subject
21	Green Ash	<i>Fraxinus pennsylvanica</i>	15	FG	FG	G		2	1.5	Co-dominant at 3.5m, minor pruning wounds, root zone excavated	Remove (development)		Subject
22	Little-leaf Linden	<i>Tilia cordata</i>	12.5	FG	FG	FG		1.5	1.5	Utility lines through crown	Remove (development)		Subject
23	Blue Spruce	<i>Picea pungens</i>	25	G	G	F		2	1.8	Utility lines through crown, minor pruning wounds due to a raised crown, minor asymmetrical crown due to competition	Remove (development)		Subject

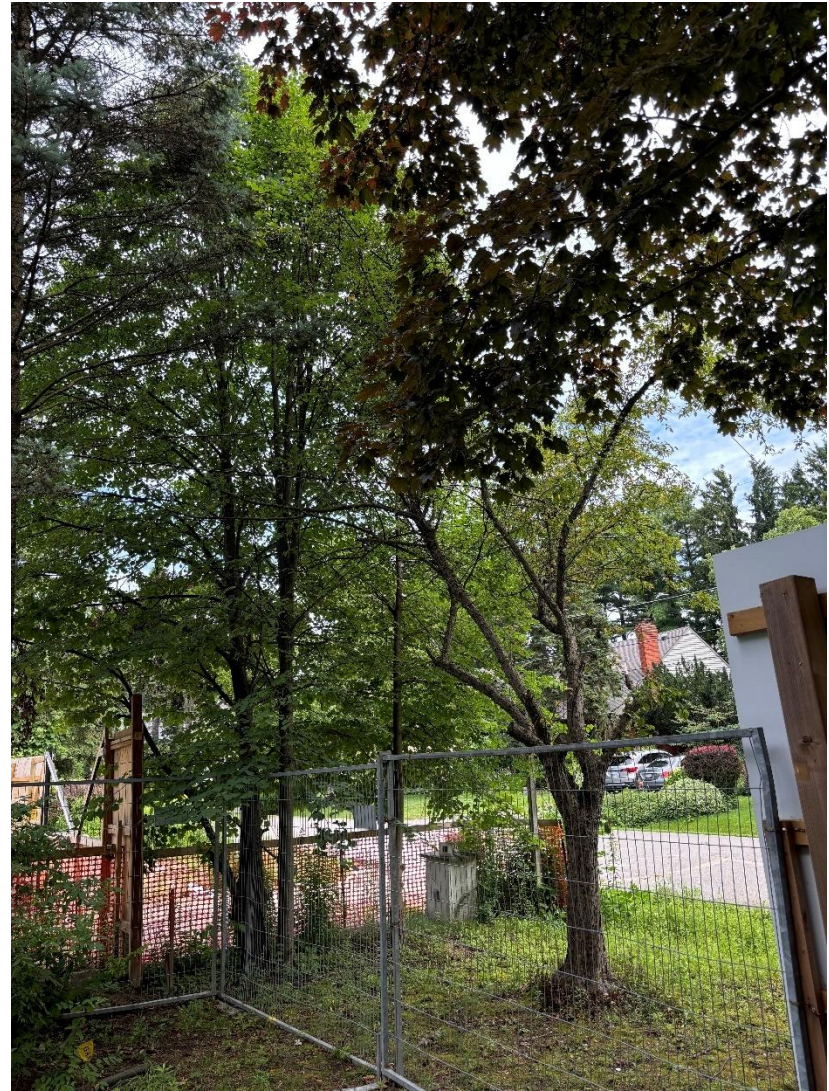
Photo 12. Trees 24 to 27 (left to right), view looking north

Tree #	Common Name	Scientific Name	Diameter at Breast Height (DBH) ¹	Trunk Integrity	Crown Structure	Crown Vigour	Crown Dieback	Dripline (radius)	minimum Tree Protection Zone (mTPZ) (radius) ²	Comments	Proposed Action	Preservation Comments	Ownership
			(cm)	Good (G), Fair (F), Poor (P)			%	(m)	(m)				
24	Little-leaf Linden	<i>Tilia cordata</i>	21.5	G	G	G		2.5	1.8	Minor pruning wounds, minor epicormic branches	Preserve		City ROW
25	Little-leaf Linden	<i>Tilia cordata</i>	15	FG	FG	G		2	1.5	Co-dominant at 4m, minor pruning wounds	Preserve – injure	Fence to be installed during final landscaping phase of development, under supervision of a Certified Arborist. Post holes to be hand-dug.	City ROW
26	Little-leaf Linden	<i>Tilia cordata</i>	12.5	G	G	G		1.5	1.5	Minor pruning wounds	Preserve - injure		City ROW
27	Apple species	<i>Malus sp.</i>	27.5	F	FP	FP		2.5	1.8	Utility lines through crown, significant pruning wounds with decay, moderate epicormic branches			City ROW

Minor to moderate encroachment into the mTPZs of Tree 24 and 25 will be required to install the proposed fence. The fence should be installed during the final landscaping phase of development, under supervision of a Certified Arborist. The post holes should be dug by hand and any exposed roots pruned according to good arboricultural practices. These trees should be monitored annually during the growing season for changes in health and condition for a minimum period of two years following construction completion.

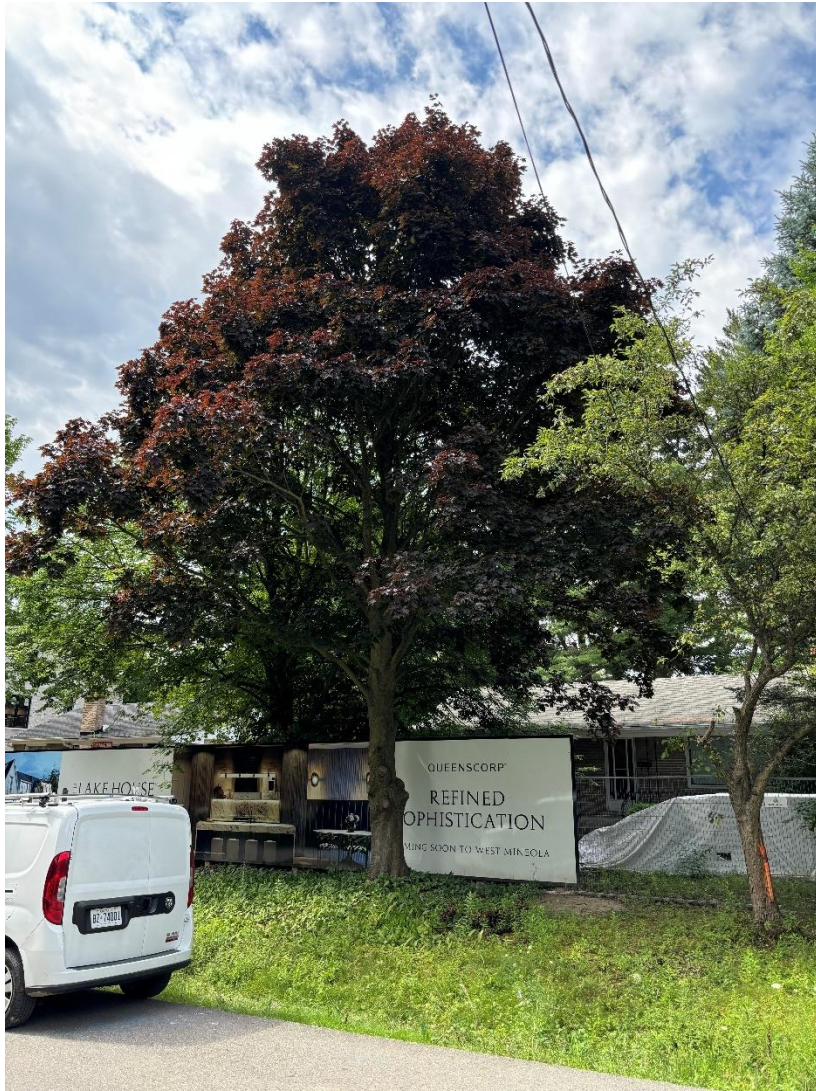
Photo 13. Tree 28 (centre), view looking south

28	Norway Maple	<i>Acer platanoides</i>	63	FG	F	FG		4	4.2	Moderate pruning wounds, vertical scaffold limbs, girdling roots	Remove (development)		City ROW (Boundary)
29	Little-leaf Linden	<i>Tilia cordata</i>	65	FP	F	FG		5	4.2	Narrow branch unions with moderate decay, significant epicormic branches	Remove (development)		Subject
30	Red Maple	<i>Acer rubrum</i>	25,30,39 [55]	FP	FP	F		6	3.6	Multi-stemmed near base, moderate pruning wounds with decay, fruiting bodies, vertical scaffold limbs	Remove (condition)		City ROW
31	Norway Maple	<i>Acer platanoides</i>	56	F	FP	F		6	3.6	Union at 2m, vertical scaffold limbs, minor broken branches with decay	Remove (development)		City ROW
32	Austrian Pine	<i>Pinus nigra</i>	55	FG	F	F		4	3.6	Utility lines through crown, moderate pruning wounds due to a raised crown, sparse	Preserve - injure	Fence to be installed during final landscaping phase of development, under supervision of a Certified Arborist. Post holes to be hand-dug.	City ROW
