Hemmera Envirochem Inc.
104 – 1540 Cornwall Road
Oakville, ON L6J 7W5
T: 905.825.4936
hemmera.com

June 19, 2019
File: 2076-002.02

Re: Summary of Phase I Environmental Site Assessment (ESA) Potential Environmental Concerns and Phase II ESA – 170 Lakeshore Road East, Port Credit, Mississauga, ON

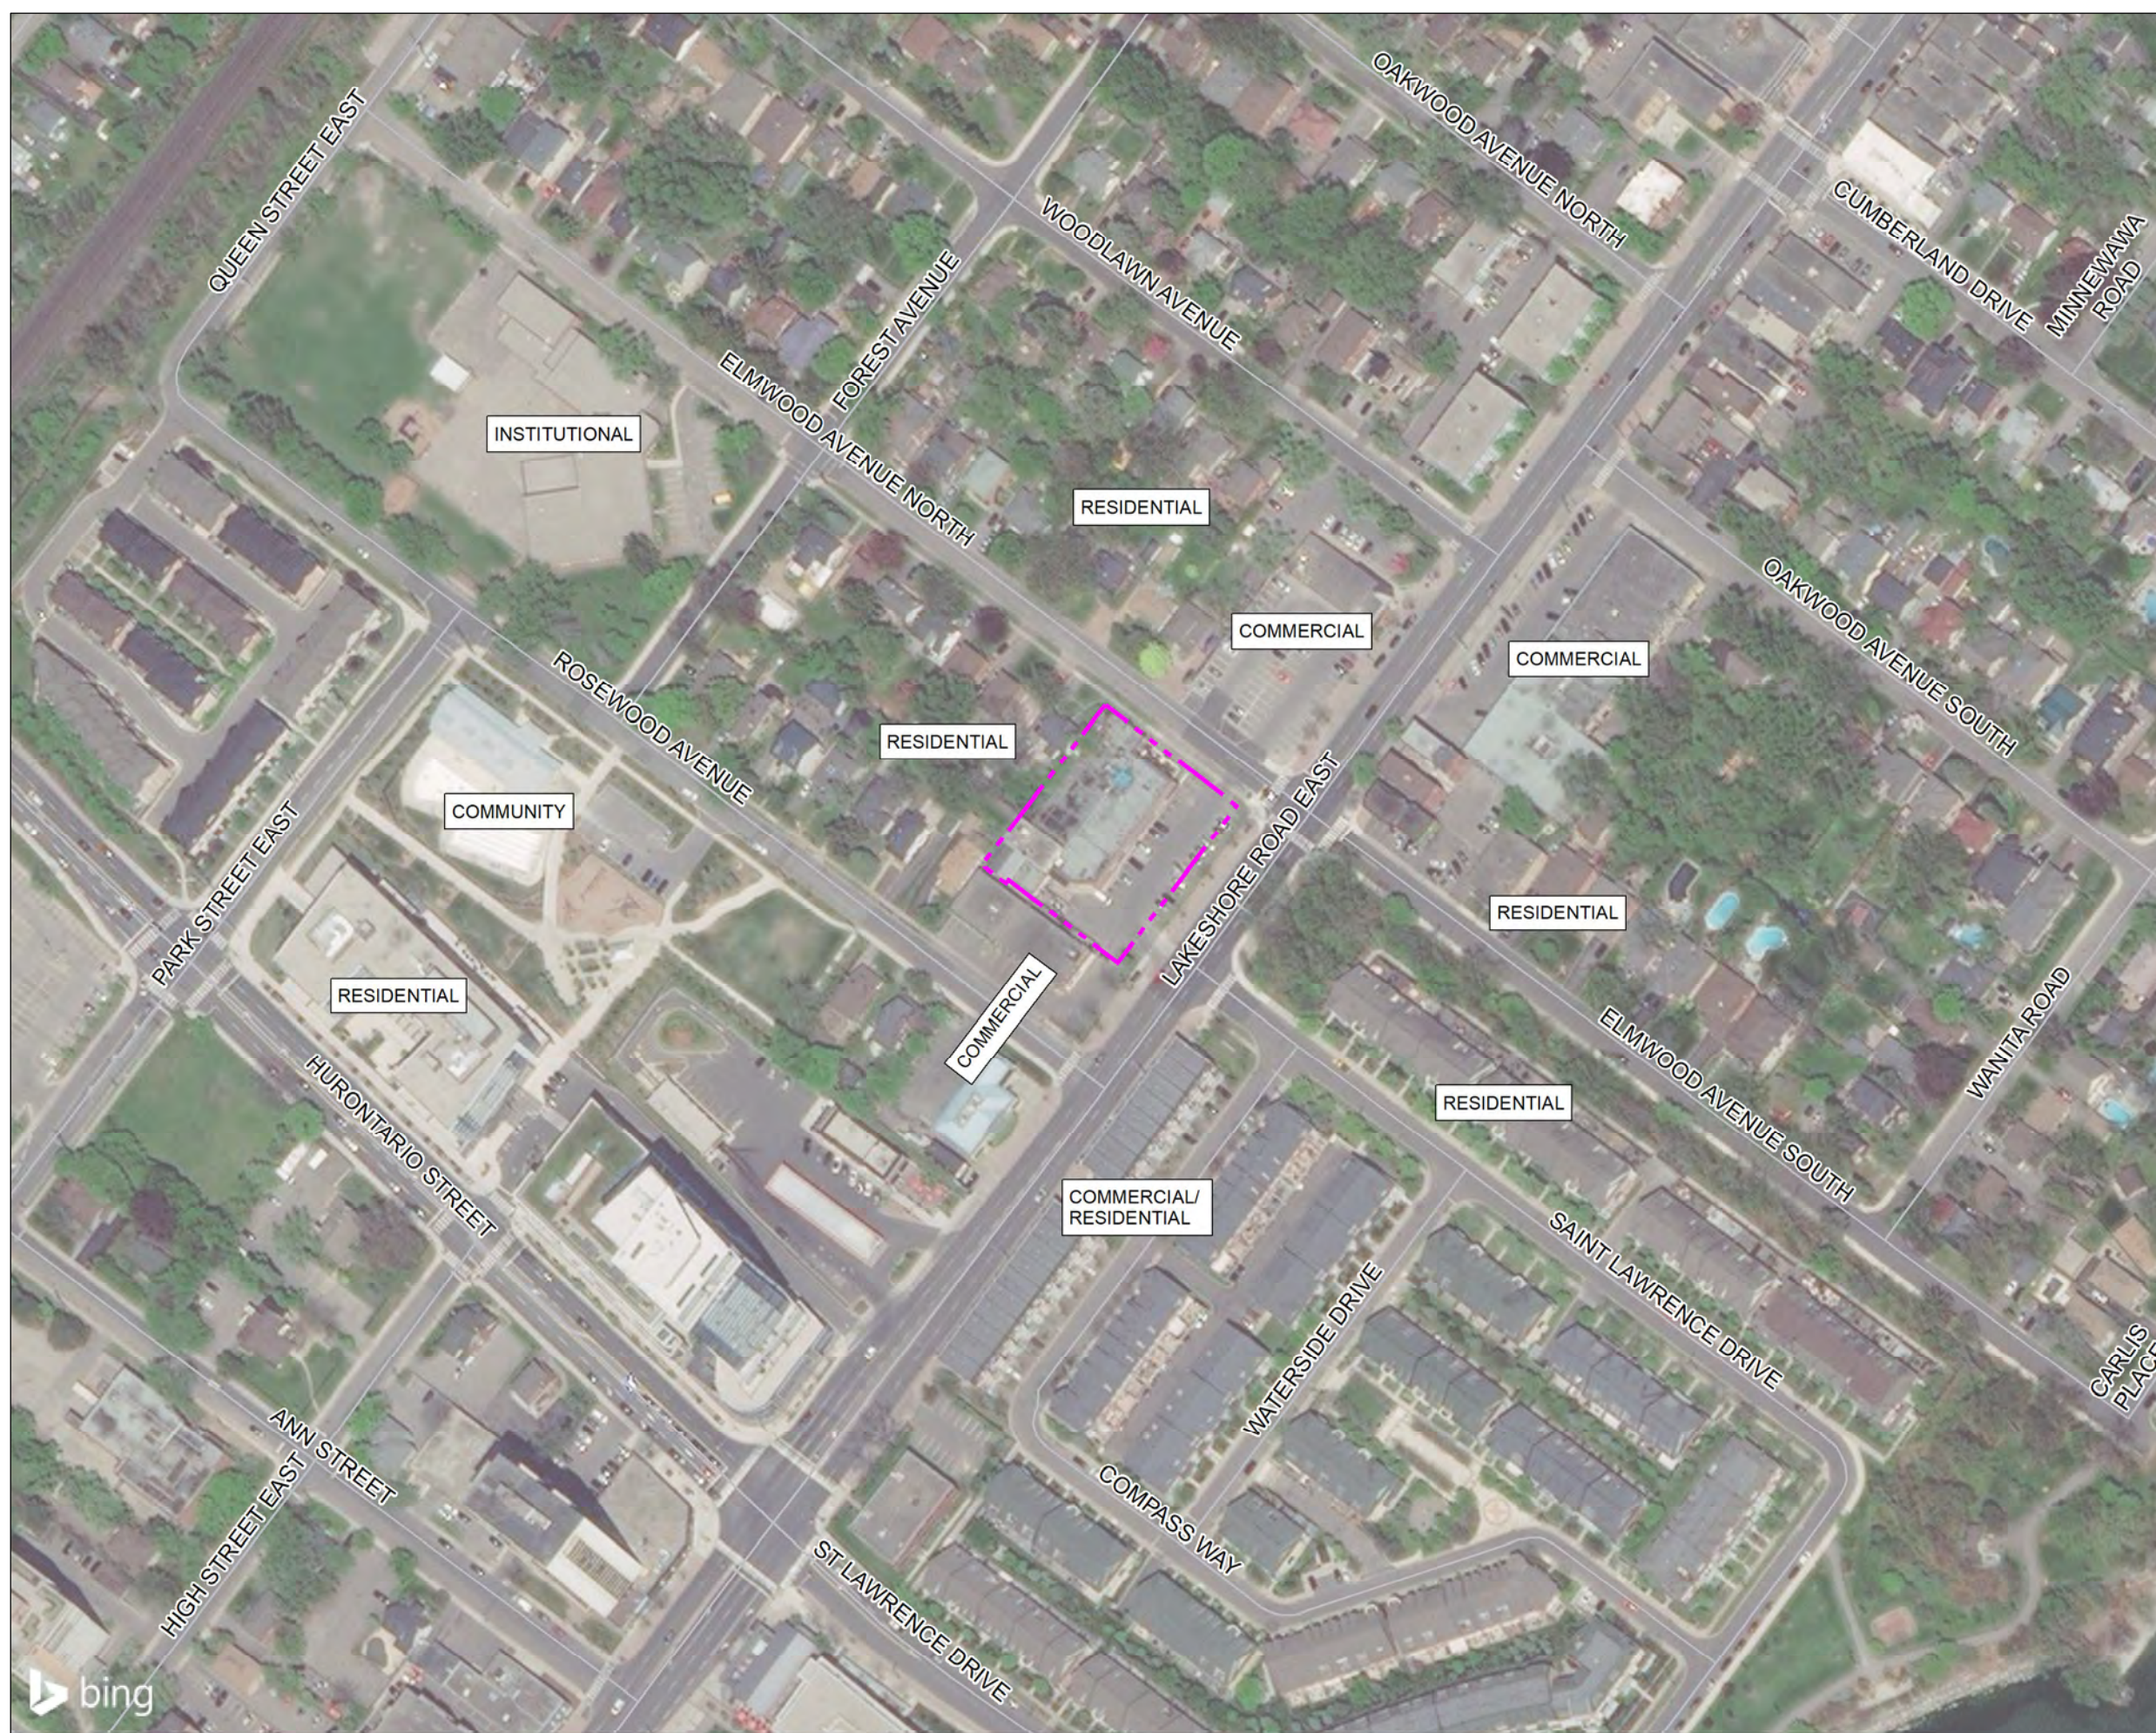
Path: C:\0200\02076\00201\mxd\Fig3_2017_002_01_SiteandSurroundingLandUse_17030.mxd

Land uses of neighbouring properties are shown on **Figure 3**.
