84, 90 High Street East, 17, 19 Ann Street and Part  
of 91 Park Street East, Mississauga, Ontario

Phase Two Environmental Site Assessment

BRM-00239423-E0

August 24, 2021

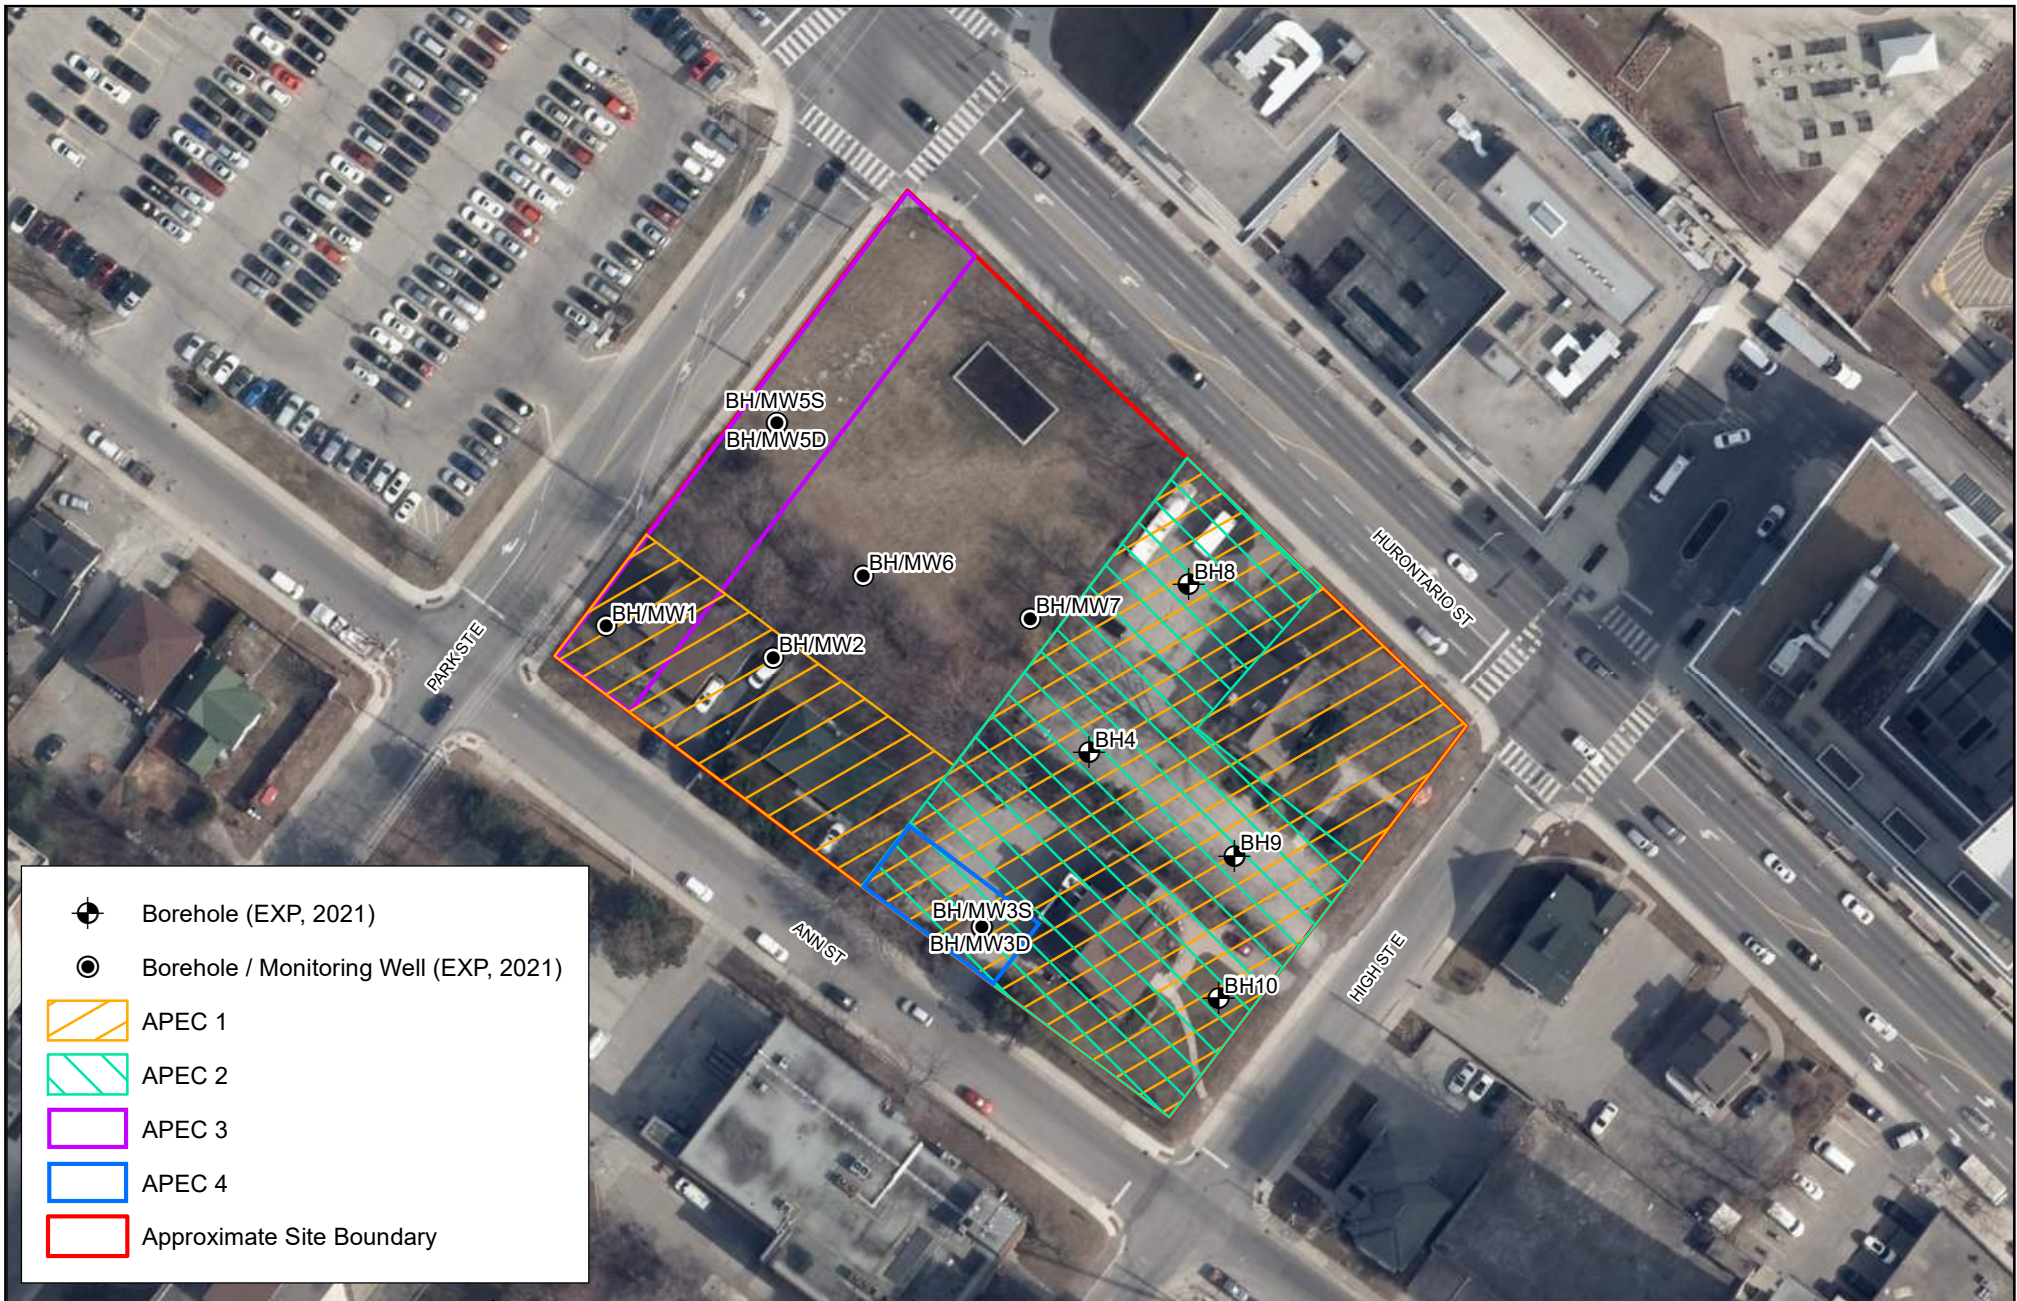
PROJECT No:	BRM-00239423-E0	OWN:	AC
SCALE:	AS NOTED	CHKD:	SL
DATE:	AUGUST 2021	FIG. No.:	5A

TITLE AND LOCATION:  
**BOREHOLE / MONITORING WELL  
 LOCATION PLAN**  
 Phase Two Environmental Site Assessment  
 84, 90 High Street East and  
 17, 19 Ann Street  
 Mississauga, Ontario

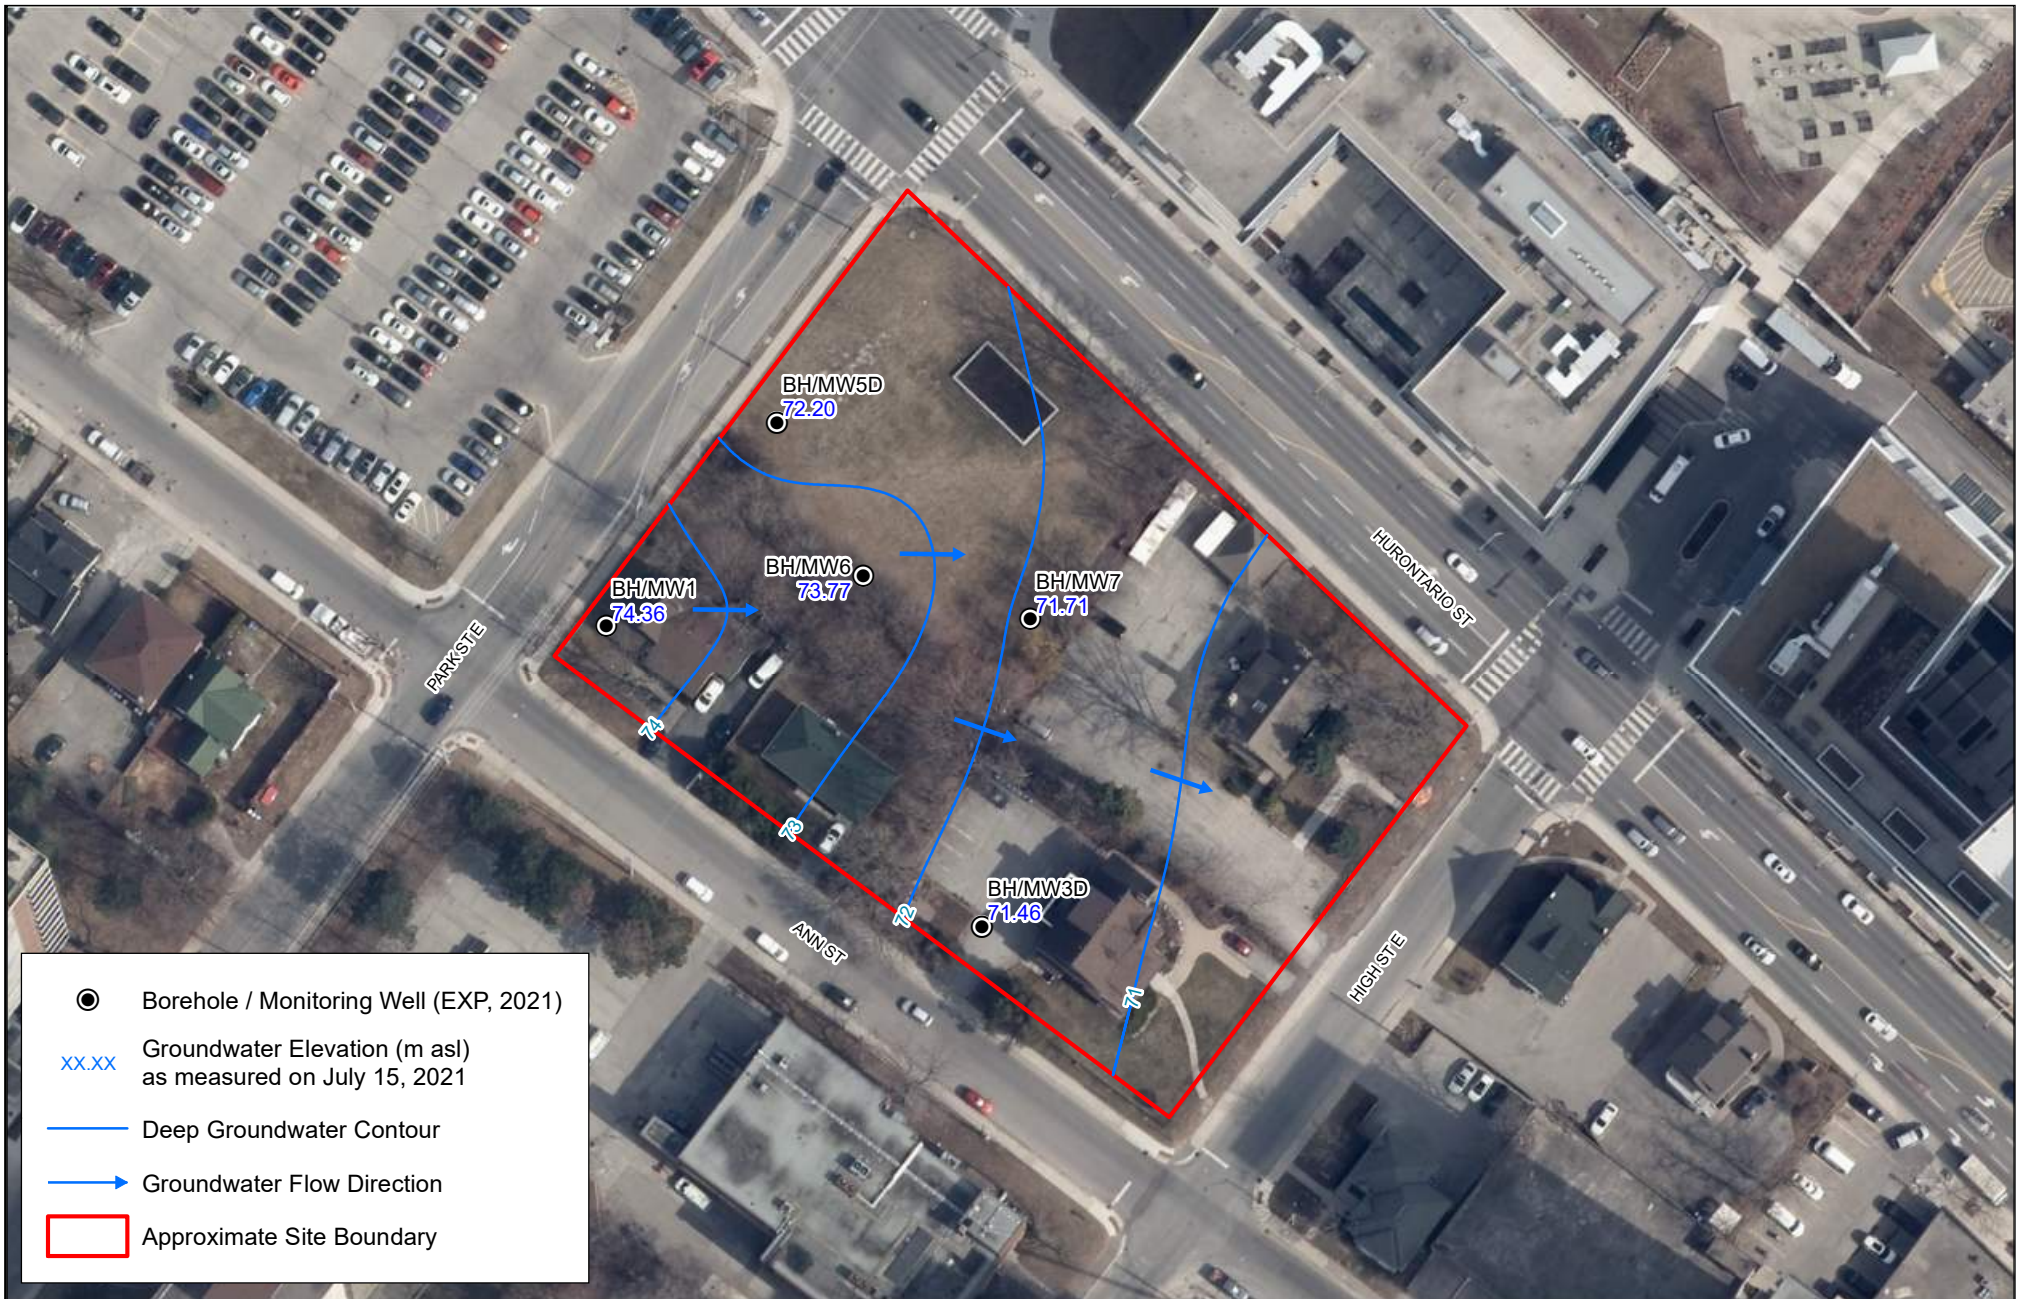
PROJECT No:	BRM-00239423-E0	OWN:	AC
SCALE:	AS NOTED	CHKD:	SL
DATE:	AUGUST 2021	FIG. No.:	6B

- Borehole / Monitoring Well (EXP, 2021)
- xx.xx Groundwater Elevation (m asl) as measured on July 15, 2021
- Deep Groundwater Contour
- ➔ Groundwater Flow Direction
- ▭ Approximate Site Boundary

The deep horizontal hydraulic gradient on-Site ranged from 0.006 m/m (between MW3D and MW7) and 0.088 m/m (between MW6 and MW7) in deep aquifer. Calculations of the horizontal hydraulic gradients observed at the Site are provided in Table 7B.

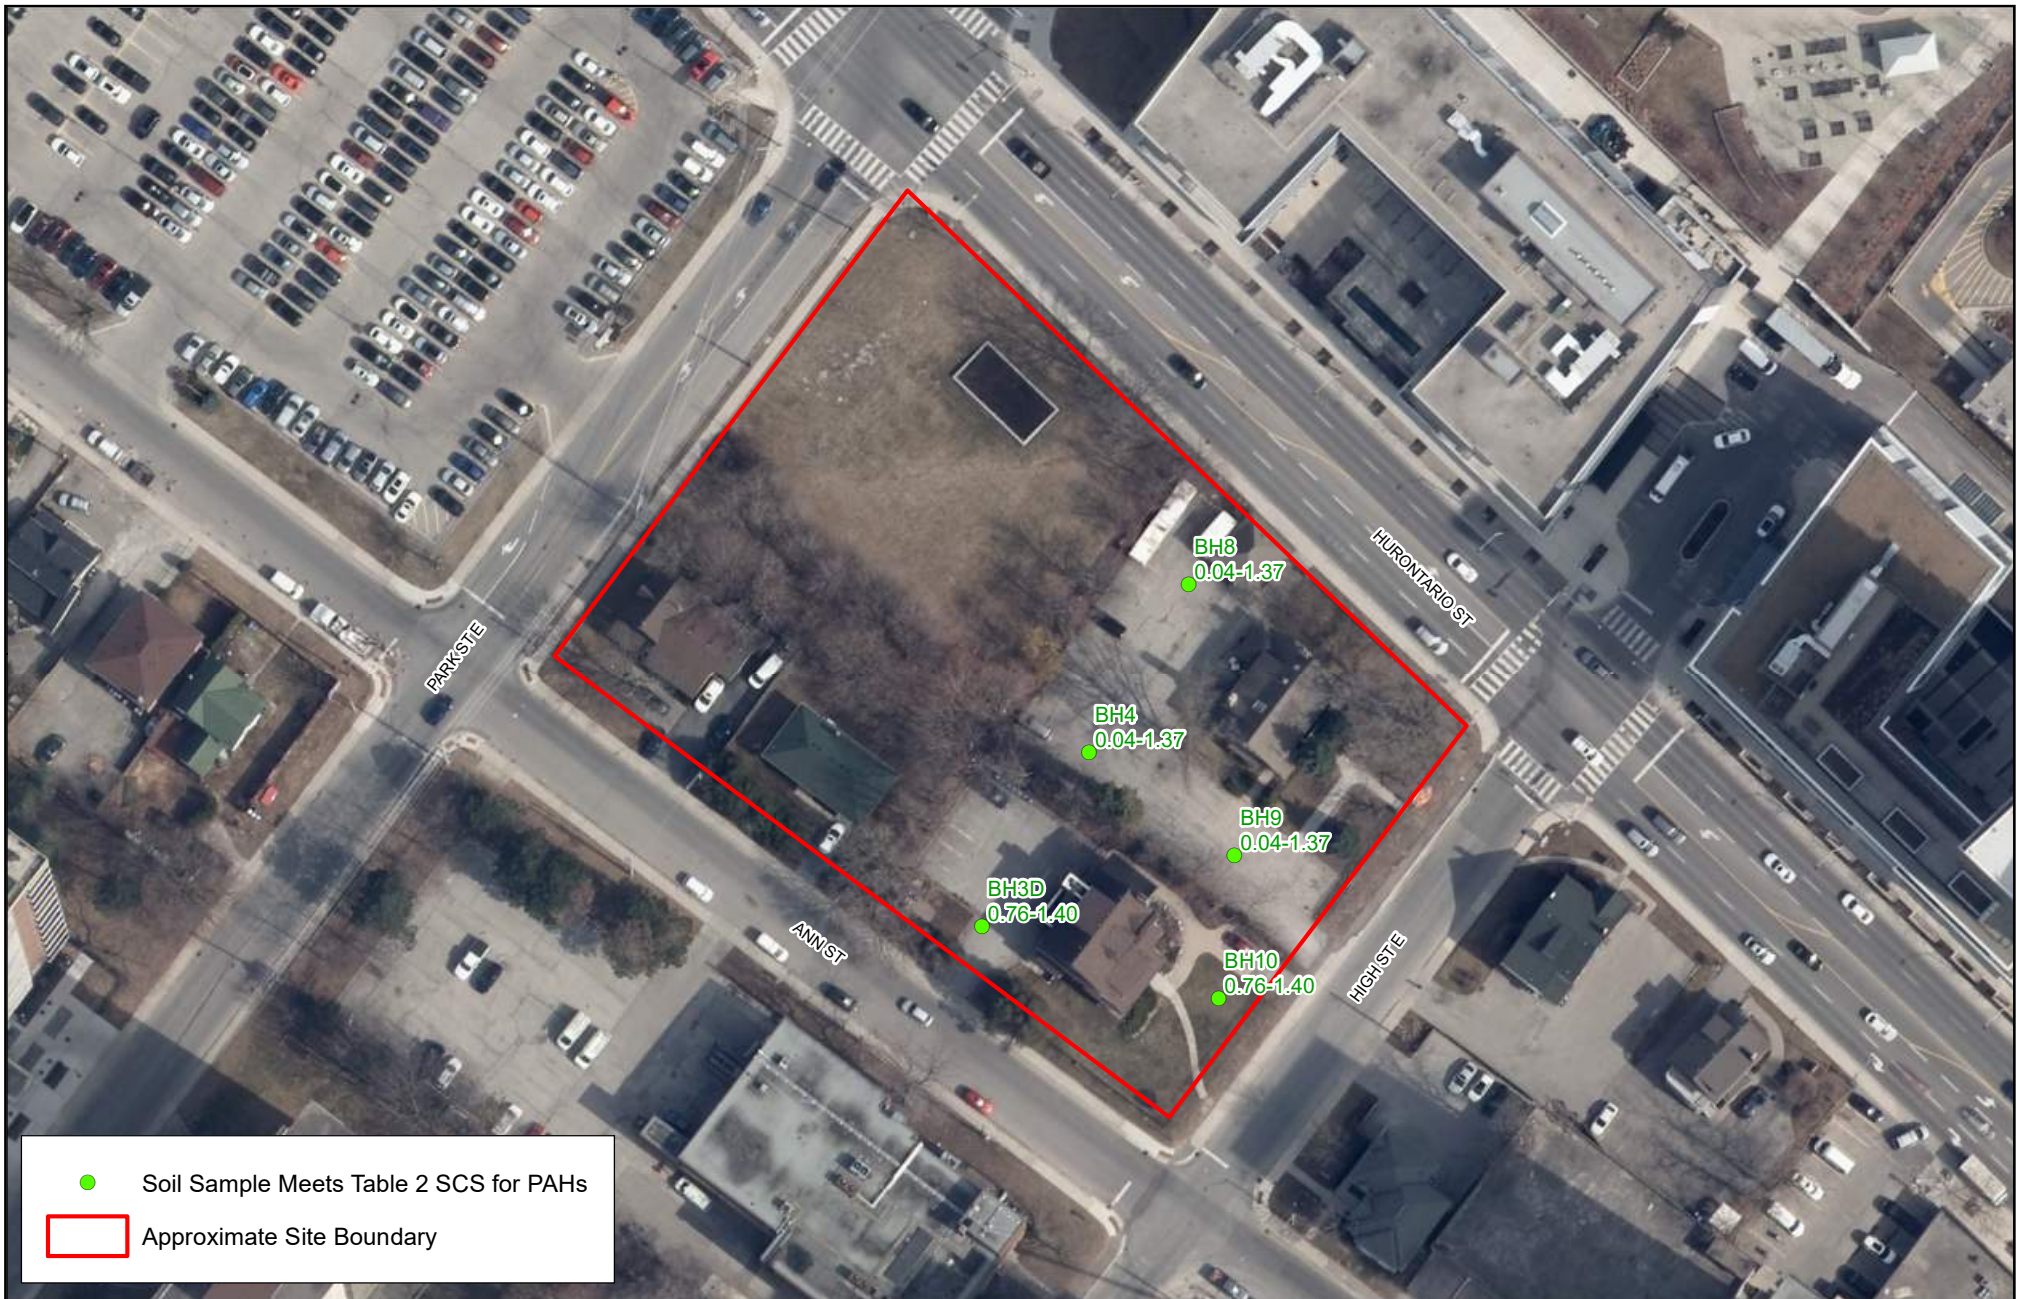
PROJECT No:	BRM-00239423-E0	OWN:	AC
SCALE:	AS NOTED	CHKD:	SL
DATE:	AUGUST 2021	FIG. No.:	7

● Soil Sample Meets Table 2 SCS for PAHs  
 □ Approximate Site Boundary

TITLE AND LOCATION:  
**SOIL ANALYTICAL RESULTS -  
 POLYCYCLIC AROMATIC HYDROCARBON (PAHs)**  
 Phase Two Environmental Site Assessment  
 84, 90 High Street East and  
 17, 19 Ann Street  
 Mississauga, Ontario

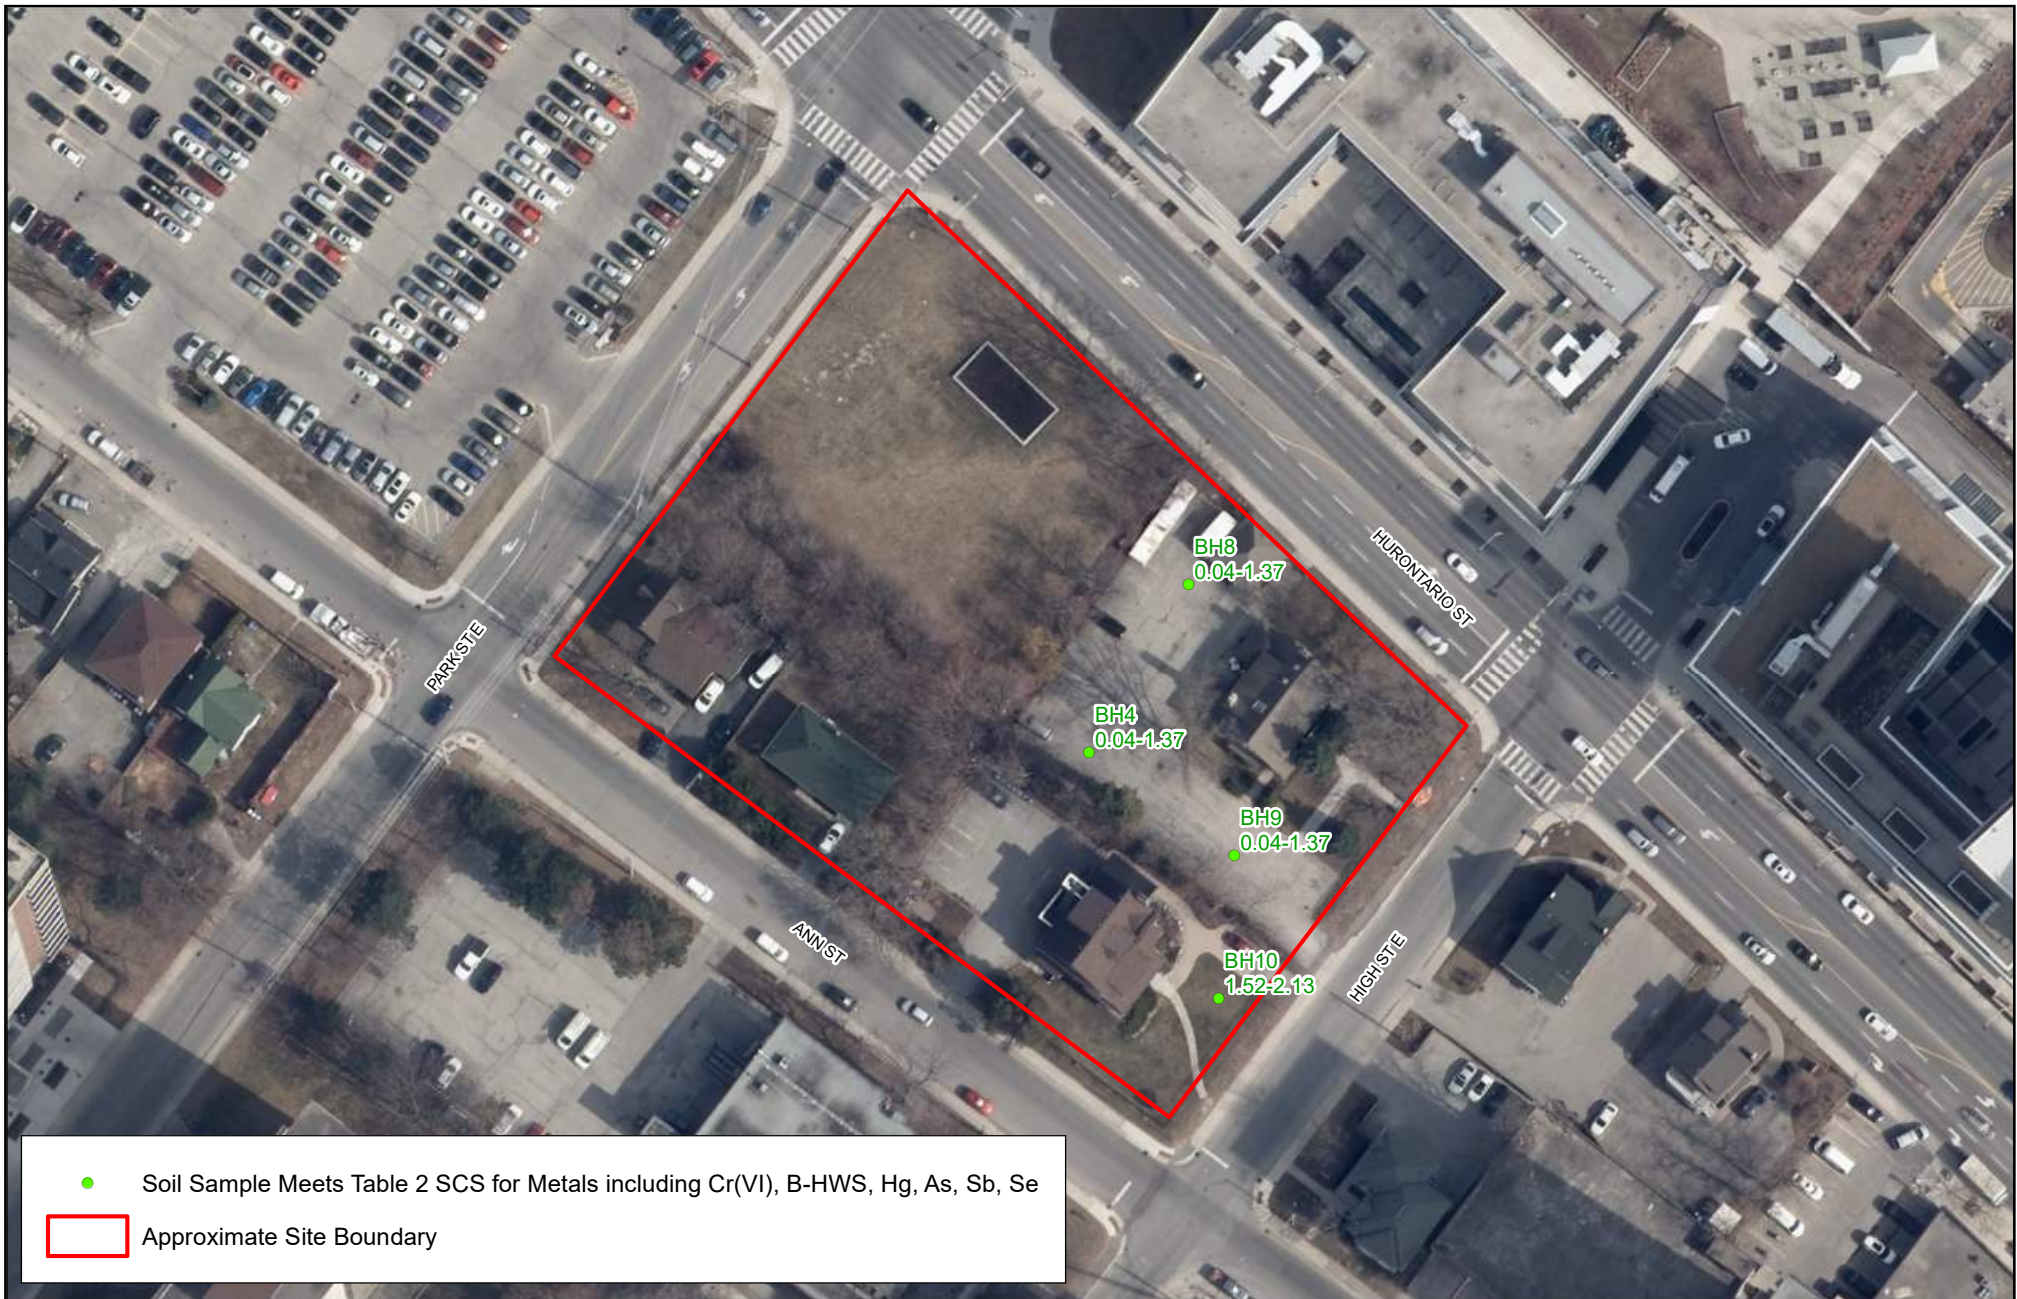
PROJECT No:	BRM-00239423-E0	OWN:	AC
SCALE:	AS NOTED	CHKD:	SL
DATE:	AUGUST 2021	FIG. No.:	8

● Soil Sample Meets Table 2 SCS for Metals including Cr(VI), B-HWS, Hg, As, Sb, Se

TITLE AND LOCATION:  
**SOIL ANALYTICAL RESULTS -  
 METALS INCLUDING Cr(VI), B-HWS, Hg, As, Sb, Se**  
 Phase Two Environmental Site Assessment  
 84, 90 High Street East and  
 17, 19 Ann Street  
 Mississauga, Ontario

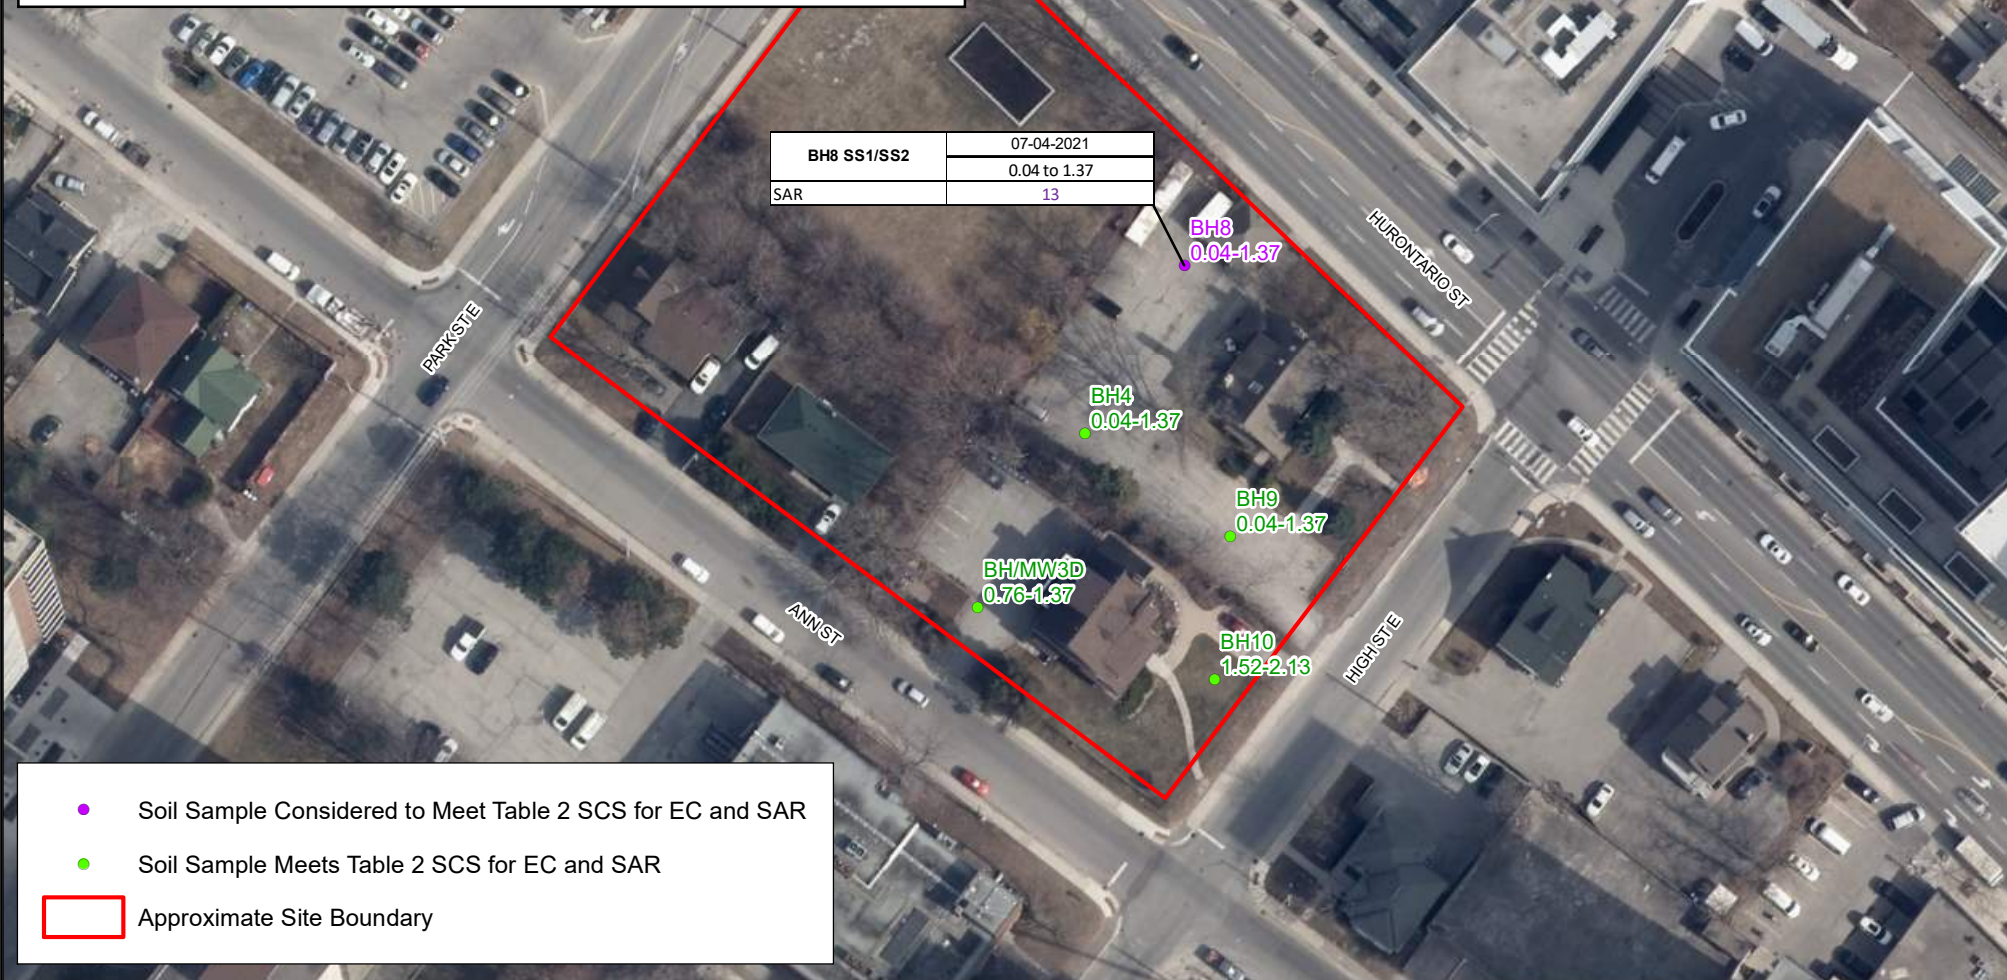
PROJECT No:	BRM-00239423-E0	OWN:	AC
SCALE:	AS NOTED	CHKD:	SL
DATE:	AUGUST 2021	FIG. No.:	10

\* MECP (2011) Table 2 Full Depth Generic Site Condition Standards in a Potable Groundwater Condition for Residential/Parkland/Institutional property use (medium to fine textured soils)  
mbgs = metres below ground surface  
Concentration of contaminant within the Table 2 Standards, per section 49.1 (1) of O.Reg. 153/04 shown in text as purple

BH8 SS1/SS2	07-04-2021
	0.04 to 1.37
SAR	13

It is also noted that elevated level of SAR, present in tested location (BH8), is related to the application of salting and de-icing substances at the driveway for the purpose of snow and ice removal during the winter months. As per Section 2 of Ontario Regulation 339 of the Revised Regulations of Ontario, 1990 (Classes of Contaminants - Exceptions), and Part IX, Subsection 49.1

of Ontario Regulation 153/04, the concentration of SAR is deemed not to be exceedances of the MECP Table 2 SCS. As such, it is the QP<sub>ESA</sub>'s opinion that the applicable Table 2 SCS for SAR in soil at the site was exceeded solely because salt was used at the driveway for the purpose of keeping the area safe for traffic under conditions of snow or ice or both, and therefore these parameters are not considered COCs.

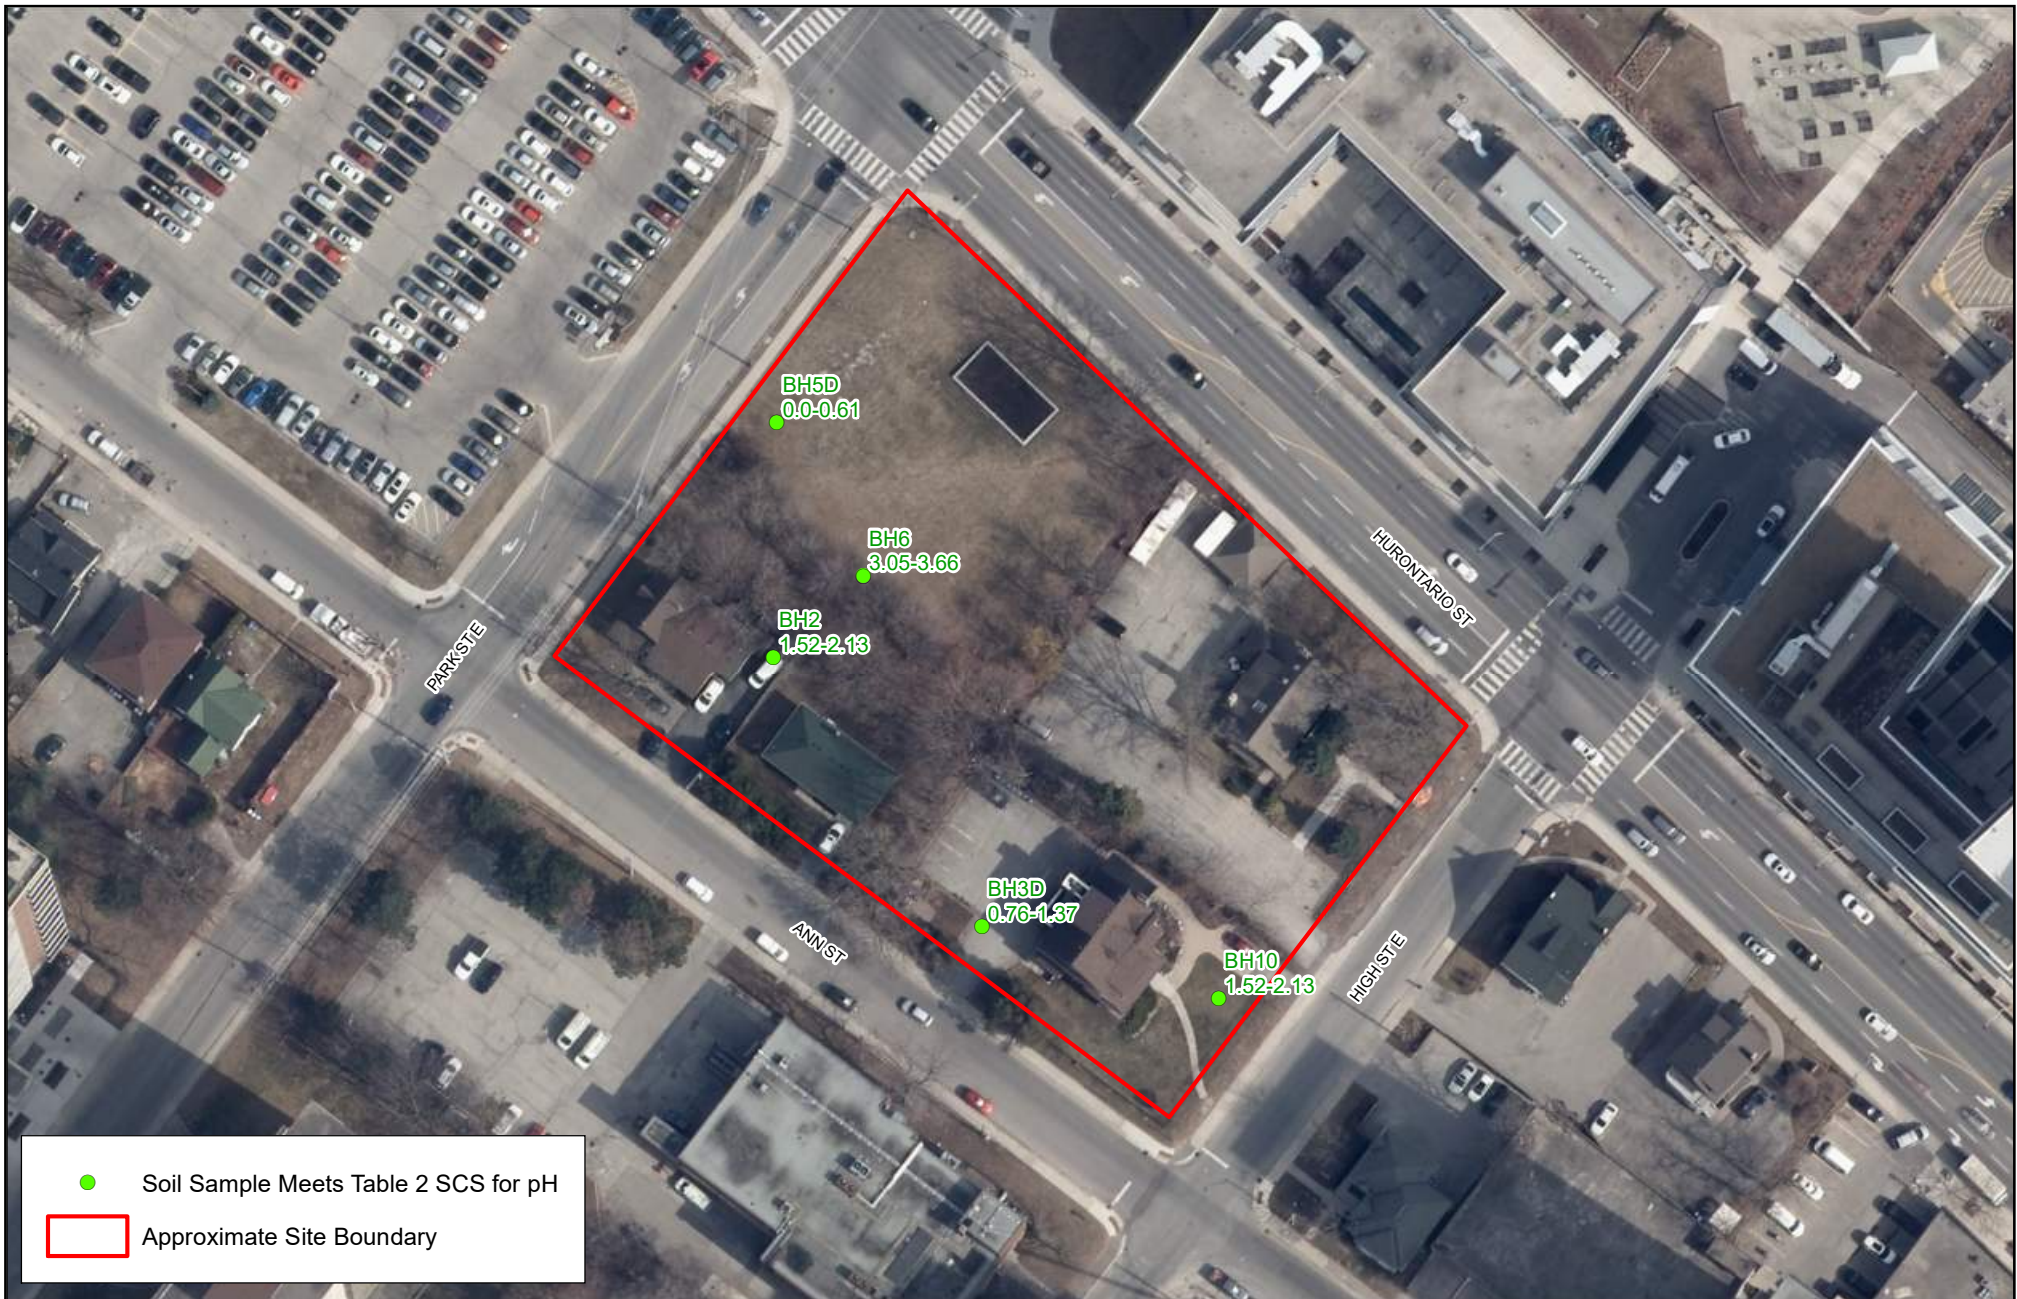
PROJECT No:	BRM-00239423-E0	OWN:	AC
SCALE:	AS NOTED	CHKD:	SL
DATE:	AUGUST 2021	FIG. No.:	11

● Soil Sample Meets Table 2 SCS for pH  
 □ Approximate Site Boundary

TITLE AND LOCATION:  
**SOIL ANALYTICAL RESULTS - pH**  
 Phase Two Environmental Site Assessment  
 84, 90 High Street East and  
 17, 19 Ann Street  
 Mississauga, Ontario

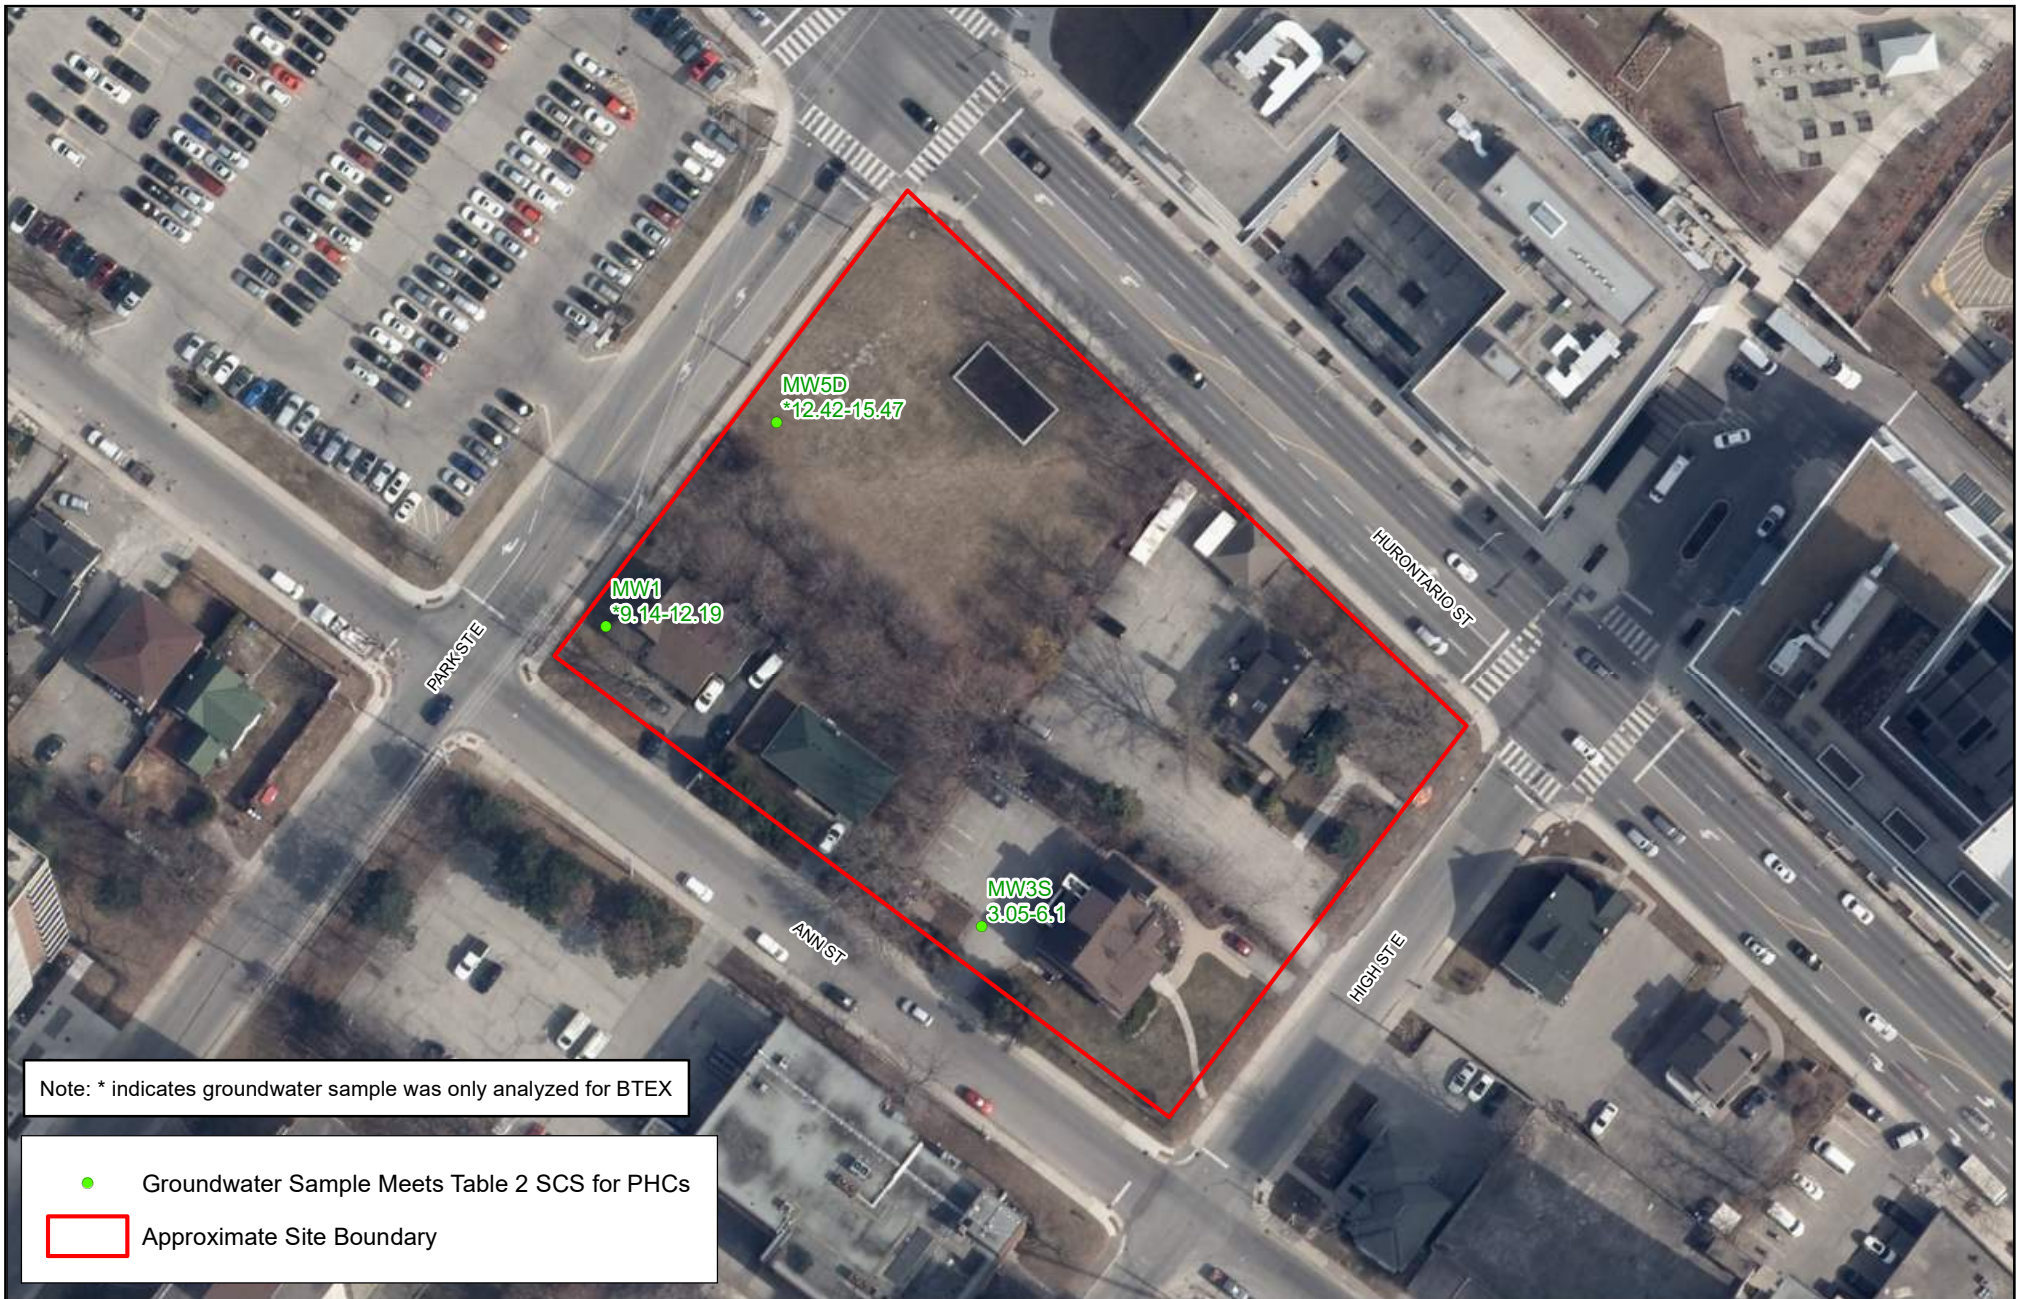
PROJECT No:	BRM-00239423-E0	OWN:	AC
SCALE:	AS NOTED	CHKD:	SL
DATE:	AUGUST 2021	FIG. No.:	12

Note: \* indicates groundwater sample was only analyzed for BTEX

TITLE AND LOCATION:  
**GROUNDWATER ANALYTICAL RESULTS -  
 PETROLEUM HYDROCARBONS (PHCs)  
 INCLUDING BTEX**  
 Phase Two Environmental Site Assessment  
 84, 90 High Street East and  
 17, 19 Ann Street  
 Mississauga, Ontario

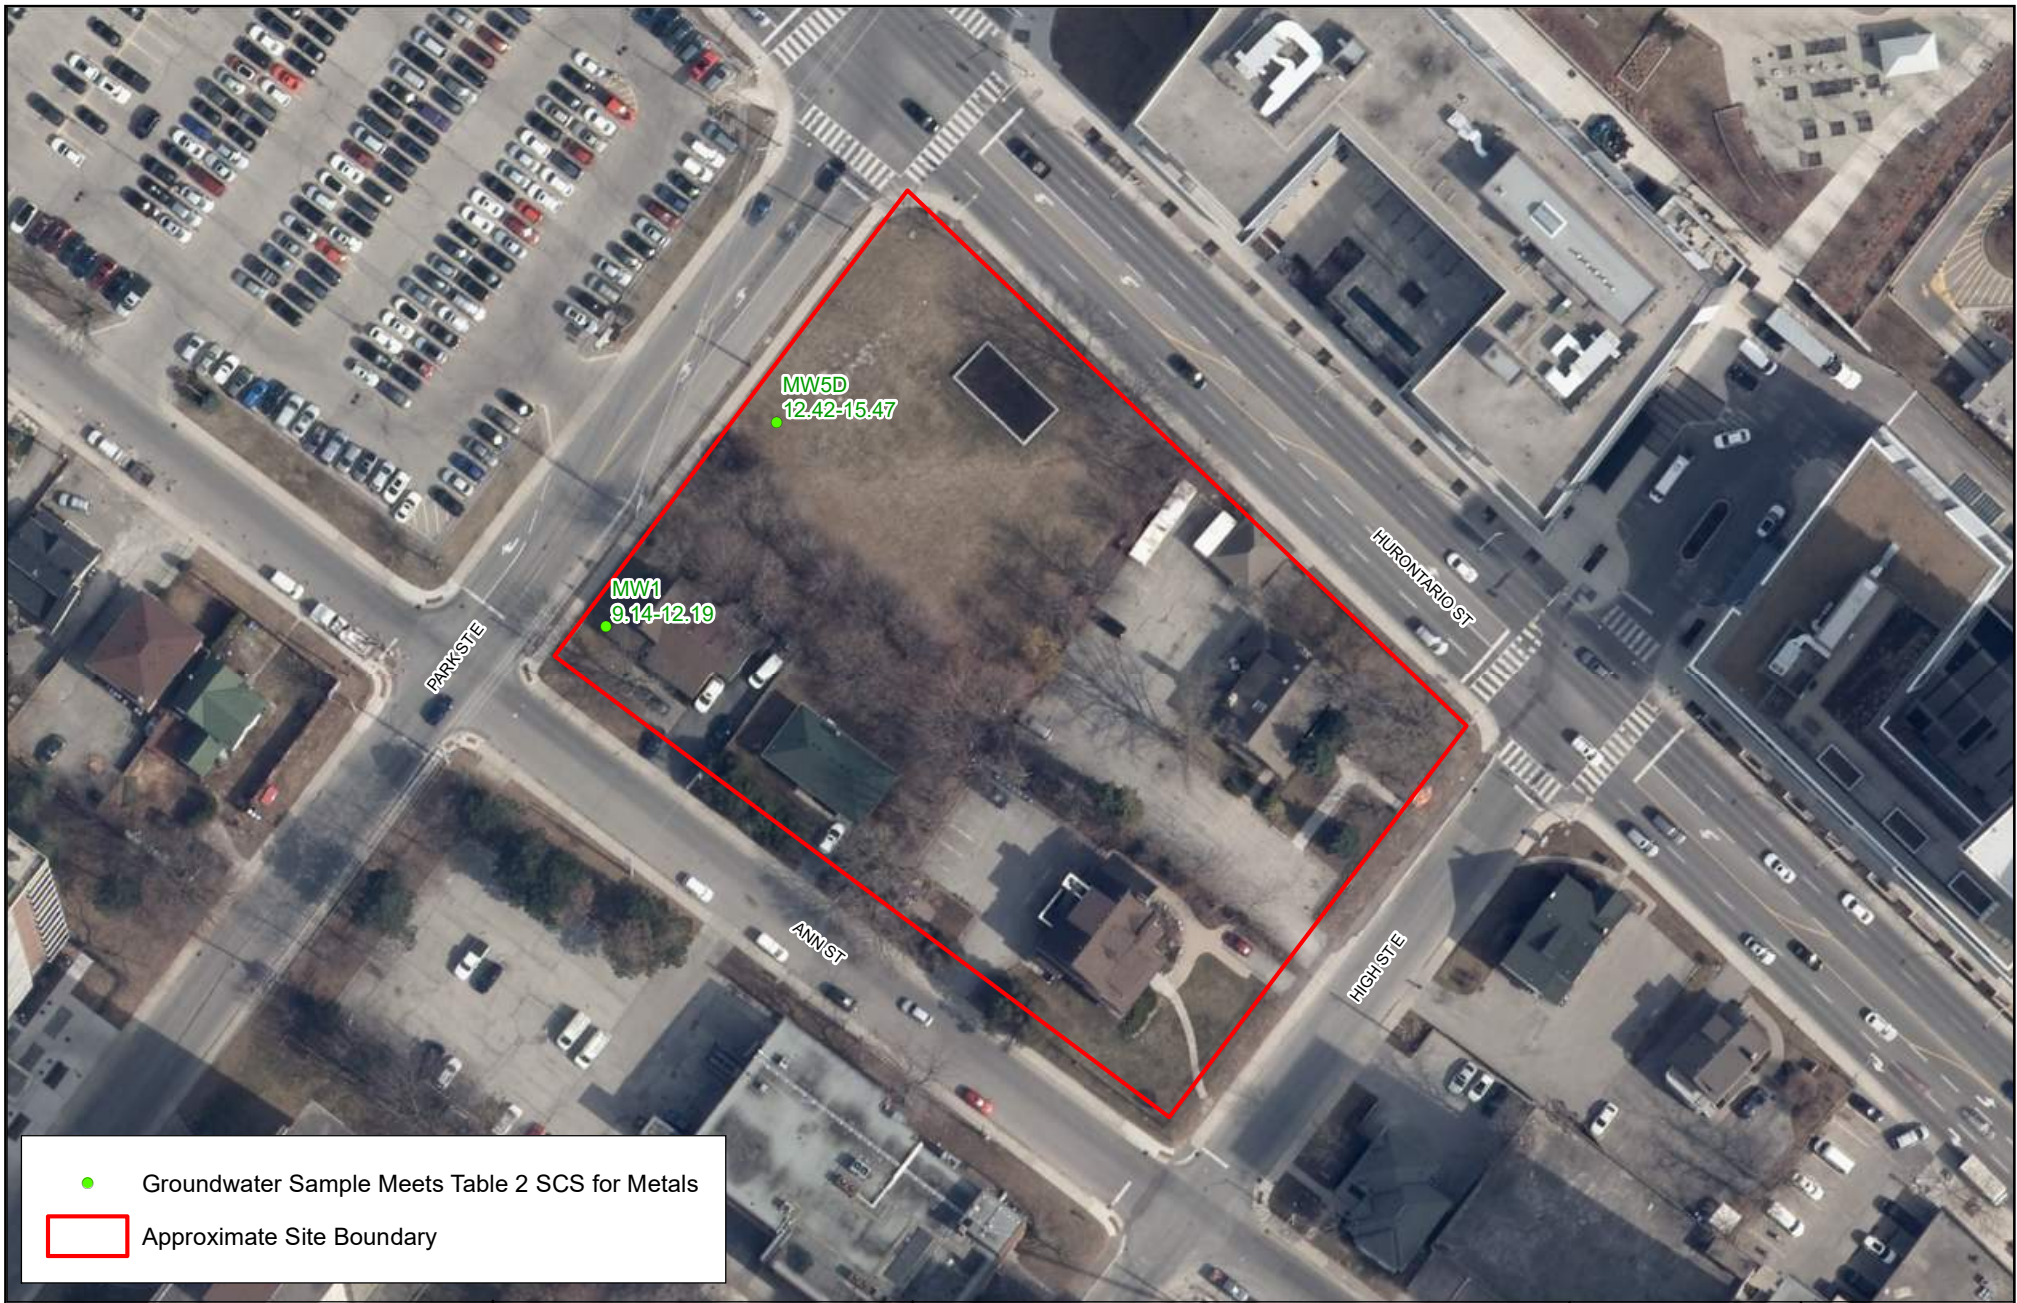
PROJECT No:	BRM-00239423-E0	OWN:	AC
SCALE:	AS NOTED	CHKD:	SL
DATE:	AUGUST 2021	FIG. No.:	13

**GROUNDWATER ANALYTICAL RESULTS -  
 VOLATILE ORGANIC COMPOUNDS (VOCs)**  
 Phase Two Environmental Site Assessment  
 84, 90 High Street East and  
 17, 19 Ann Street  
 Mississauga, Ontario
