84, 90 High Street East, 17, 19 Ann Street and Part  
of 91 Park Street East, Mississauga, Ontario

Phase Two Environmental Site Assessment

BRM-00239423-E0

August 24, 2021

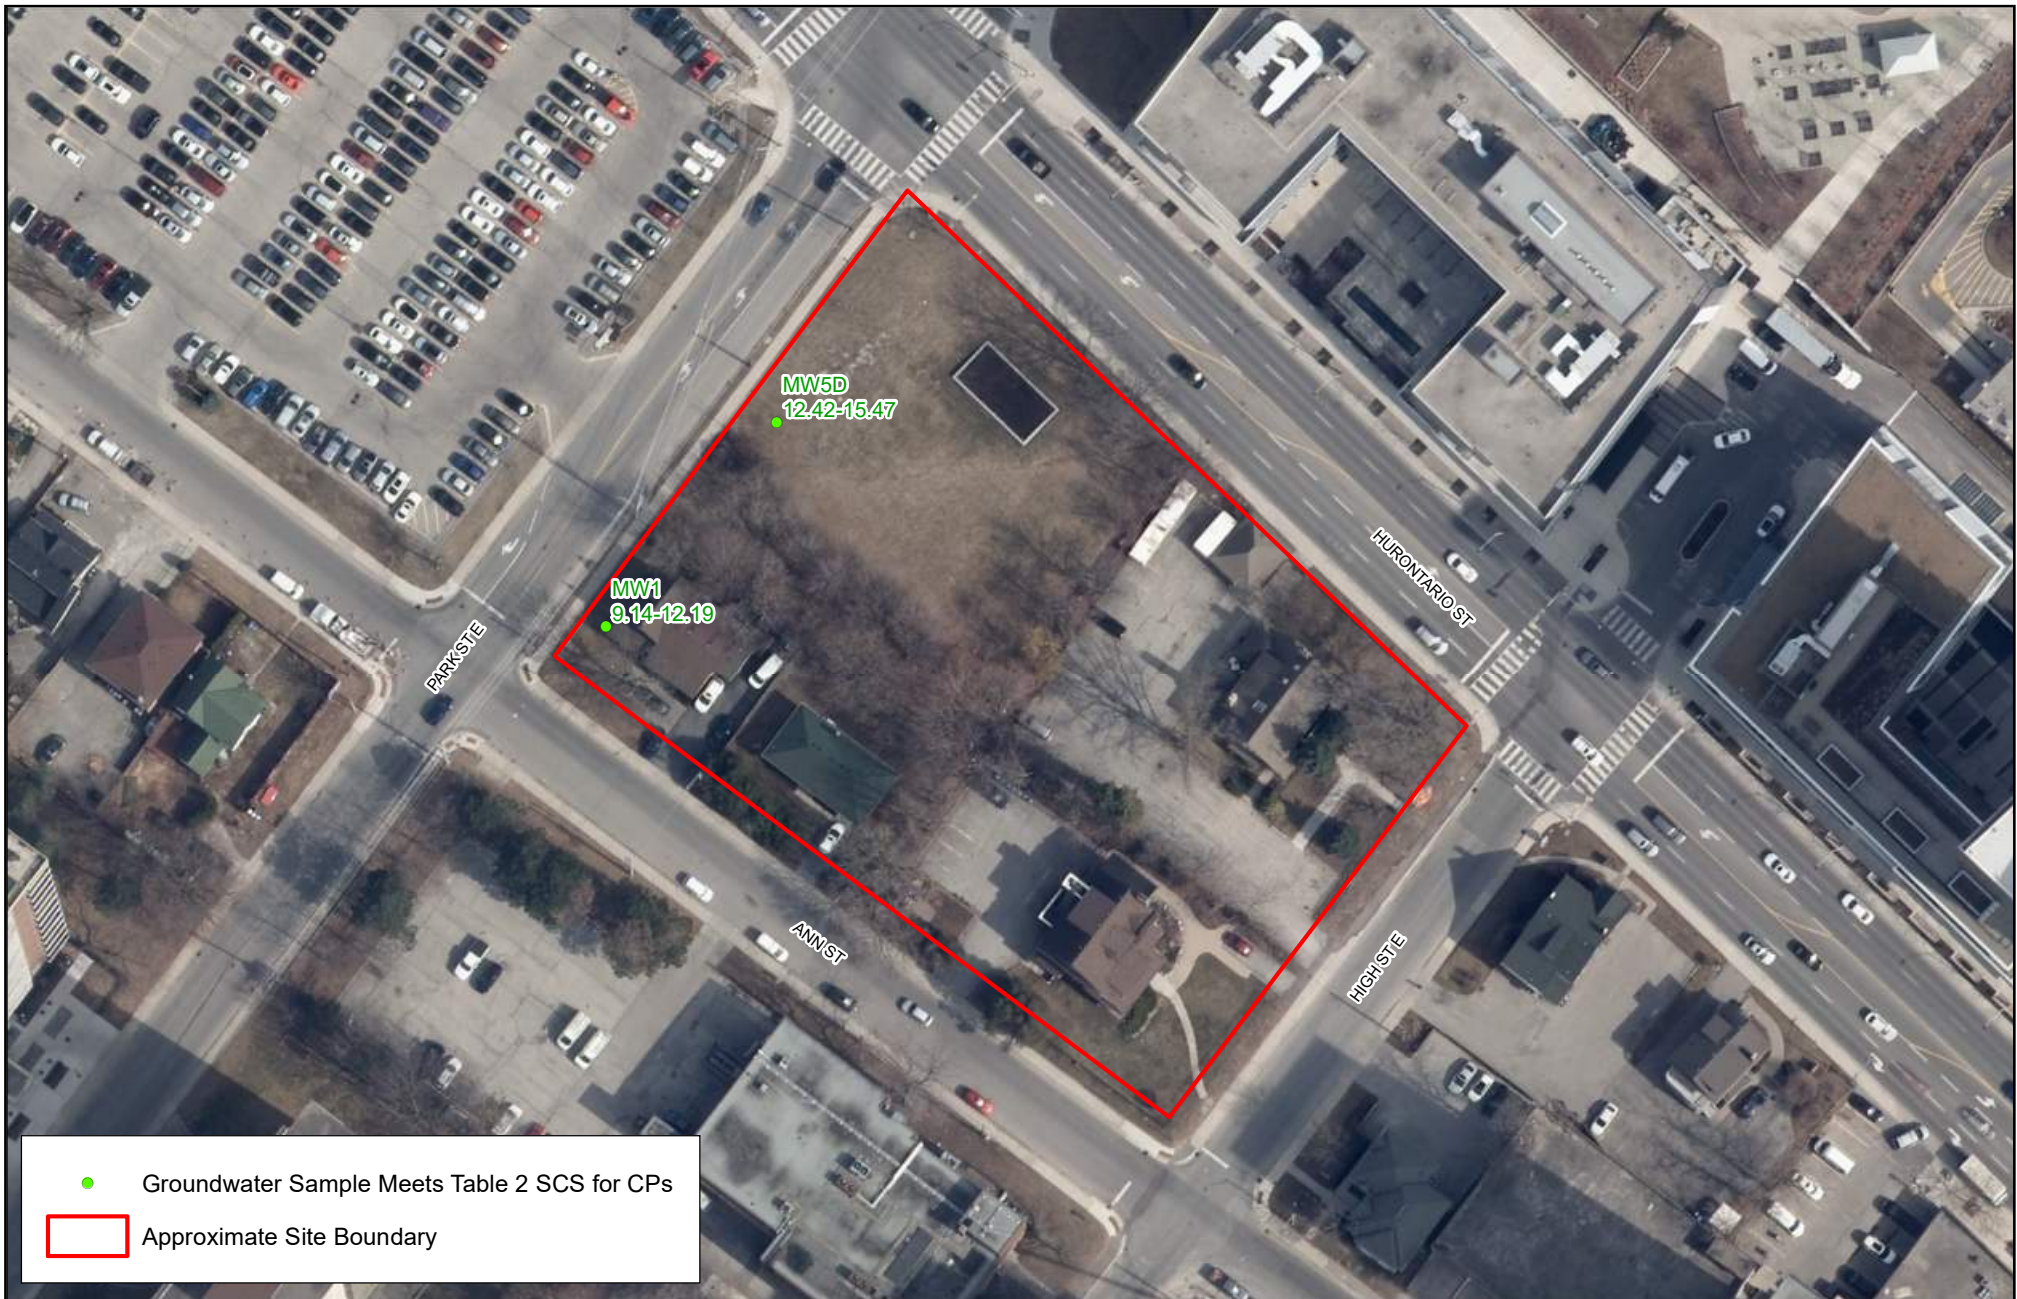
PROJECT No:	BRM-00239423-E0	OWN:	AC
SCALE:	AS NOTED	CHKD:	SL
DATE:	AUGUST 2021	FIG. No.:	16

● Groundwater Sample Meets Table 2 SCS for CPs  
 Approximate Site Boundary

**TITLE AND LOCATION:**  
 GROUNDWATER ANALYTICAL RESULTS -  
 CHLOROPHENOLS (CPs)  
 Phase Two Environmental Site Assessment  
 84, 90 High Street East and  
 17, 19 Ann Street  
 Mississauga, Ontario

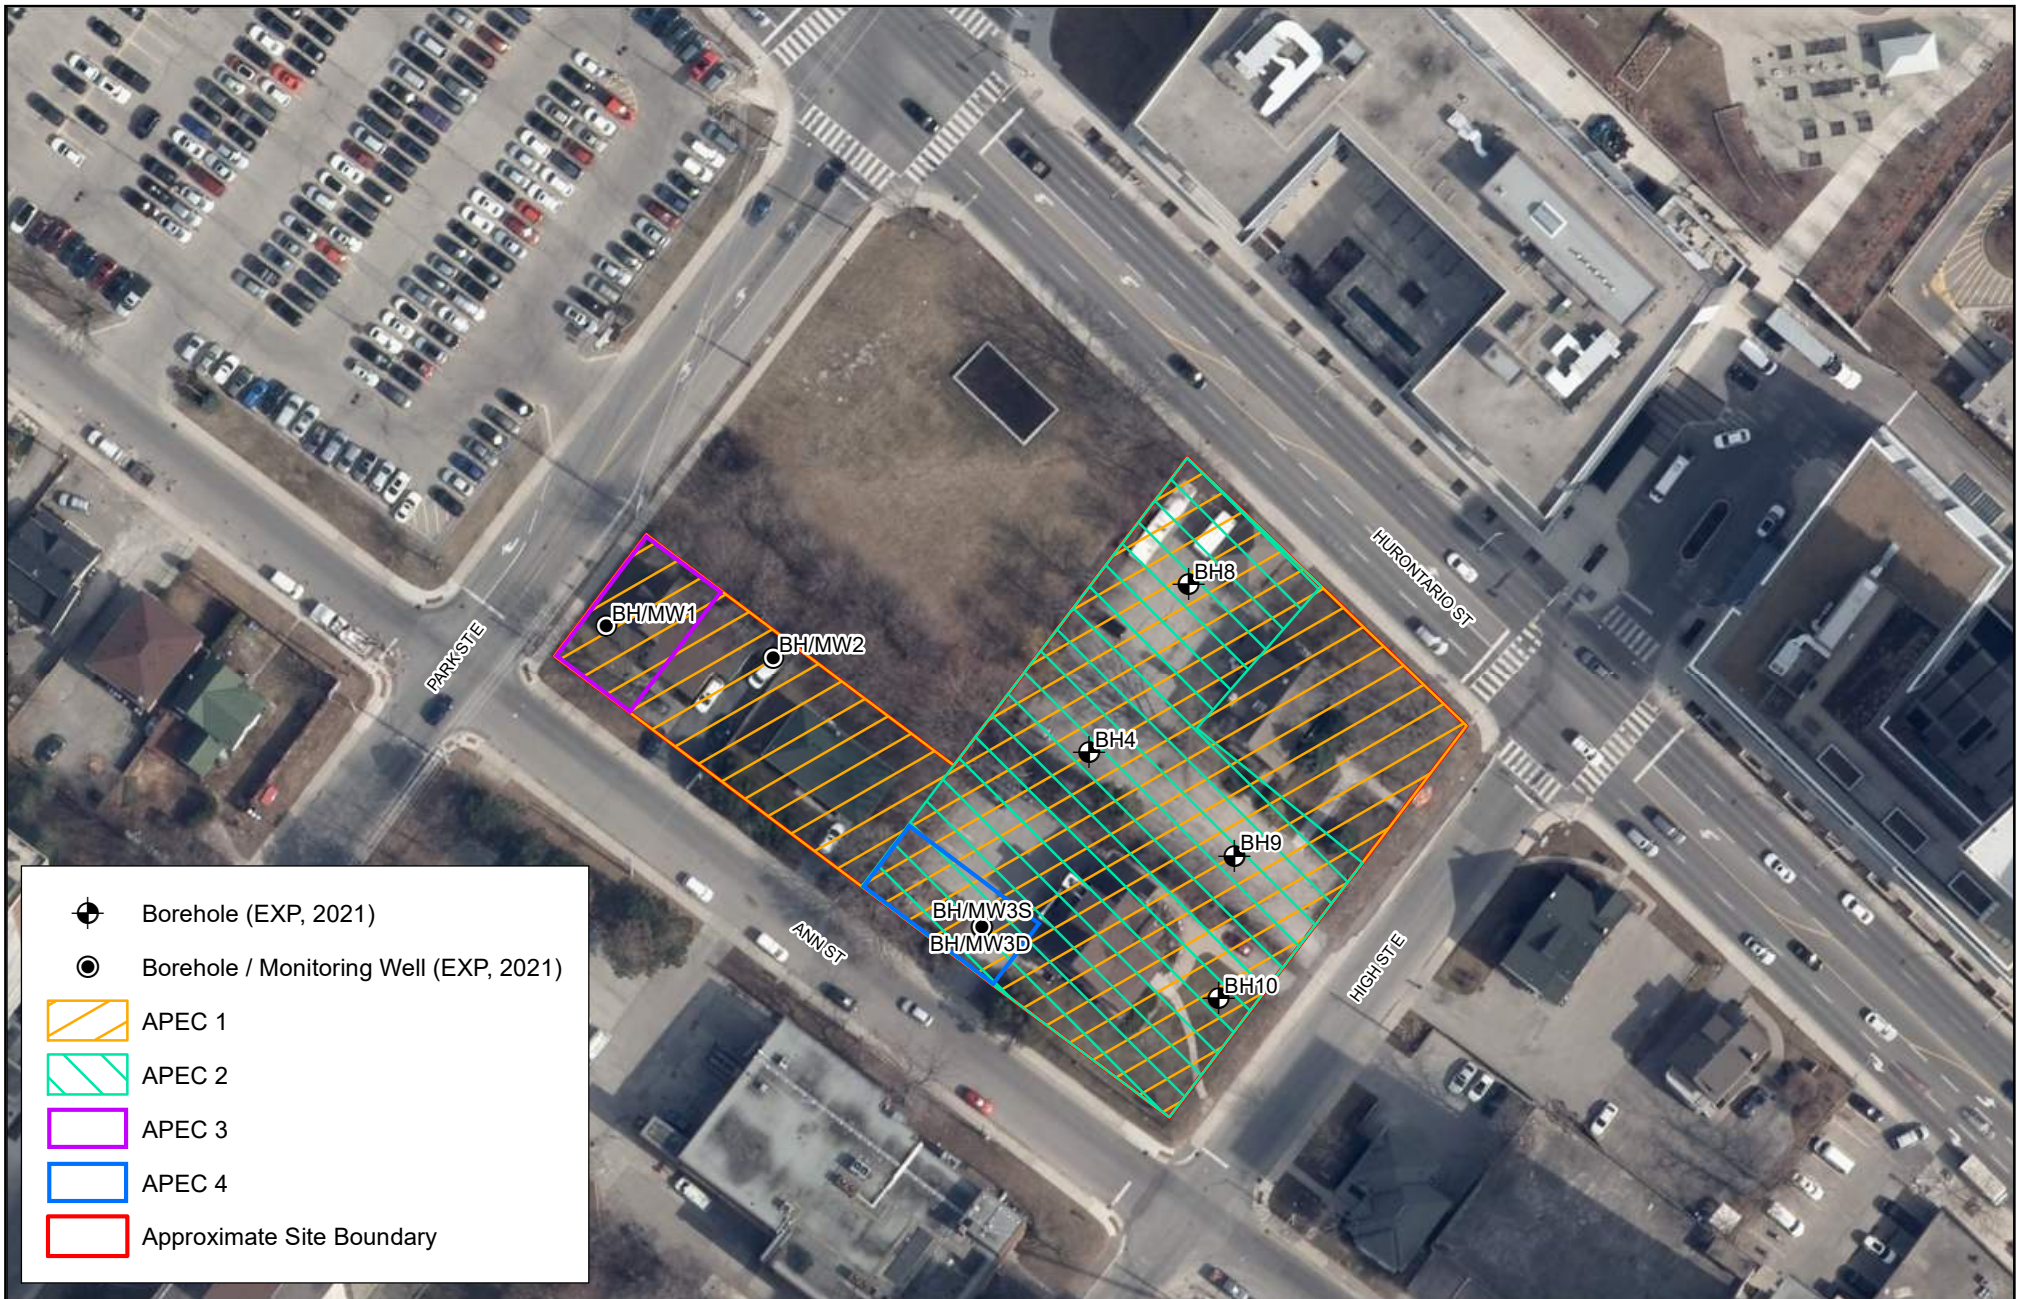
PROJECT No:	BRM-00239423-E0	OWN:	AC
SCALE:	AS NOTED	CHKD:	SL
DATE:	AUGUST 2021	FIG. No.:	5A

TITLE AND LOCATION:  
**BOREHOLE / MONITORING WELL  
 LOCATION PLAN**  
 Phase Two Environmental Site Assessment  
 84, 90 High Street East and  
 17, 19 Ann Street  
 Mississauga, Ontario

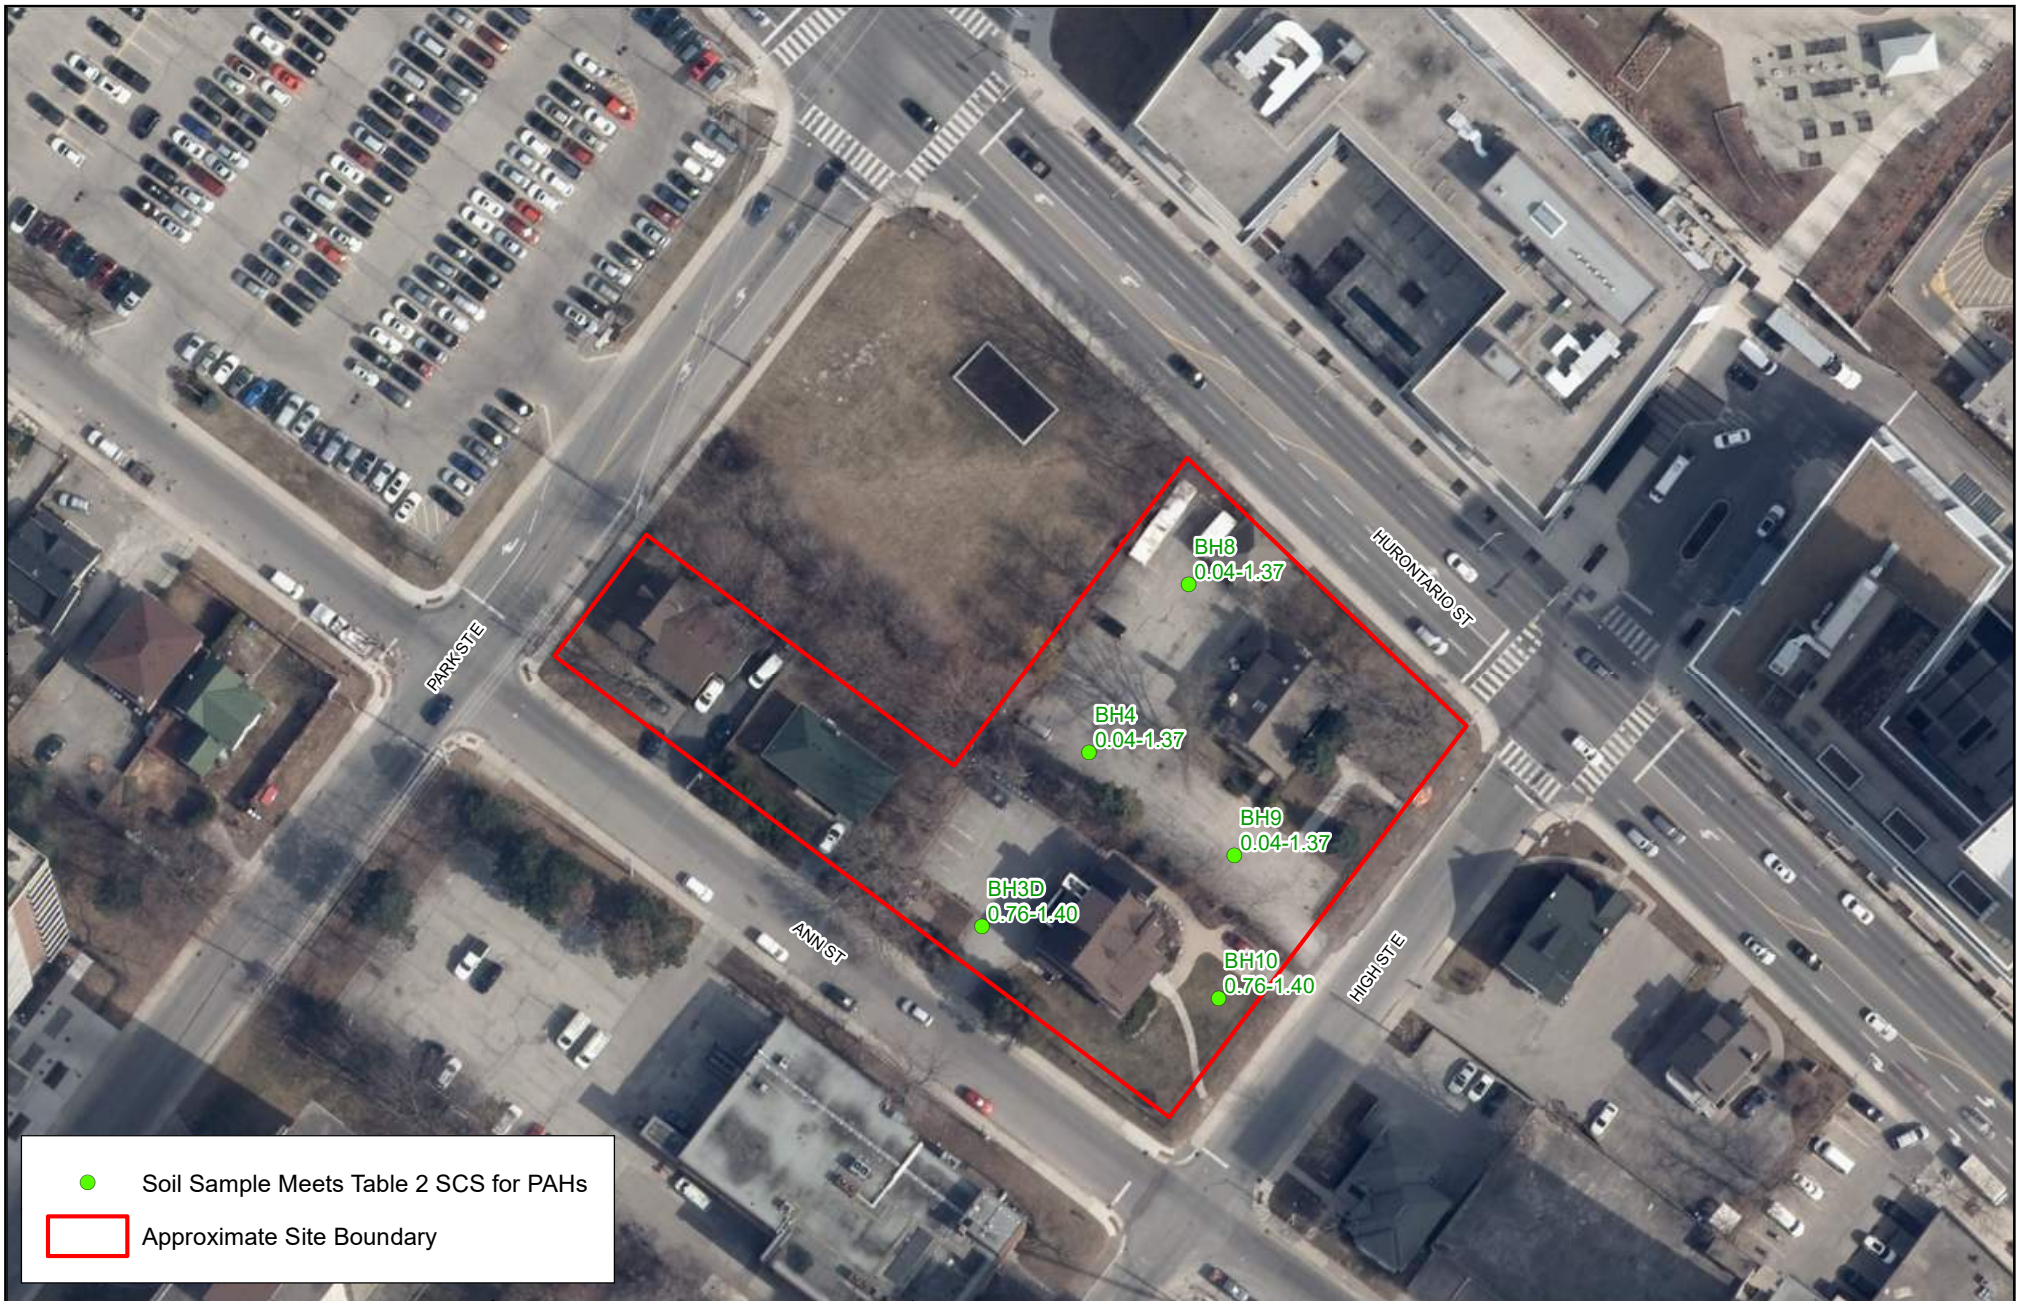
PROJECT No: BRM-00239423-E0	OWN: AC
SCALE: AS NOTED	CHKD: SL
DATE: AUGUST 2021	FIG. No.: 6

TITLE AND LOCATION:  
**GROUNDWATER CONTOUR PLAN**  
 Phase Two Environmental Site Assessment  
 84, 90 High Street East and  
 17, 19 Ann Street  
 Mississauga, Ontario

The shallow horizontal hydraulic gradient on-Site ranged from 0.009 m/m (between MW3S and MW5s) and 0.034 m/m (between MW2 and MW3S) in shallow aquifer. Calculations of the horizontal hydraulic gradients observed at the Site are provided in Table 7A.

The deep horizontal hydraulic gradient on-Site ranged from 0.006 m/m (between MW3D and MW7) and 0.088 m/m (between MW6 and MW7) in deep aquifer. Calculations of the horizontal hydraulic gradients observed at the Site are provided in Table 7B.

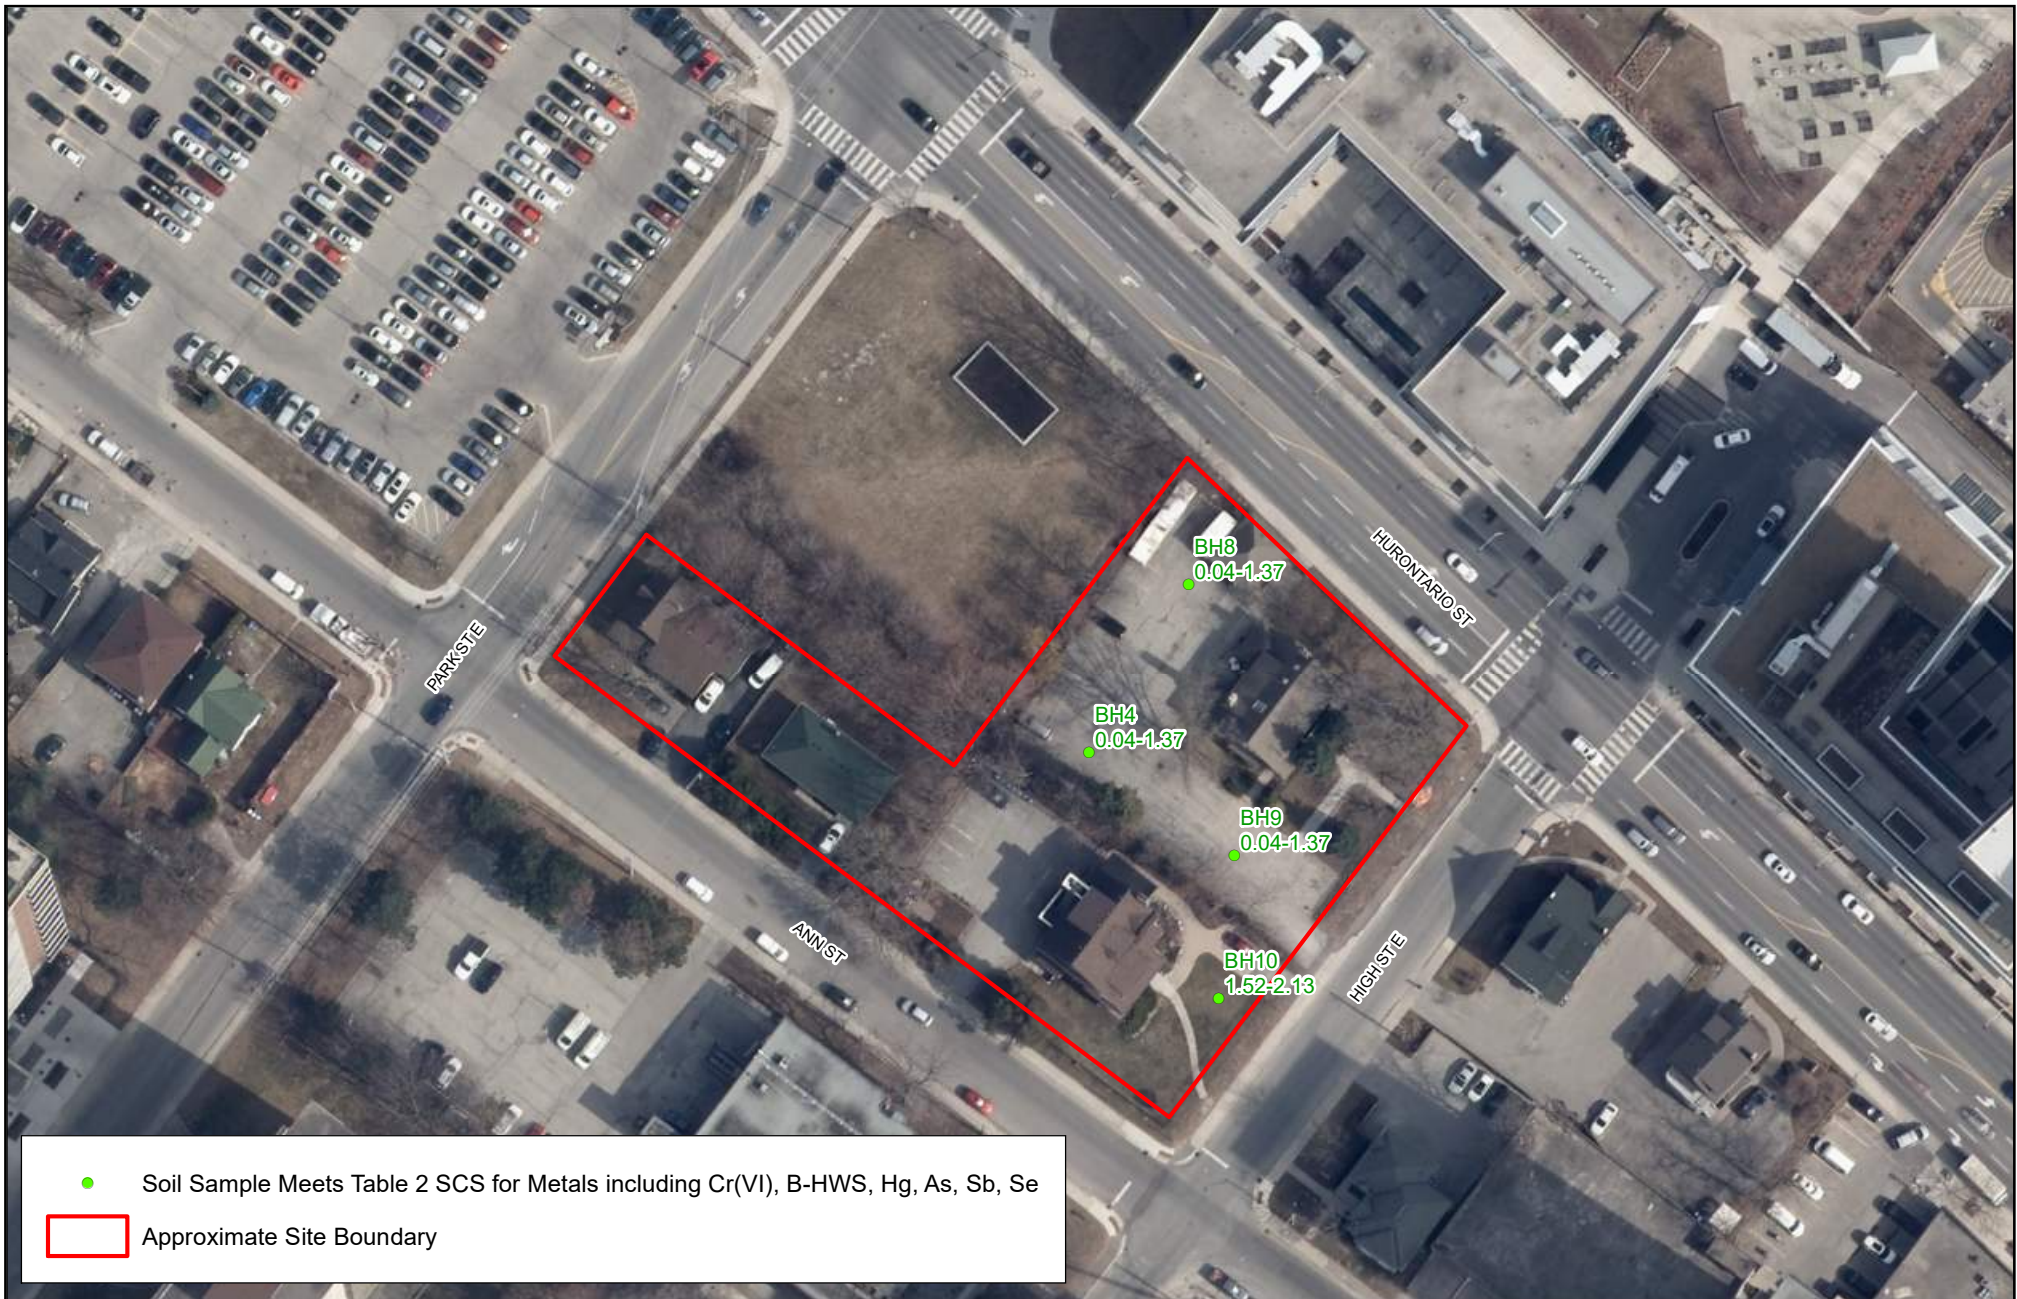
PROJECT No:	BRM-00239423-E0	OWN:	AC
SCALE:	AS NOTED	CHKD:	SL
DATE:	AUGUST 2021	FIG. No.:	7

TITLE AND LOCATION:  
**SOIL ANALYTICAL RESULTS -  
 POLYCYCLIC AROMATIC HYDROCARBON (PAHs)**  
 Phase Two Environmental Site Assessment  
 84, 90 High Street East and  
 17, 19 Ann Street  
 Mississauga, Ontario

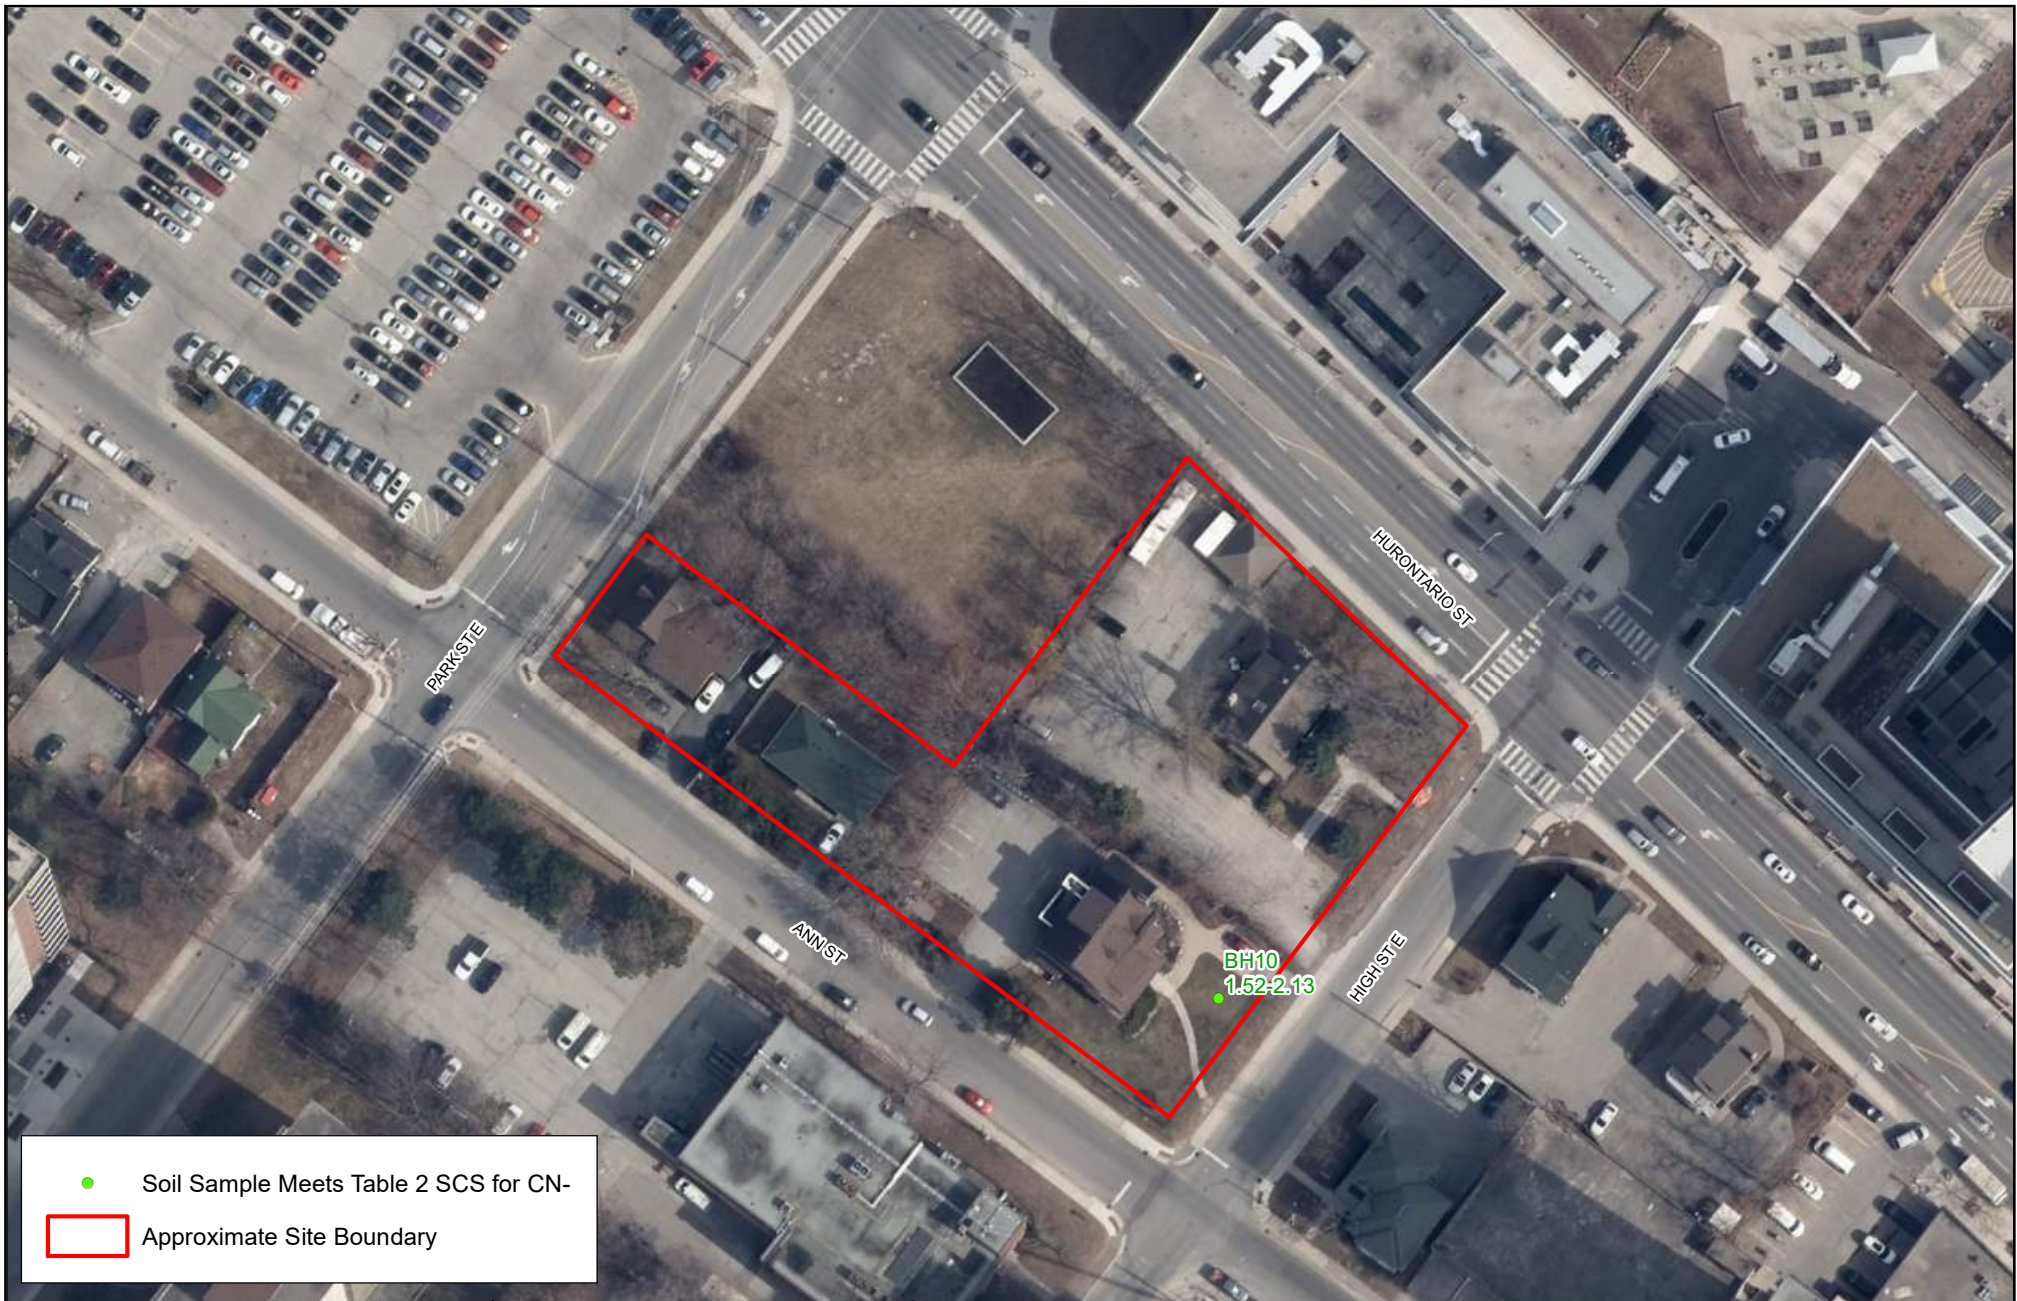
PROJECT No:	BRM-00239423-E0	OWN:	AC
SCALE:	AS NOTED	CHKD:	SL
DATE:	AUGUST 2021	FIG. No.:	8

**SOIL ANALYTICAL RESULTS -  
 METALS INCLUDING Cr(VI), B-HWS, Hg, As, Sb, Se**  
 Phase Two Environmental Site Assessment  
 84, 90 High Street East and  
 17, 19 Ann Street  
 Mississauga, Ontario

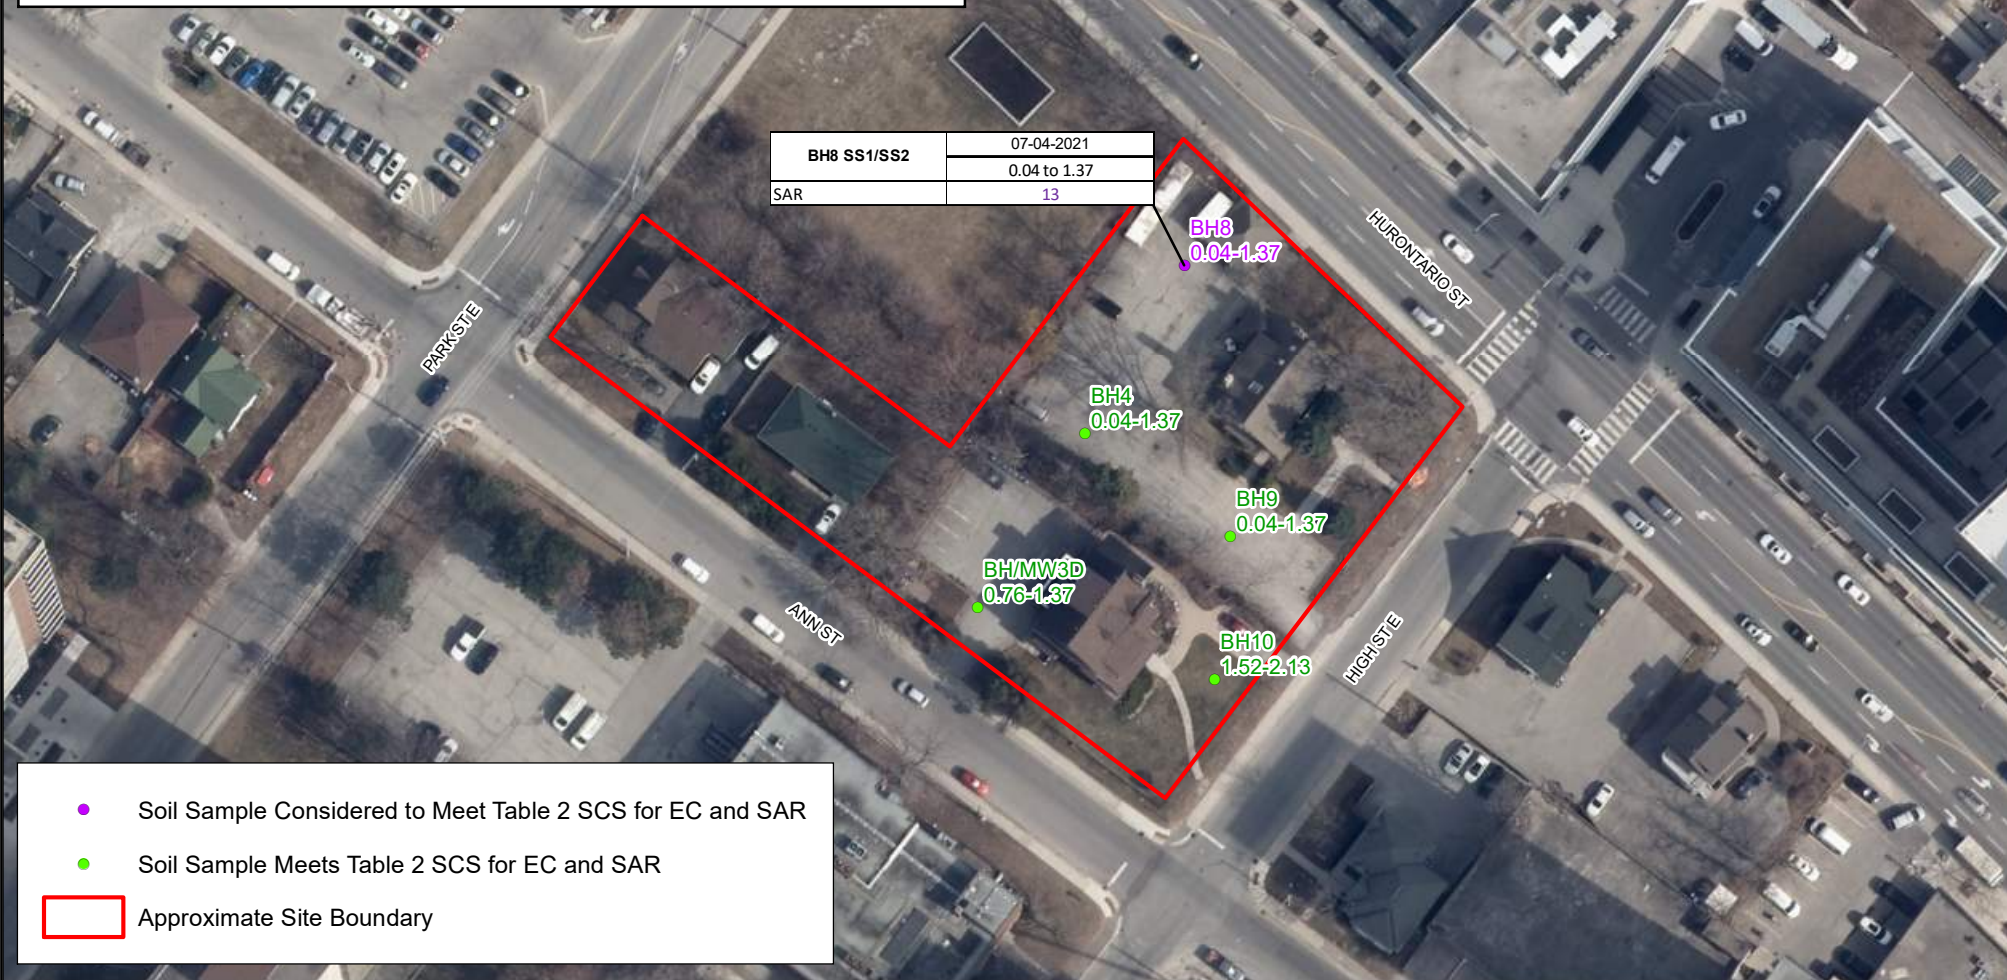
2011 MECP Table 2 SCS*			
Parameter	Abbreviation	Units	Concentration
Sodium Adsorption Ratio	SAR	Unitless	5

\* MECP (2011) Table 2 Full Depth Generic Site Condition Standards in a Potable Groundwater Condition for Residential/Parkland/Institutional property use (medium to fine textured soils)  
mbgs = metres below ground surface  
Concentration of contaminant within the Table 2 Standards, per section 49.1 (1) of O.Reg. 153/04 shown in text as purple

BH8 SS1/SS2	07-04-2021
	0.04 to 1.37
	13

It is also noted that elevated level of SAR, present in tested location (BH8), is related to the application of salting and de-icing substances at the driveway for the purpose of snow and ice removal during the winter months. As per Section 2 of Ontario Regulation 339 of the Revised Regulations of Ontario, 1990 (Classes of Contaminants - Exceptions), and Part IX, Subsection 49.1

of Ontario Regulation 153/04, the concentration of SAR is deemed not to be exceedances of the MECP Table 2 SCS. As such, it is the QP<sub>ESA</sub>'s opinion that the applicable Table 2 SCS for SAR in soil at the site was exceeded solely because salt was used at the driveway for the purpose of keeping the area safe for traffic under conditions of snow or ice or both, and therefore these parameters are not considered COCs.

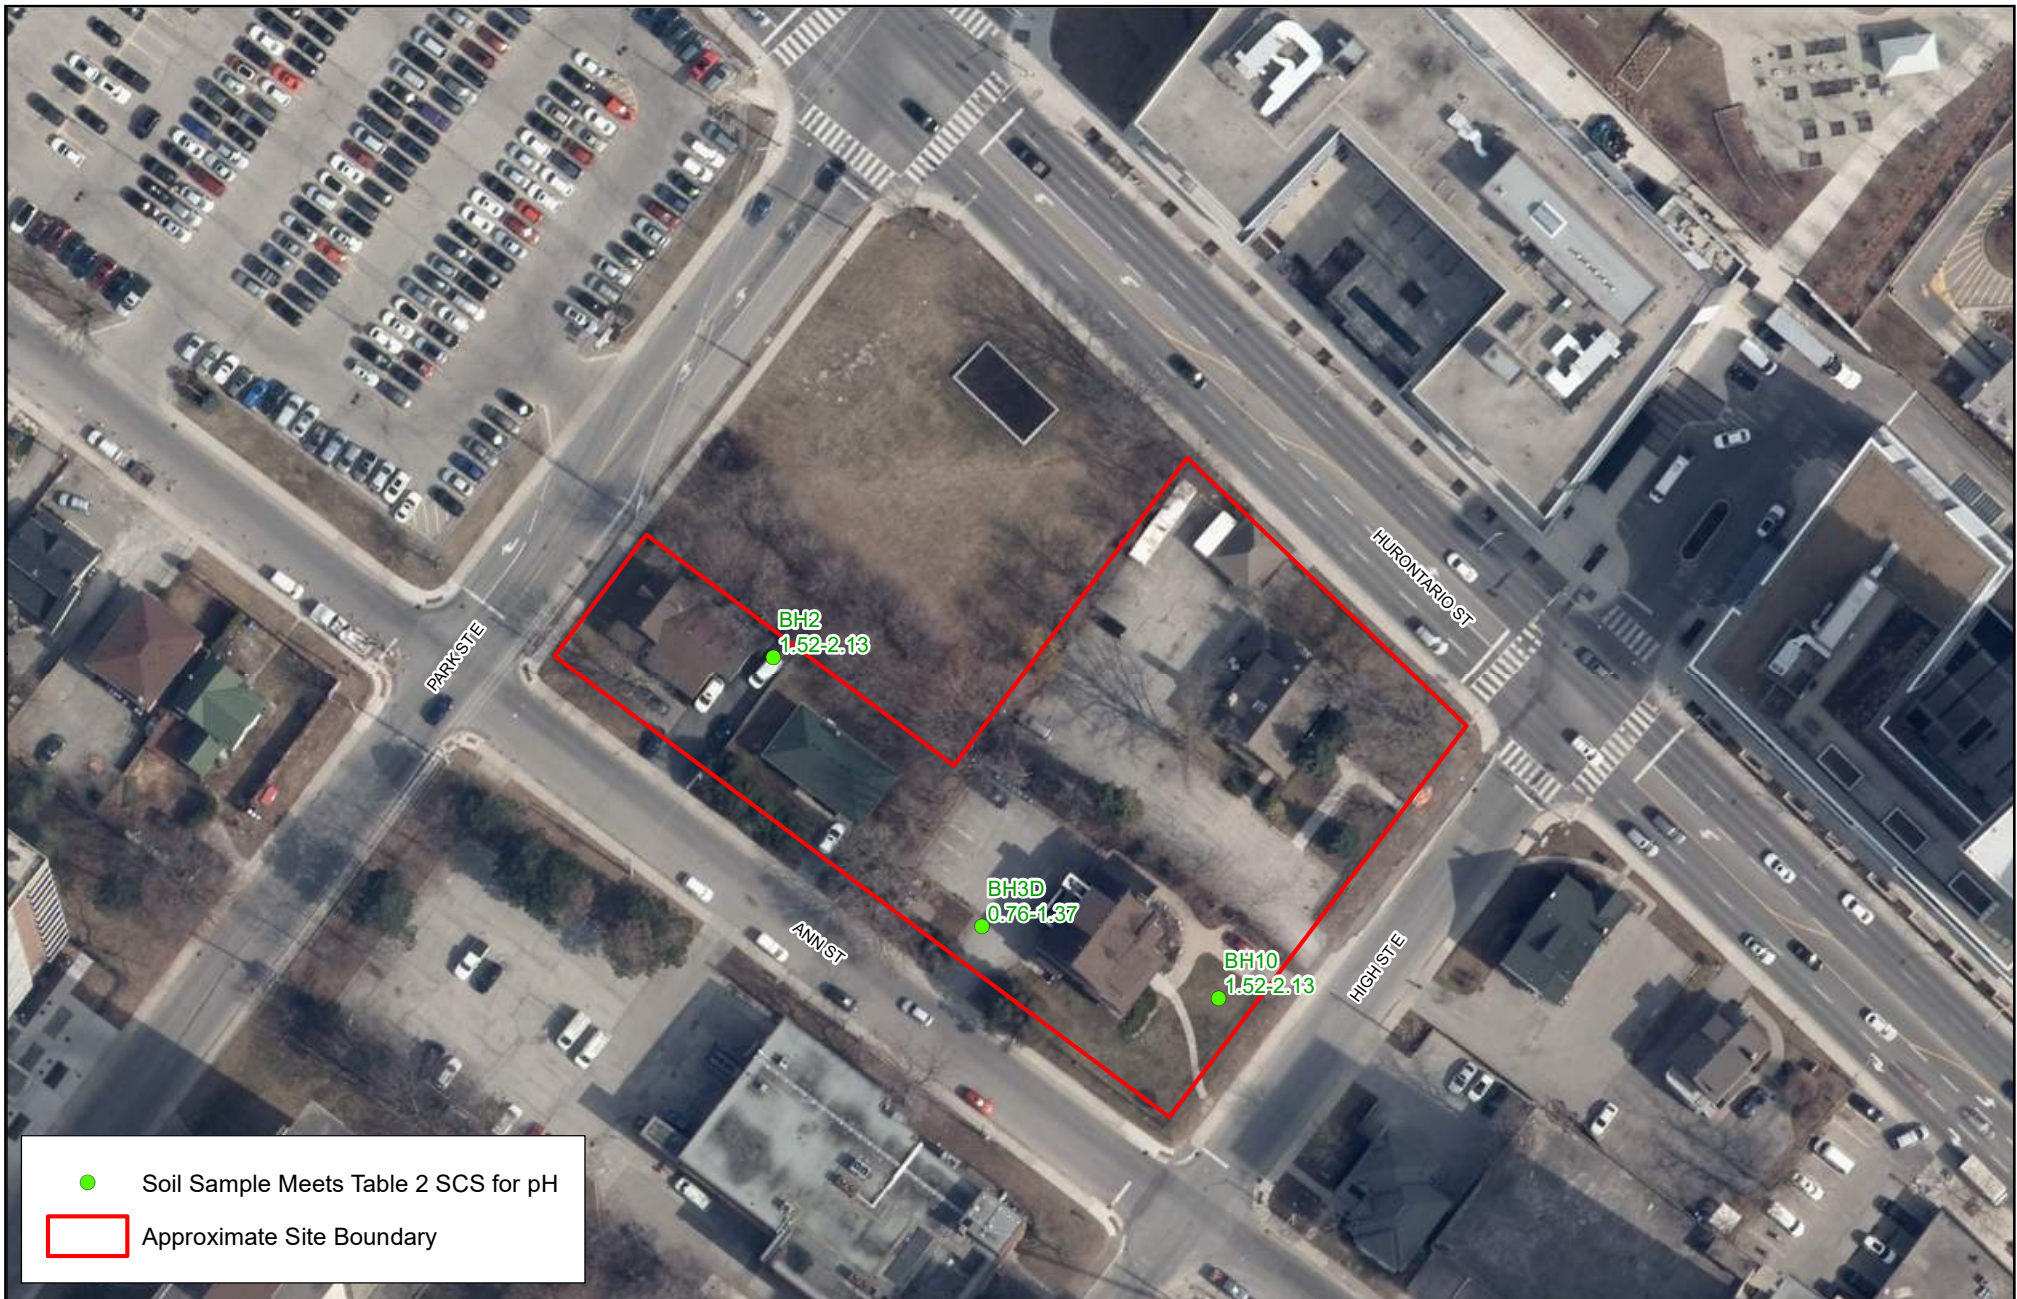
PROJECT No:	BRM-00239423-E0	OWN:	AC
SCALE:	AS NOTED	CHKD:	SL
DATE:	AUGUST 2021	FIG. No.:	10

TITLE AND LOCATION:  
SOIL ANALYTICAL RESULTS -  
ELECTRICAL CONDUCTIVITY (EC) AND  
SODIUM ADSORPTION RATIO (SAR)  
Phase Two Environmental Site Assessment  
84, 90 High Street East and  
17, 19 Ann Street  
Mississauga, Ontario

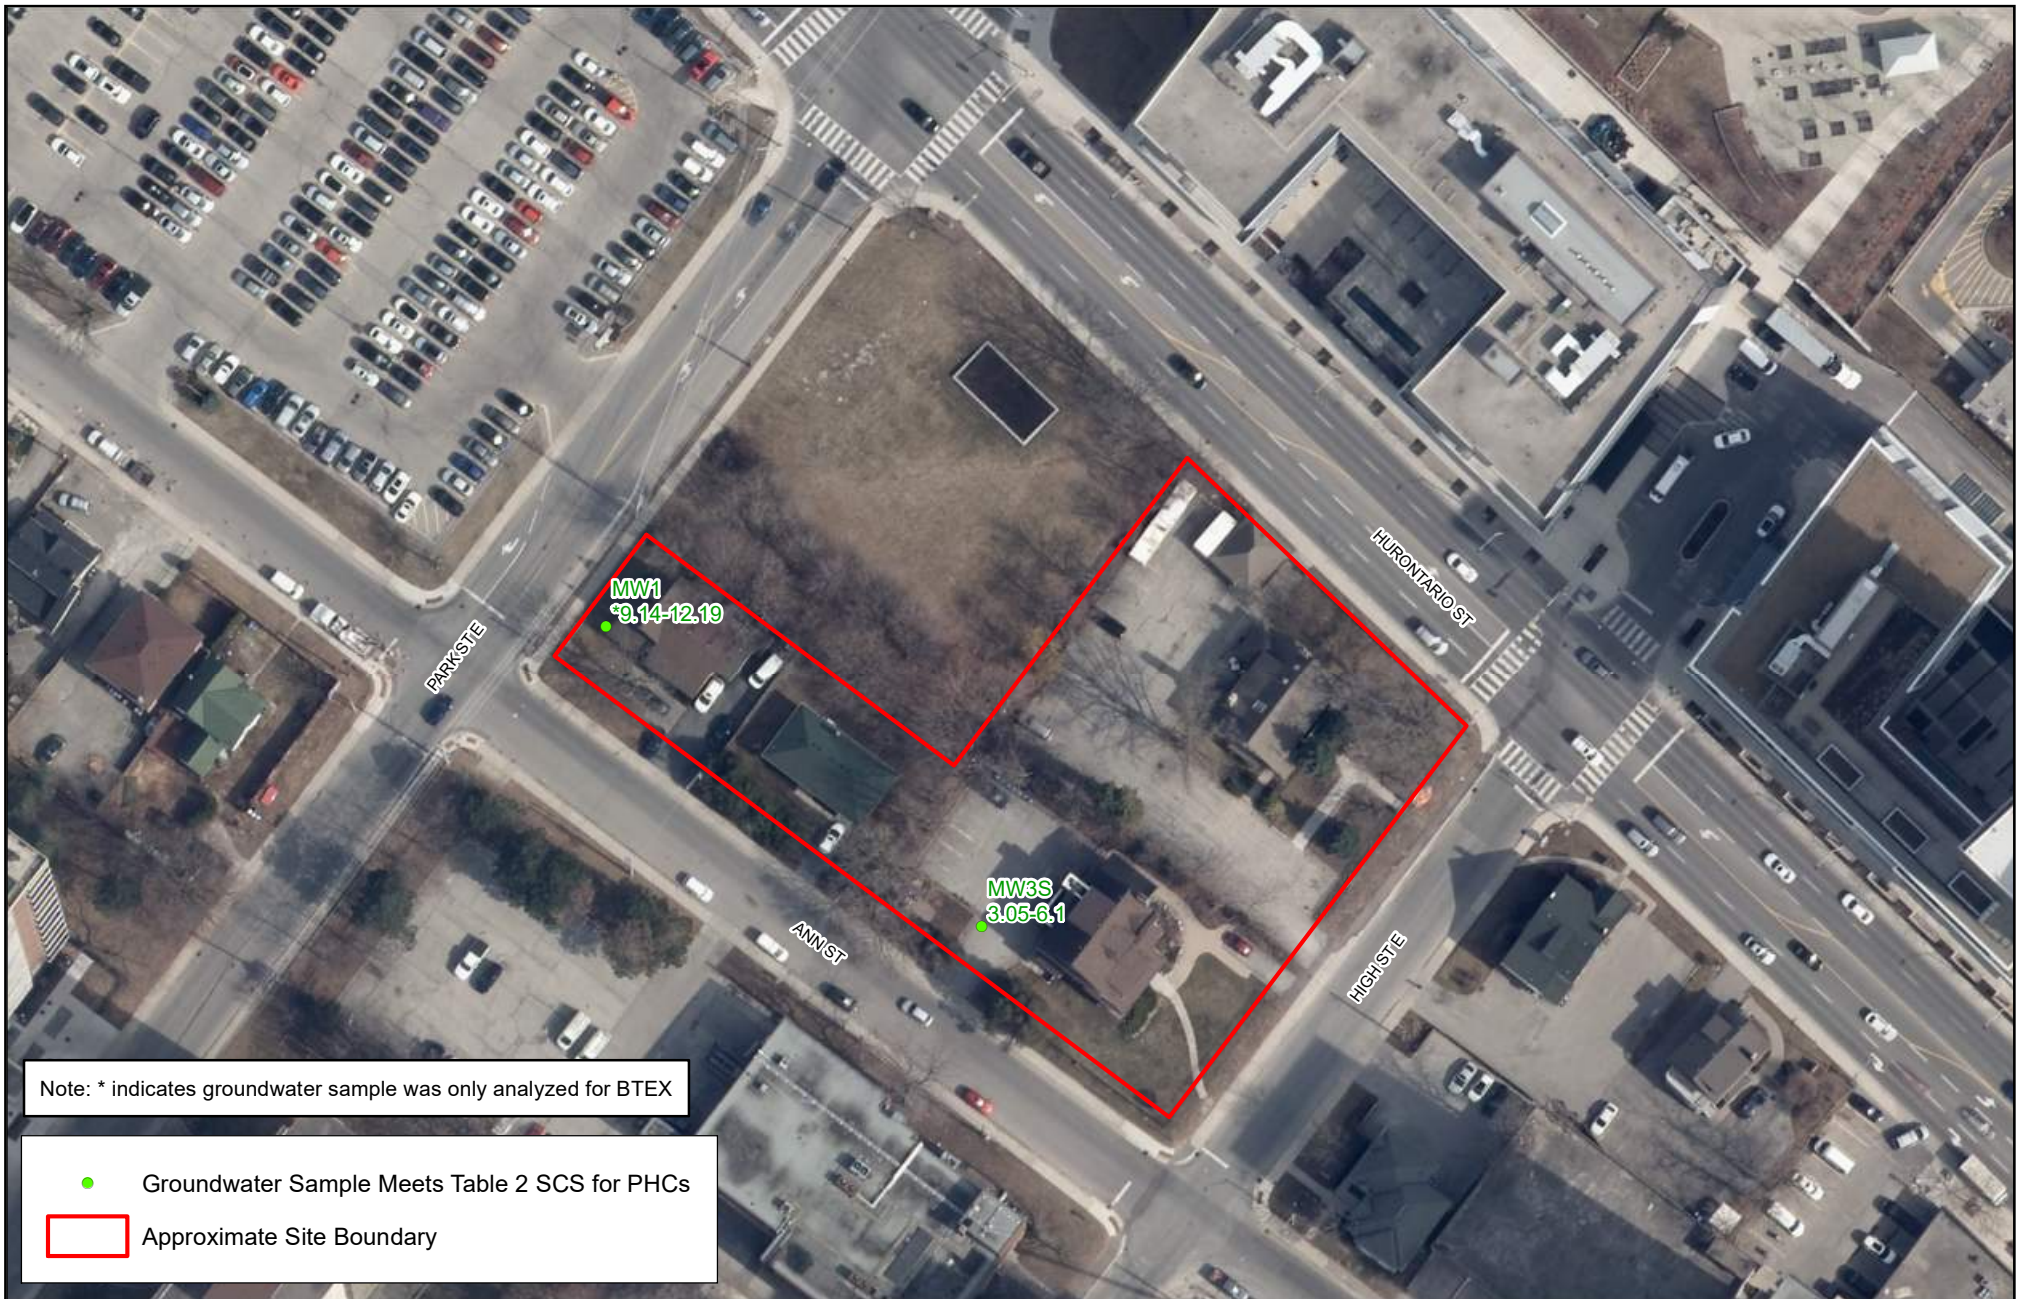
PROJECT No:	BRM-00239423-E0	OWN:	AC
SCALE:	AS NOTED	CHKD:	SL
DATE:	AUGUST 2021	FIG. No.:	11

TITLE AND LOCATION:  
**SOIL ANALYTICAL RESULTS - pH**  
 Phase Two Environmental Site Assessment  
 84, 90 High Street East and  
 17, 19 Ann Street  
 Mississauga, Ontario
