84, 90 High Street East, 17, 19 Ann Street and Part  
of 91 Park Street East, Mississauga, Ontario

Phase Two Environmental Site Assessment

BRM-00239423-E0

August 24, 2021

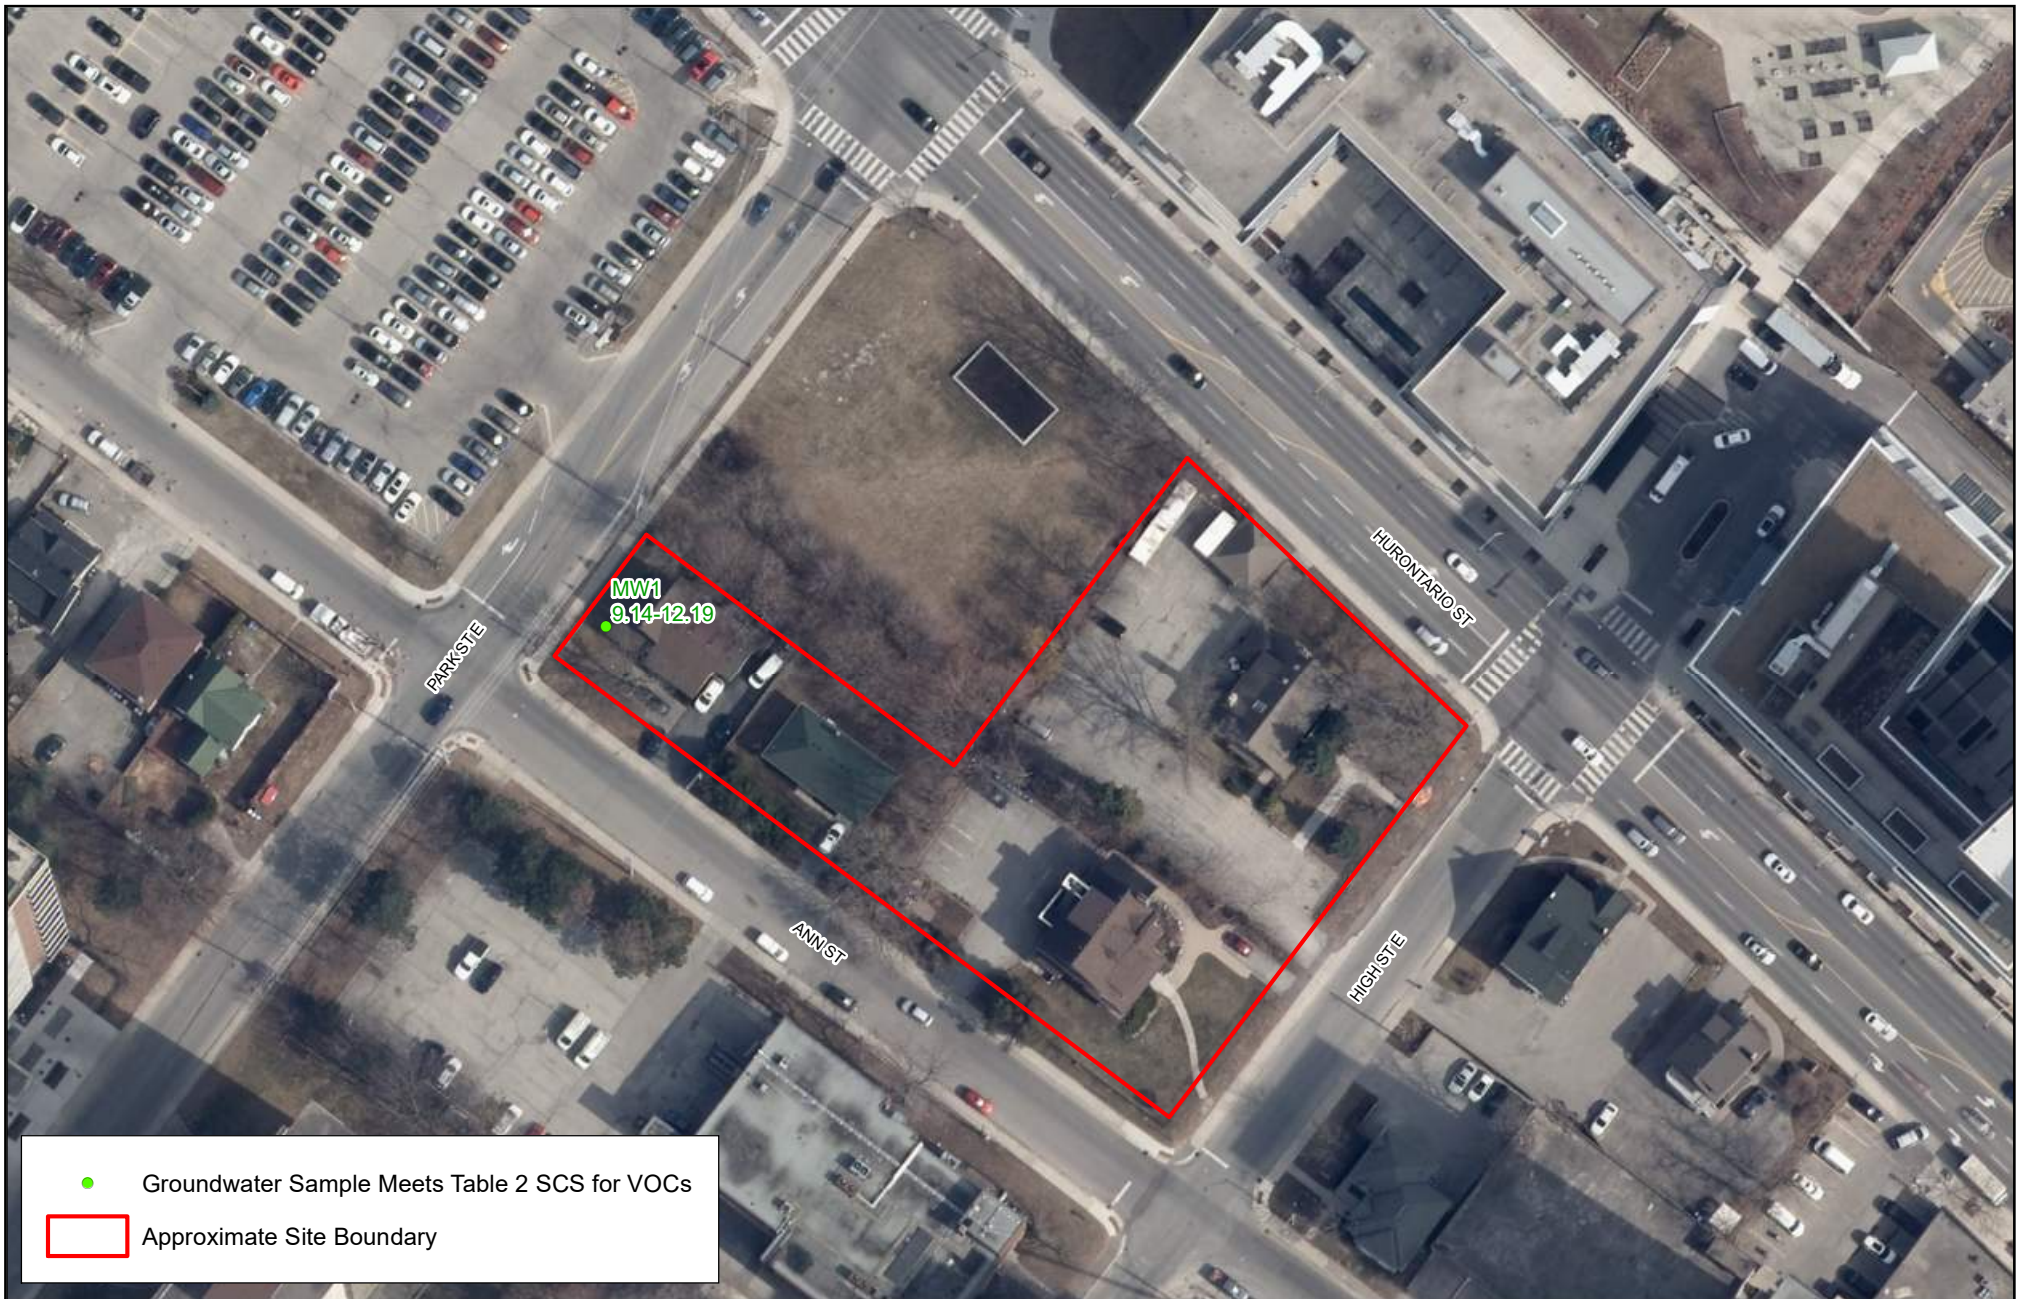
PROJECT No:	BRM-00239423-E0	OWN:	AC
SCALE:	AS NOTED	CHKD:	SL
DATE:	AUGUST 2021	FIG. No.:	12

TITLE AND LOCATION:  
**GROUNDWATER ANALYTICAL RESULTS -  
 PETROLEUM HYDROCARBONS (PHCs)  
 INCLUDING BTEX**  
 Phase Two Environmental Site Assessment  
 84, 90 High Street East and  
 17, 19 Ann Street  
 Mississauga, Ontario

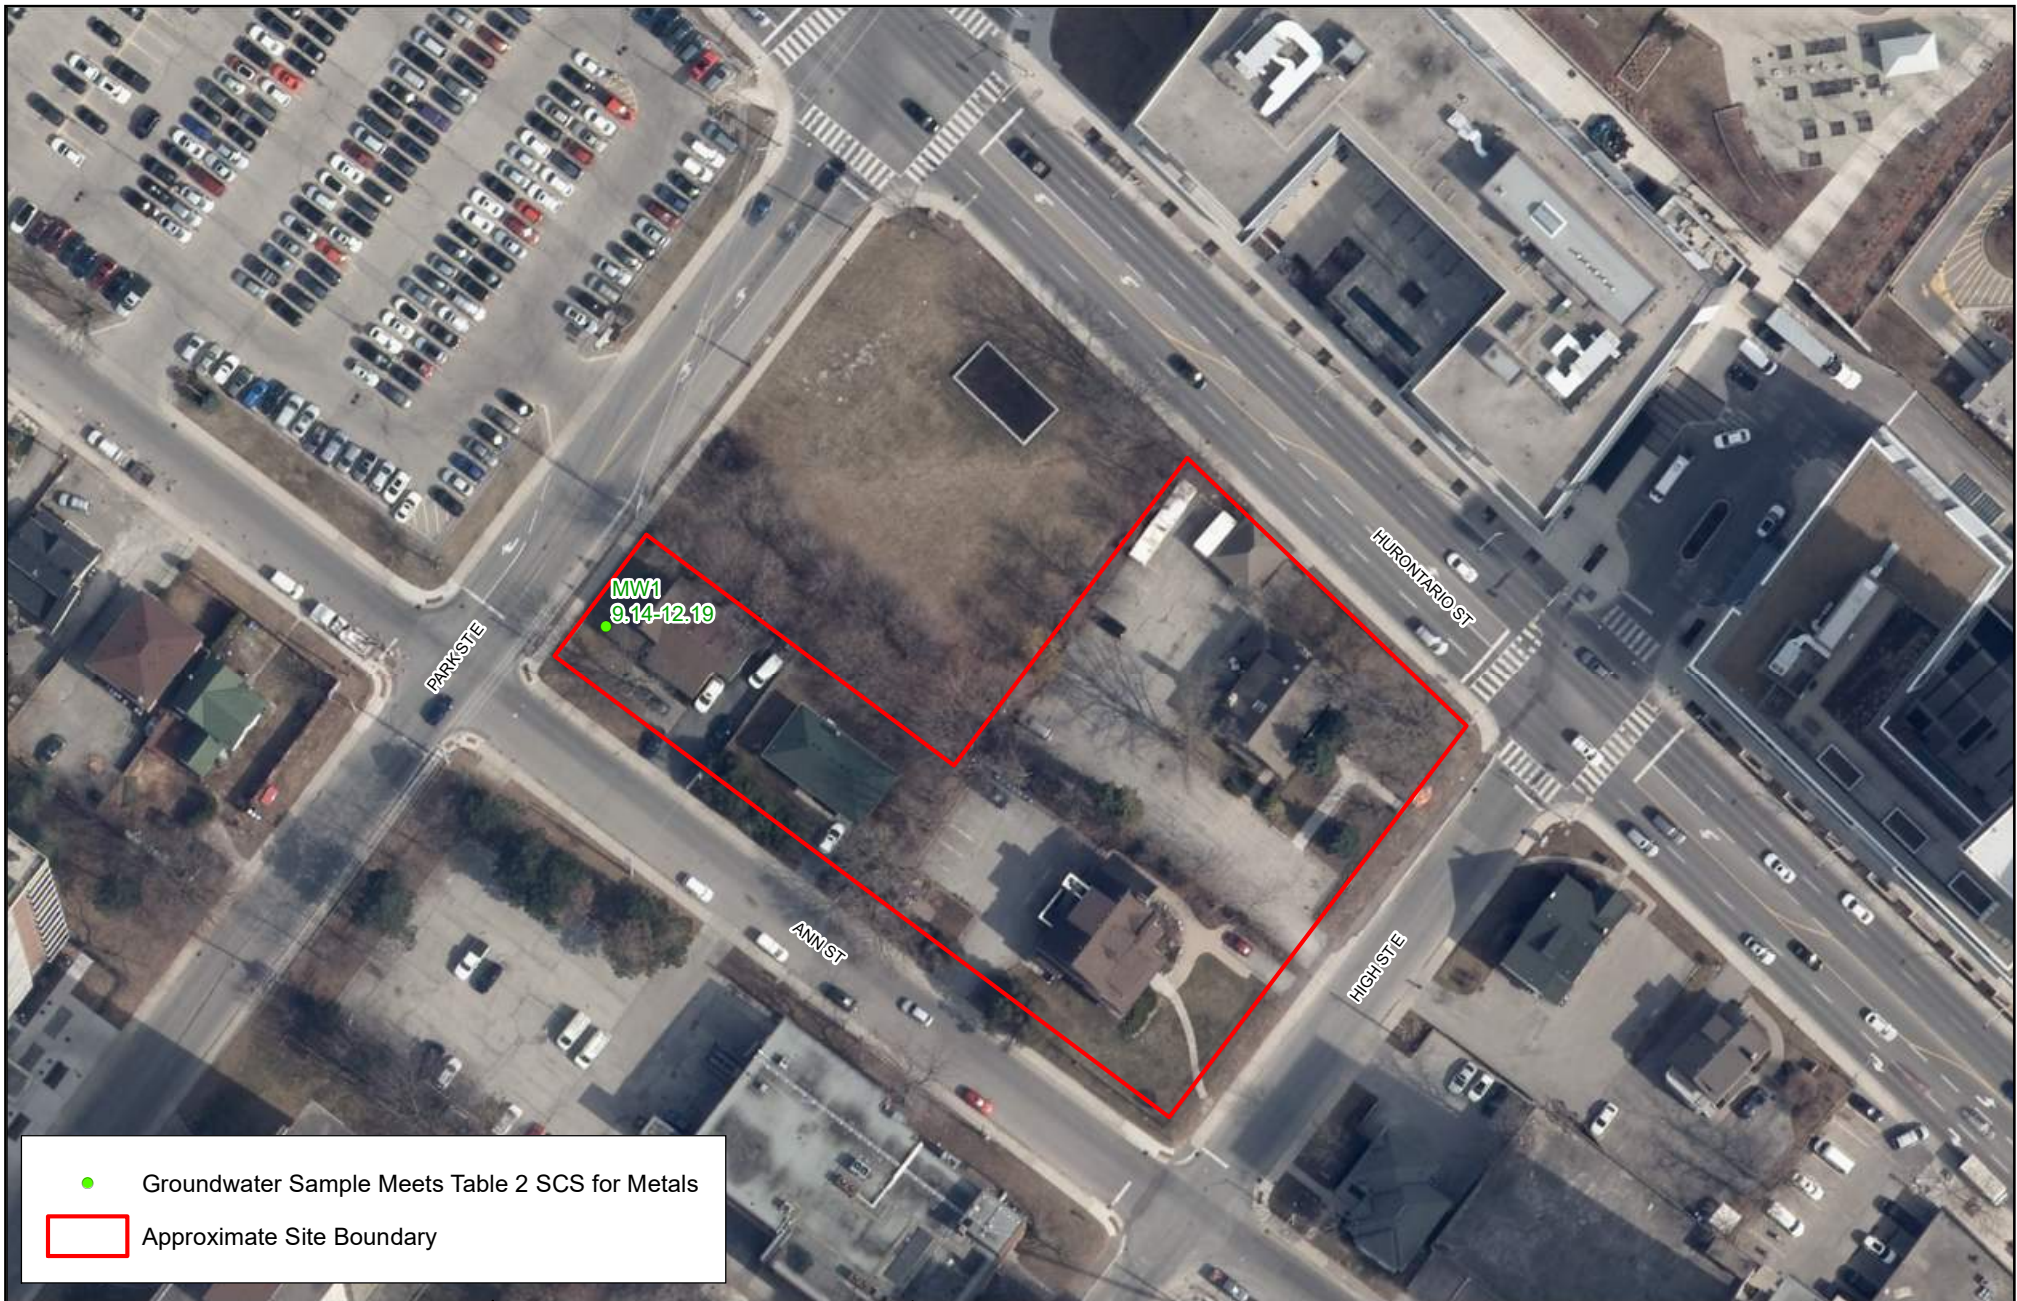
PROJECT No:	BRM-00239423-E0	OWN:	AC
SCALE:	AS NOTED	CHKD:	SL
DATE:	AUGUST 2021	FIG. No.:	13

TITLE AND LOCATION:  
**GROUNDWATER ANALYTICAL RESULTS -  
 VOLATILE ORGANIC COMPOUNDS (VOCs)**  
 Phase Two Environmental Site Assessment  
 84, 90 High Street East and  
 17, 19 Ann Street  
 Mississauga, Ontario

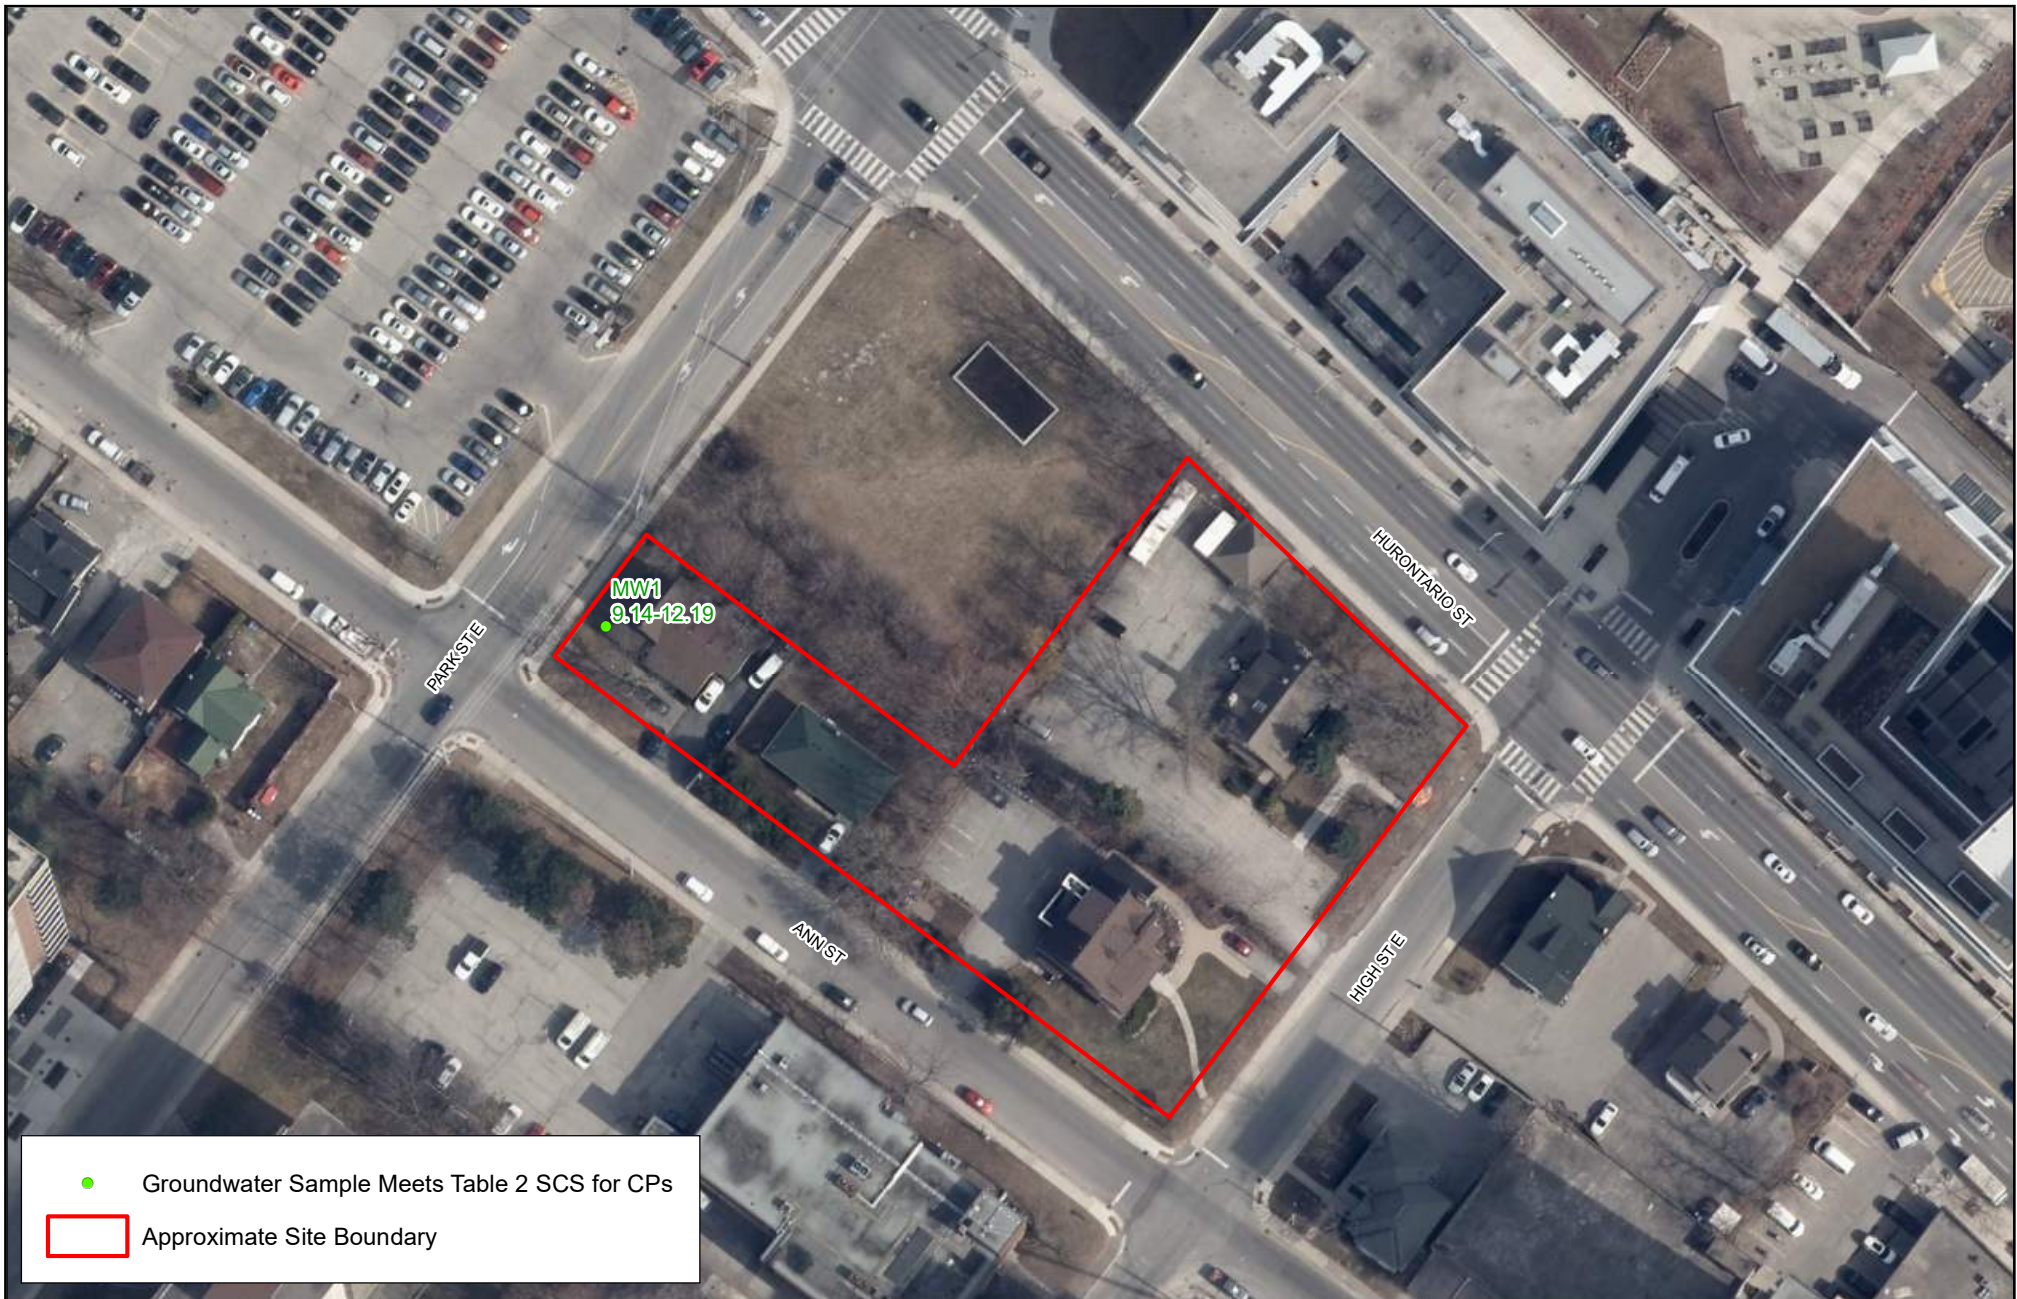
PROJECT No:	BRM-00239423-E0	OWN:	AC
SCALE:	AS NOTED	CHKD:	SL
DATE:	AUGUST 2021	FIG. No.:	15

GROUNDWATER ANALYTICAL RESULTS - SODIUM  
 Phase Two Environmental Site Assessment  
 84, 90 High Street East and  
 17, 19 Ann Street  
 Mississauga, Ontario
