Wolfedale Creek Erosion Control Project from Burnhamthorpe Road West to the Credit River

**Municipal Class Environmental
Assessment**

Online Public Information Centre

Date: June 18, 2024

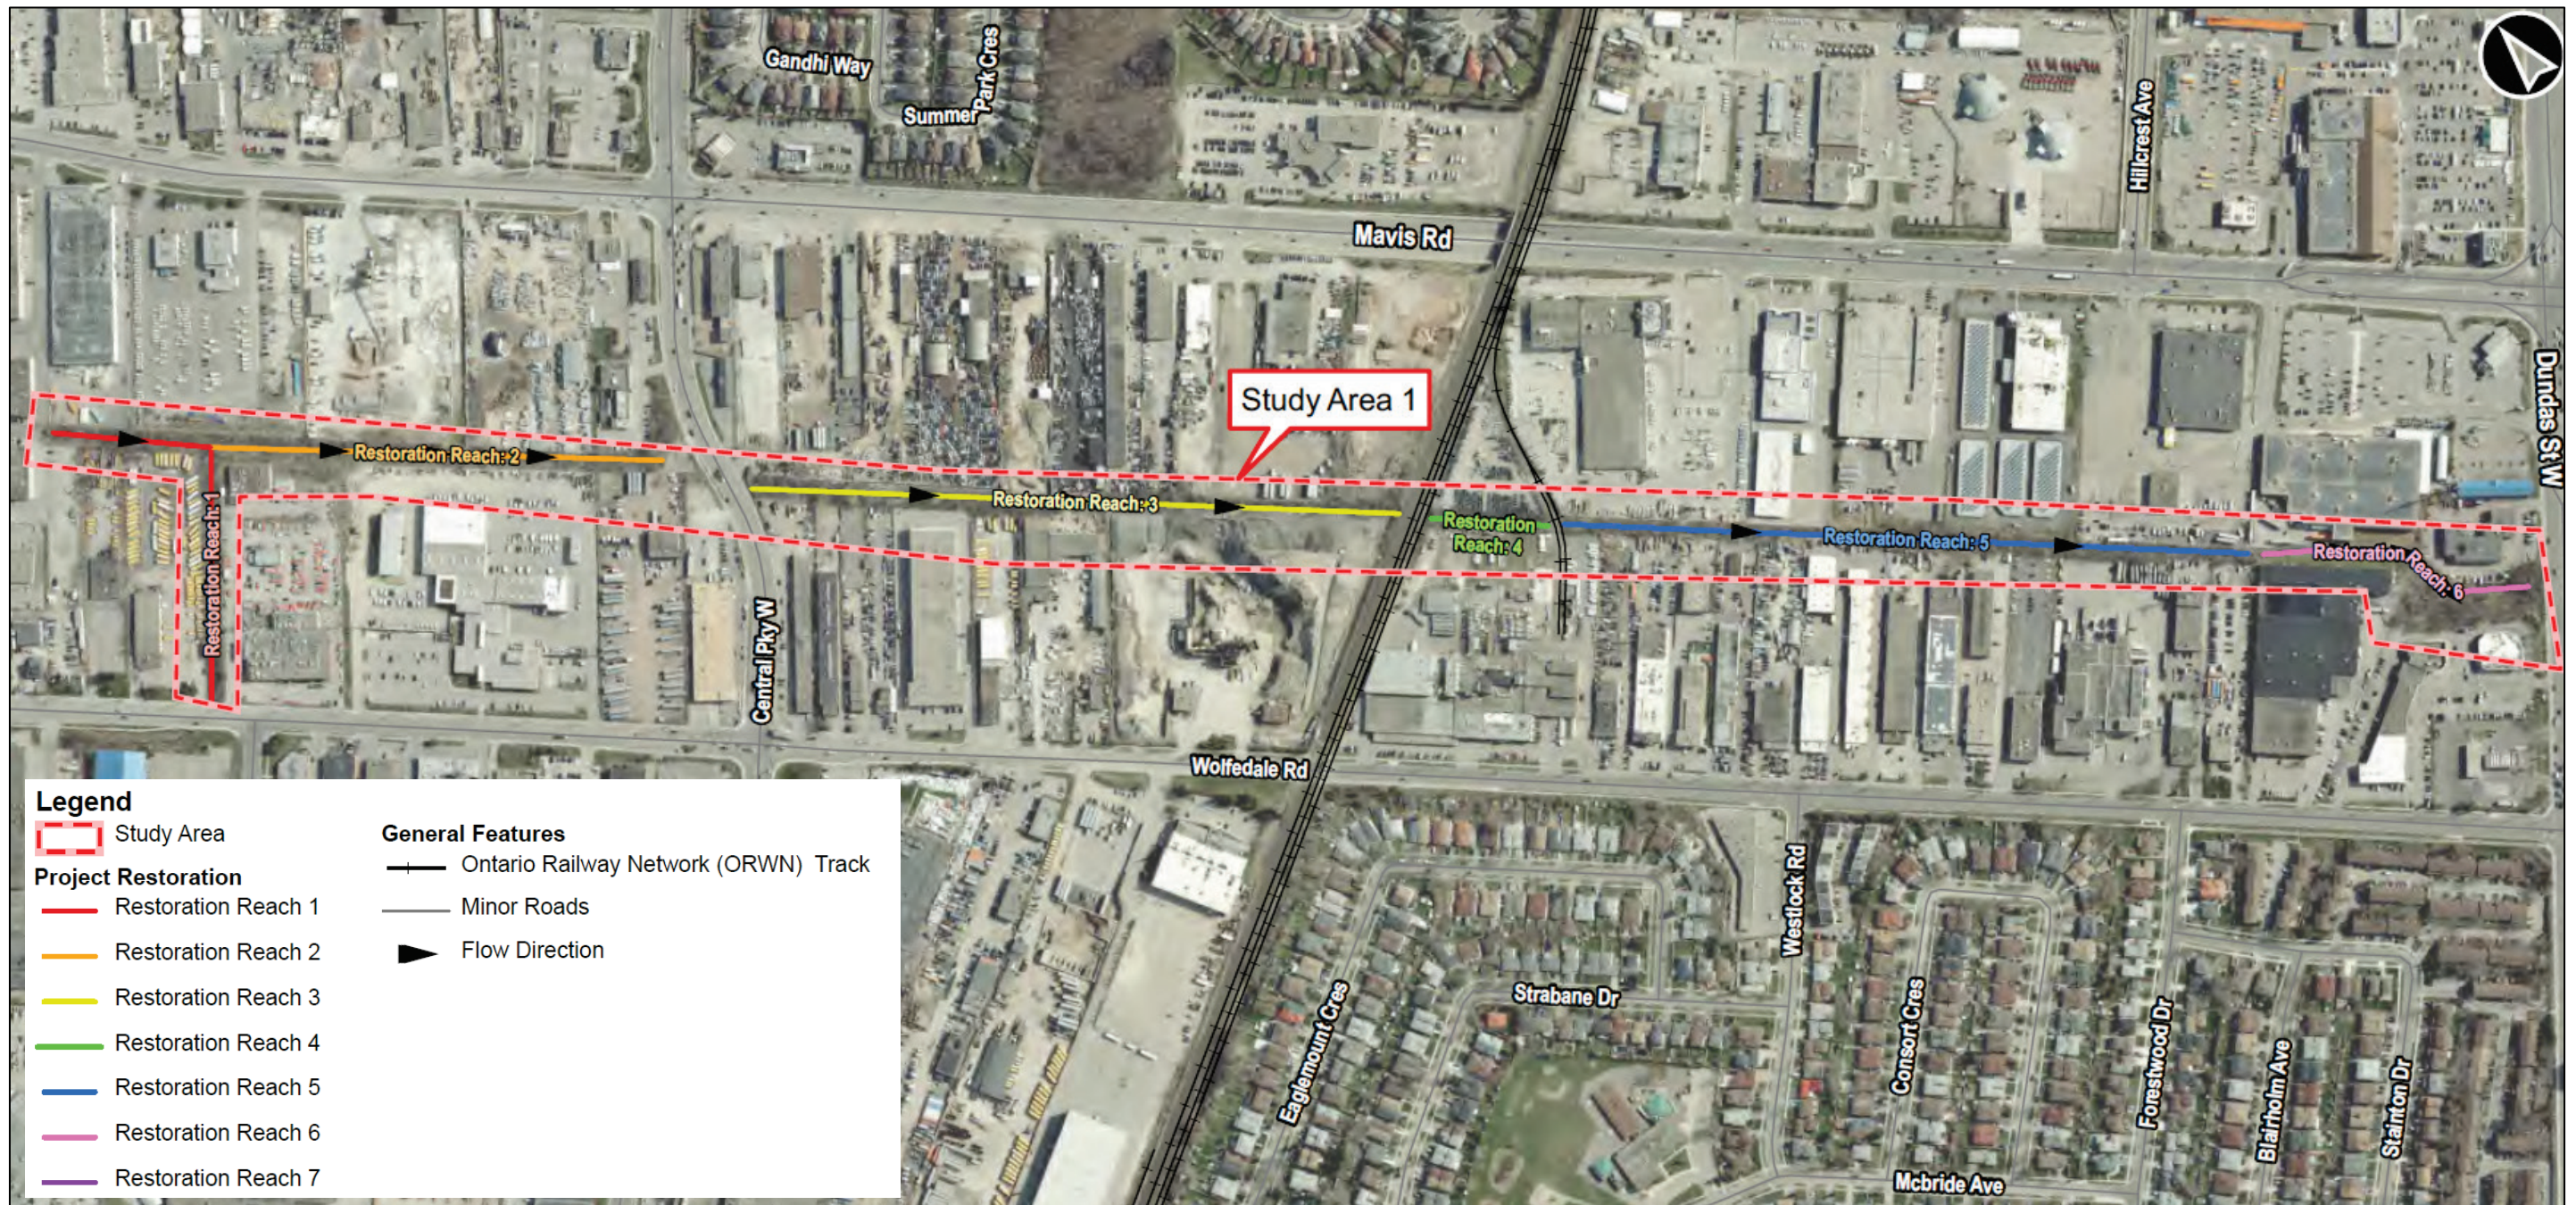
Project Overview – Study Area 2

- Study Area 2 includes the tributary outlet to the Credit River, south of Queensway West and west of Stavebank Road
- The watercourse is surrounded by residential development to the west and east and by forested lands/ a large golf course in the south.
- The watercourse discharges into the Credit River

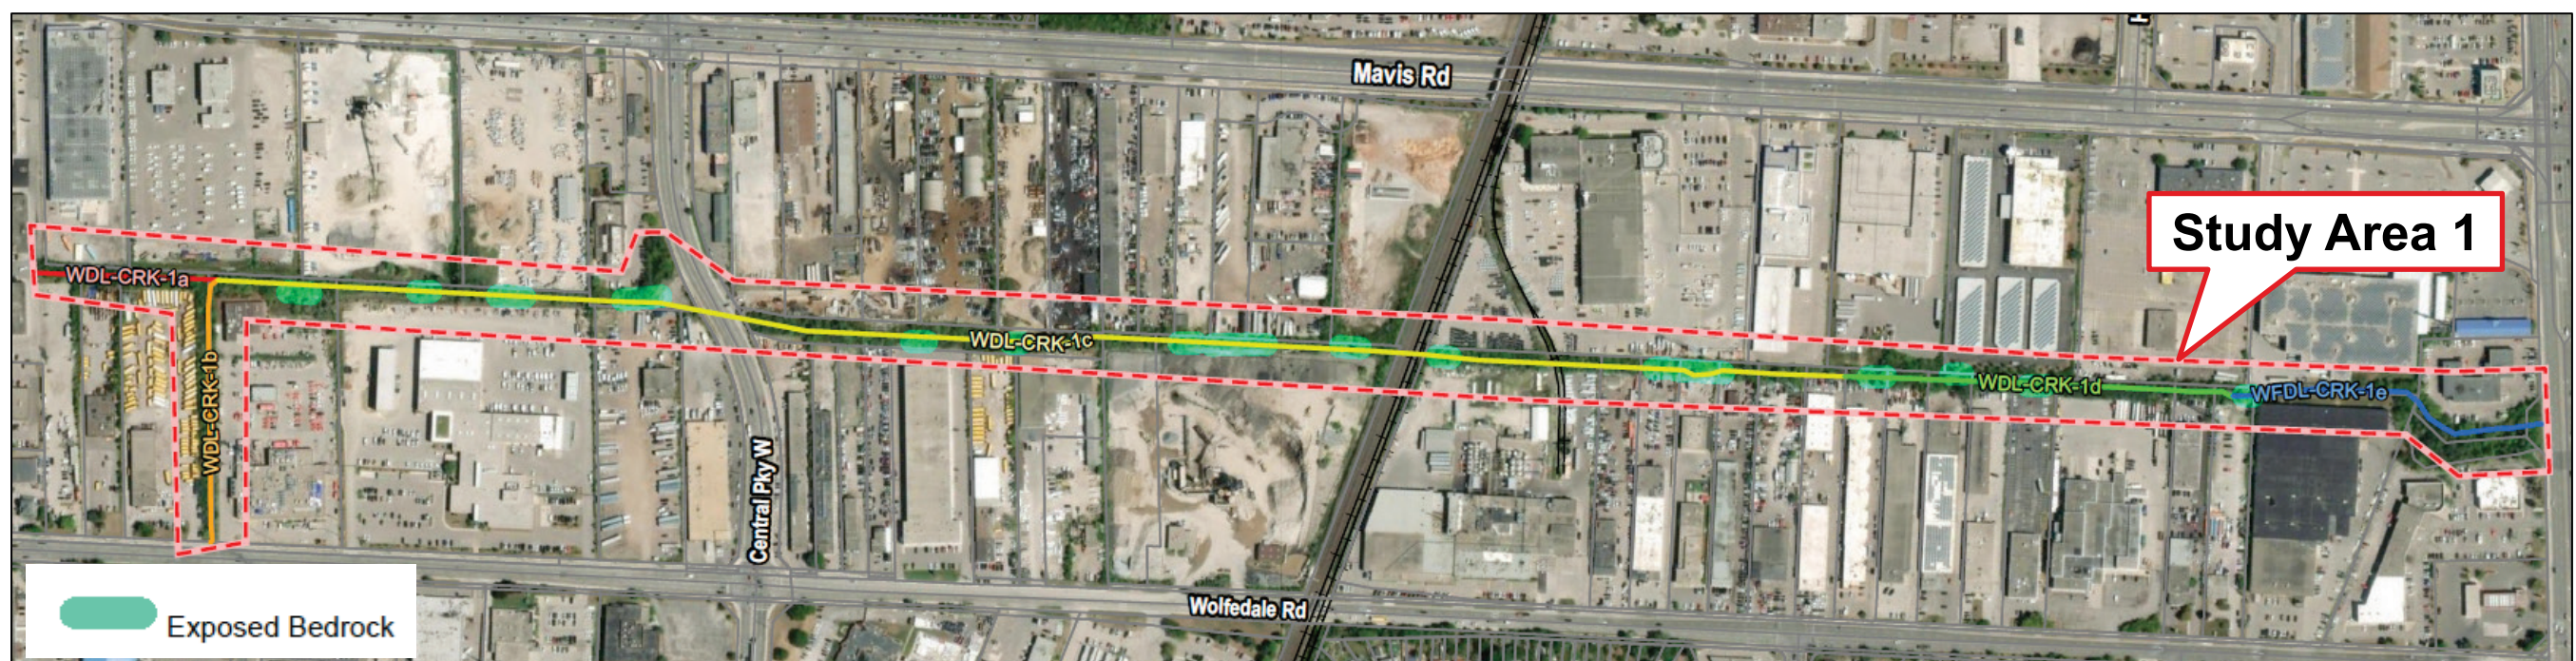
Hydraulics

- The study area is very confined with often steep and occasionally vertical side slopes. During large storm events water levels along the creek increase quickly
- In locations where the creek is confined to a concrete lined channel with vertical side walls, flow velocities will become quite high in large storms due to the smooth surfaces
- High velocities may create erosion concerns. Hydraulic modelling for the existing conditions has been updated to reflect current conditions and will be used for comparison of the detailed design of the preferred solution
- The cross-sections of the proposed design will be reflected in the proposed conditions hydraulic model

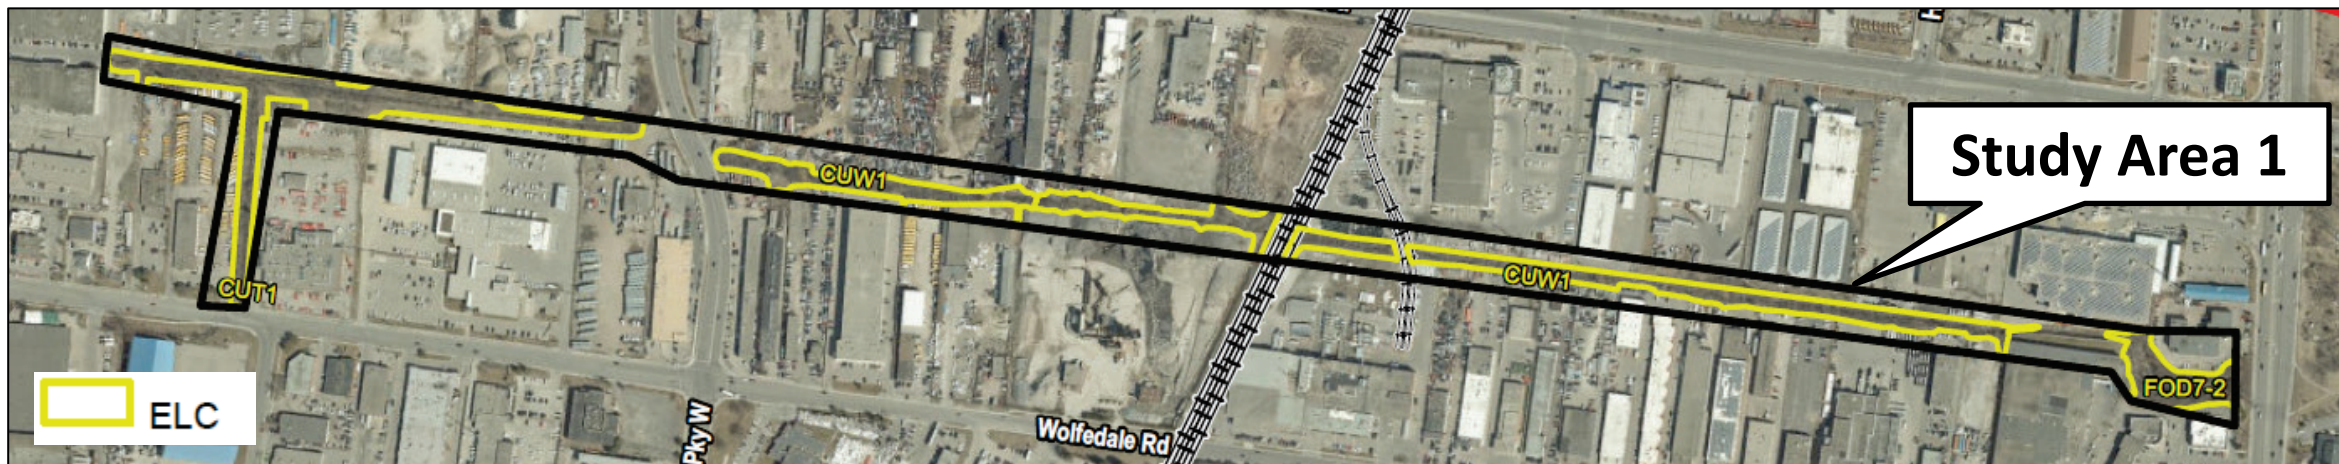
Ecological Land Classification

- Study Area 1: all vegetation communities were disturbed and largely limited to narrow vegetation strips along Wolfedale Creek surrounded by heavily developed commercial and industrial areas
- Study Area 2: consisted of more naturalized communities that were a part of the Credit River Marshes Wetland PSW Complex and ANSI, which were surrounded by residential development and the Mississauga Golf and Country Club

ELC Code/Description

- CUT1:** Mineral Cultural Thicket Ecosite
- FOD7-2:** Fresh-Moist Ash Lowland Deciduous Forest
- CUW1:** Mineral Cultural Woodland Ecosite
- FOD7-3:** Fresh-Moist Willow Lowland Deciduous Forest
- MAS2-1:** Cattail Mineral Shallow Marsh
- FOD5-3:** Dry-Fresh Sugar Maple Deciduous Forest

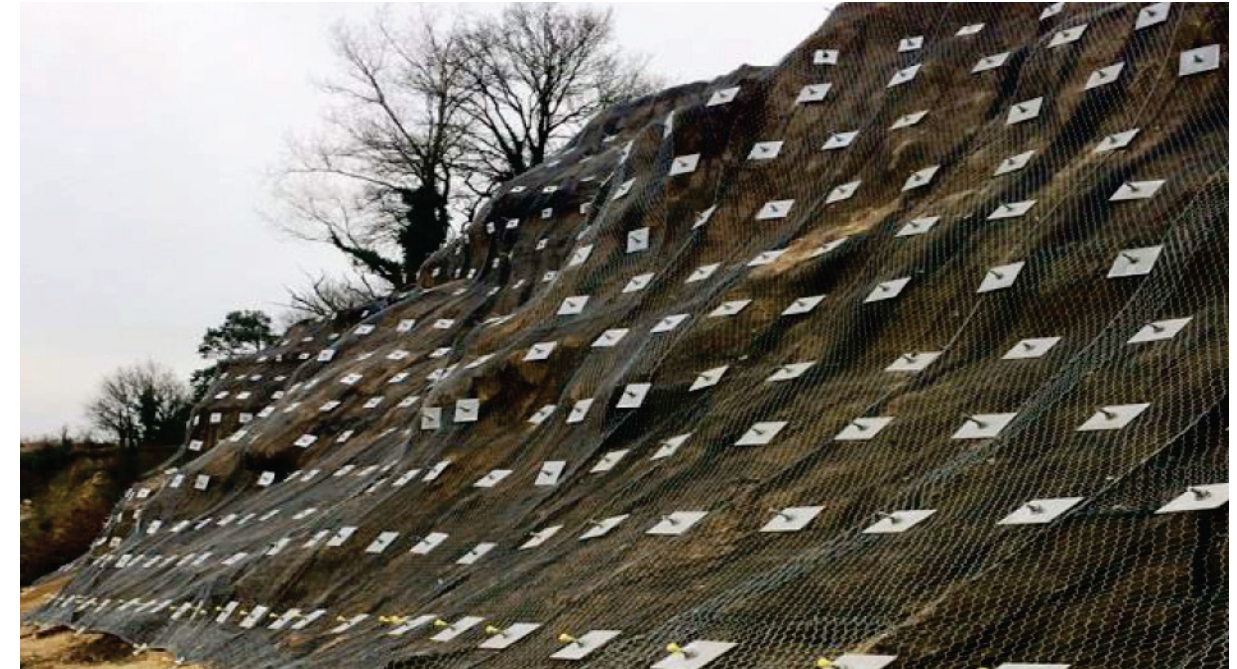
Example of Structural Bank Protection – Soil Nails

- Full replacement of failed bank protection with structural bank protection options to maintain long term erosion protection, such as reinforced soil slope walls, cast-in-place re-enforced concrete walls, or steel sheet pile
- Structural grade control solutions will consist of structural options, such as concrete weir structures. Incorporation of a natural channel bed will be included to improve fish habitat and passage

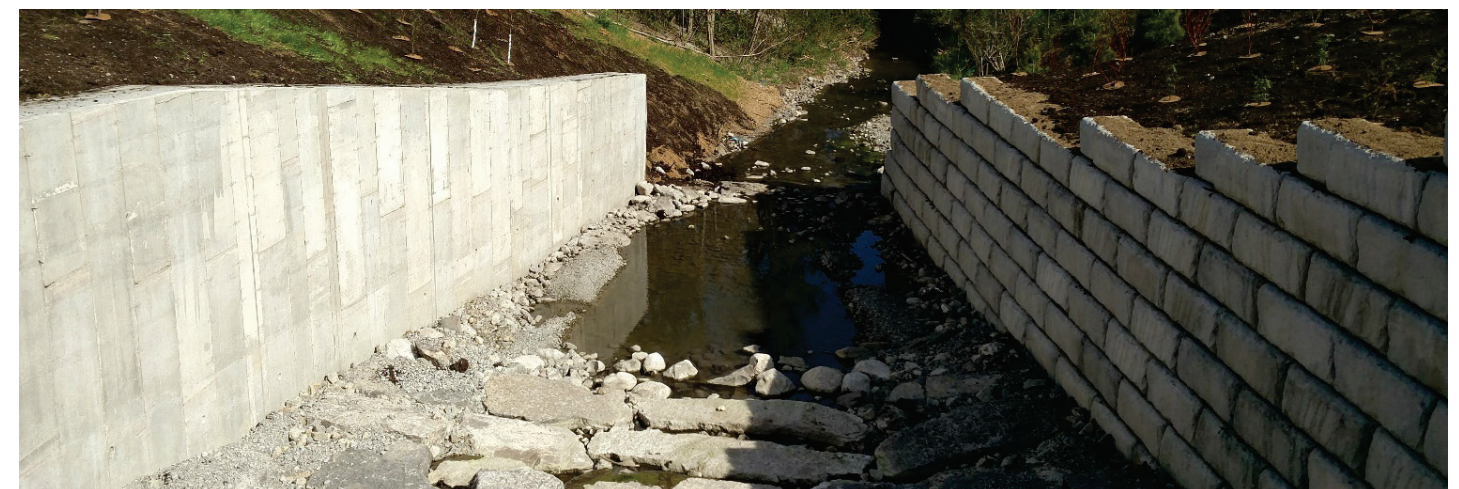
Example of Structural Bank Protection – Concrete Revetment and Armourstone Retaining Wall

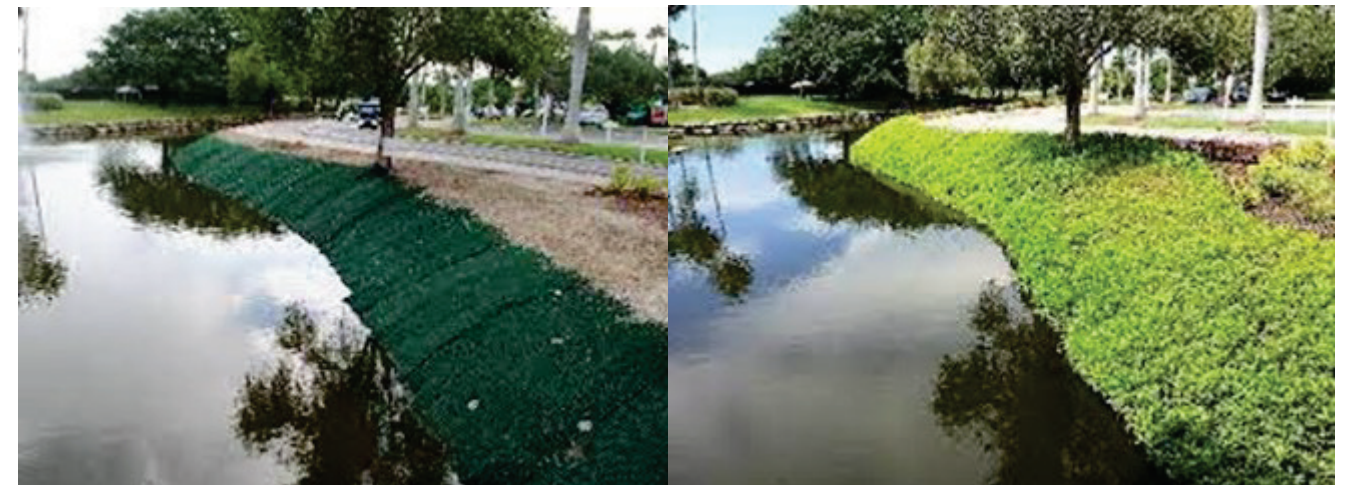
Example of Non-structural Bank Protection – Turf Reinforcement Matting

- Full replacement of failed bank protection with non-structural bank protection options to maintain long term erosion protection, such as rock, green gabion, or geogrid retaining walls
- Non-structural grade control could include rock weir structures
- Incorporation of a natural channel bed will be included to improve fish habitat and passage

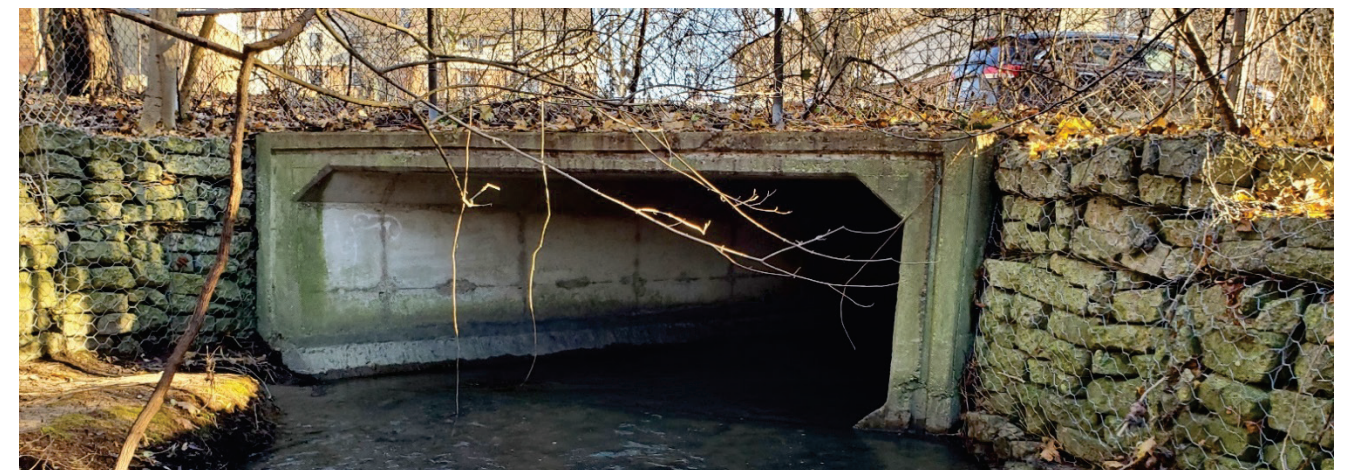
Example of Enclosed Watercourse in Storm Sewer

- Enclose the watercourse in storm sewer and landscape a trail over top.

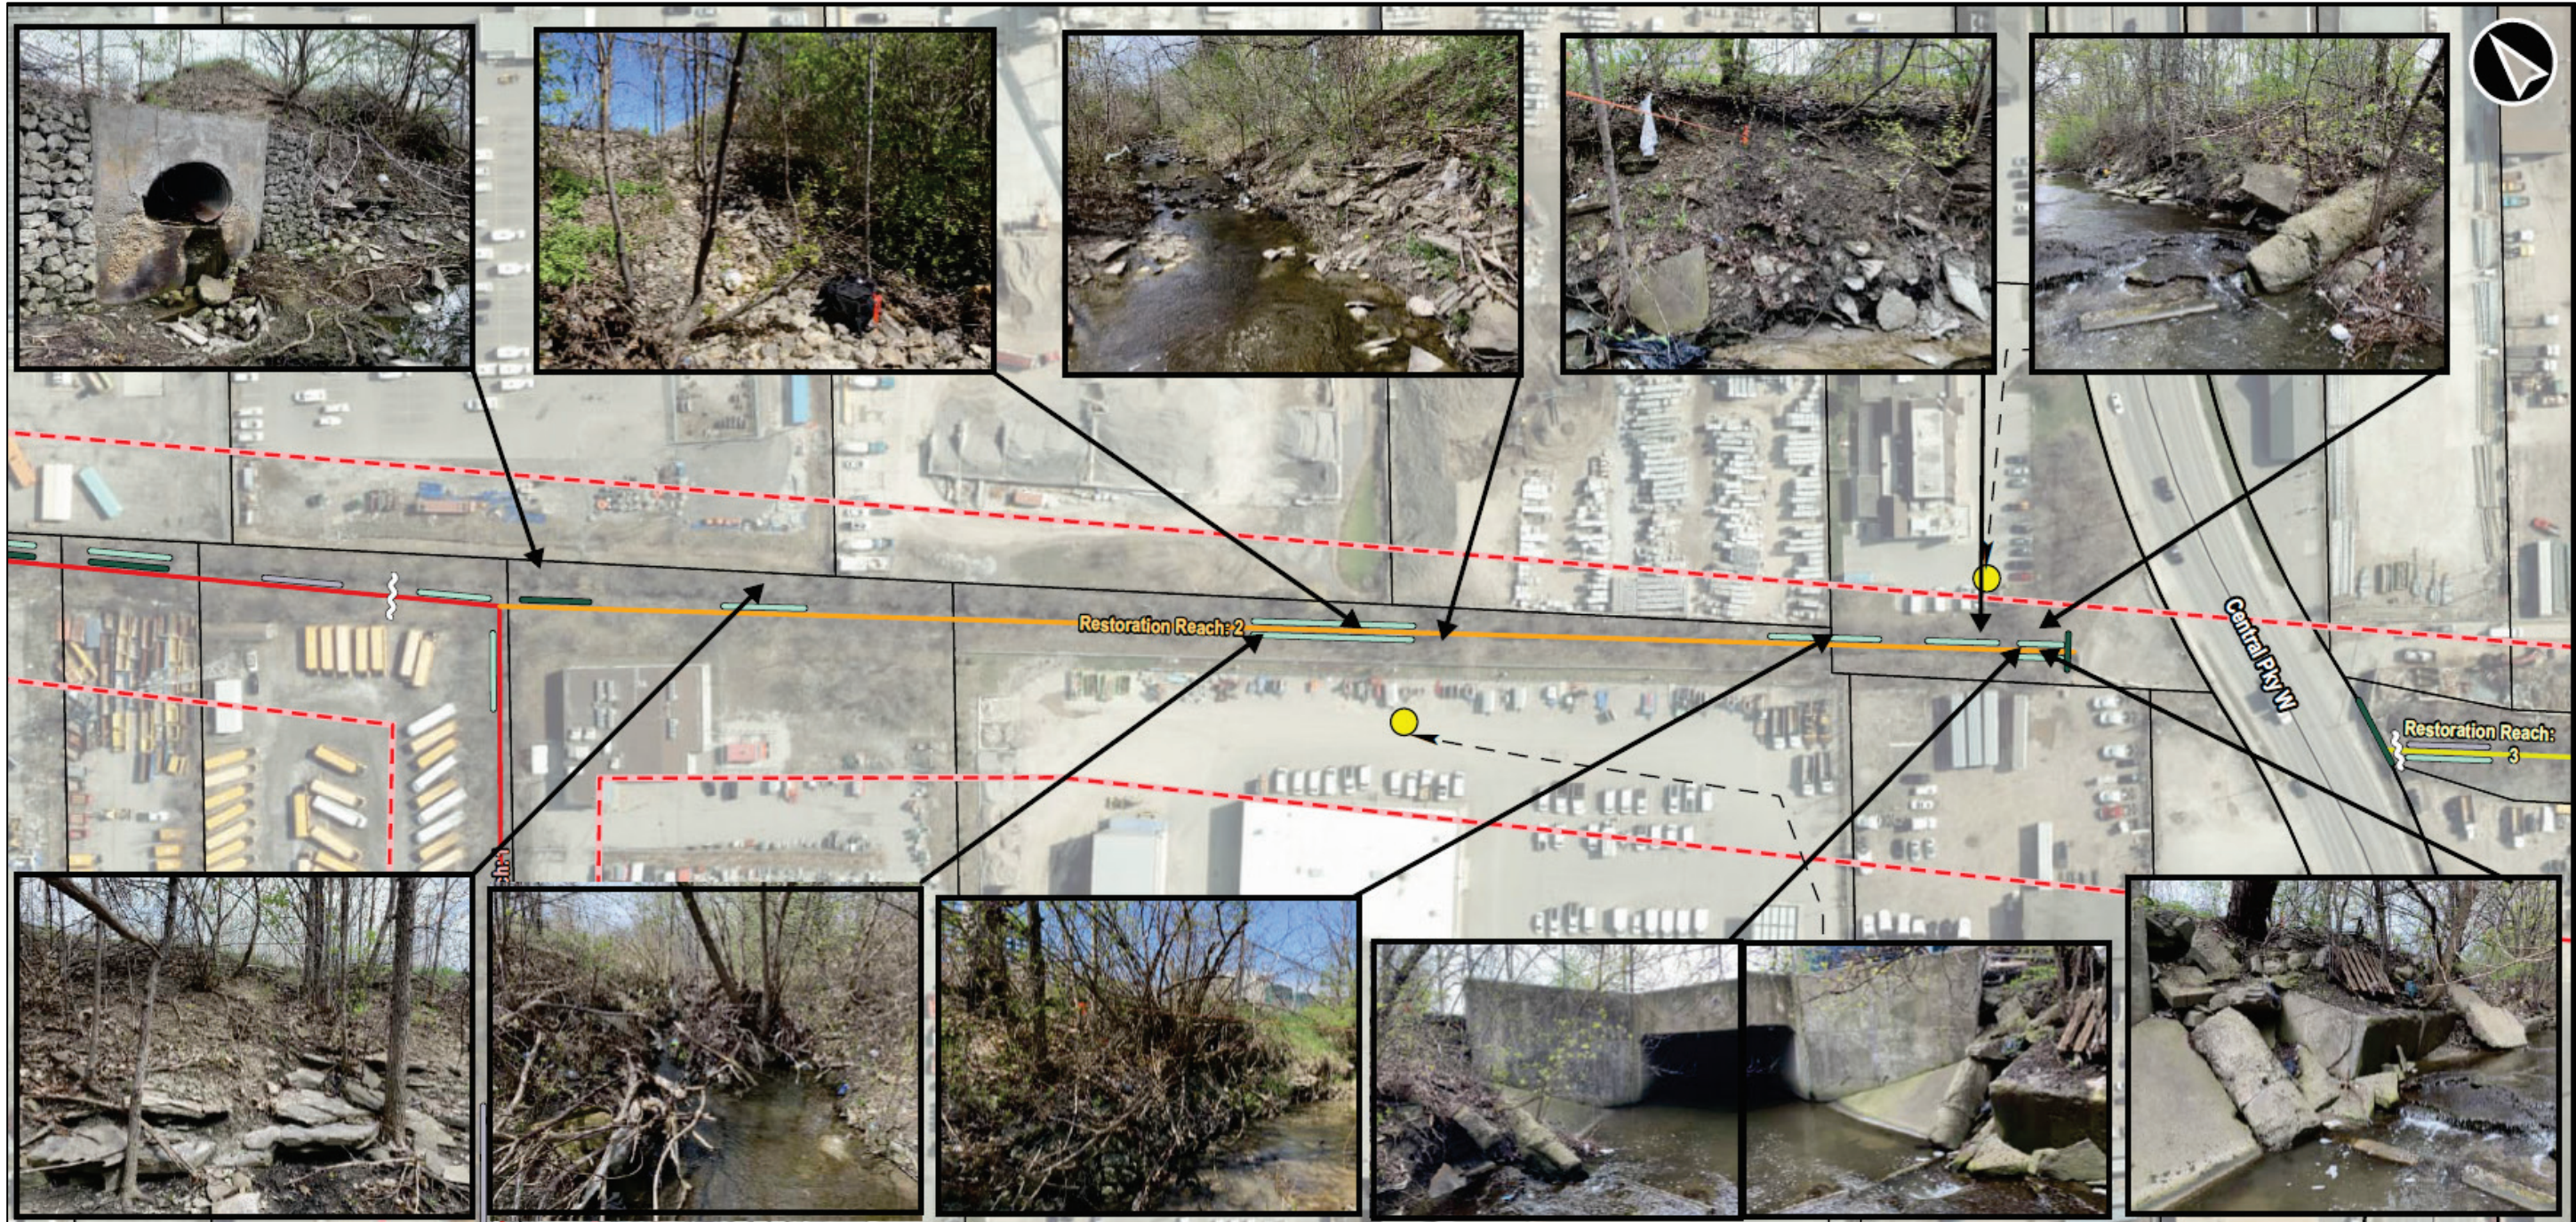
Preliminary Preferred Solution – Study Area 1

- The City is currently investigating potential access locations across Study Area 1 and Study Area 2
- Access locations are subject to change
