**PHASE ONE  
ENVIRONMENTAL SITE  
ASSESSMENT**

**86 THOMAS STREET,  
MISSISSAUGA, ONTARIO**

Project No. FE-P 21-10933

March 5, 2021

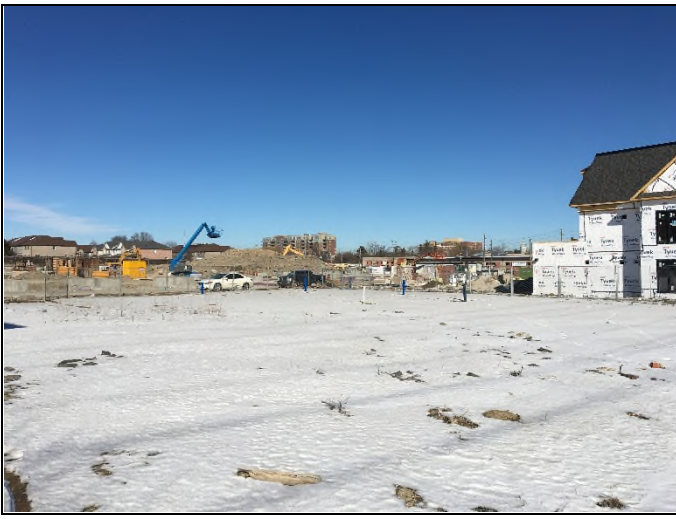
The Site is currently undeveloped/vacant. It is bounded by chain-link fences along its north, east, south and west sides. A supporting concrete wall, approximately 0.5 m high, was observed along the south side of the Site. Refer to photos 1 and 2 in Appendix B.

1. 86 Thomas Street – View of the Site looking northeast.

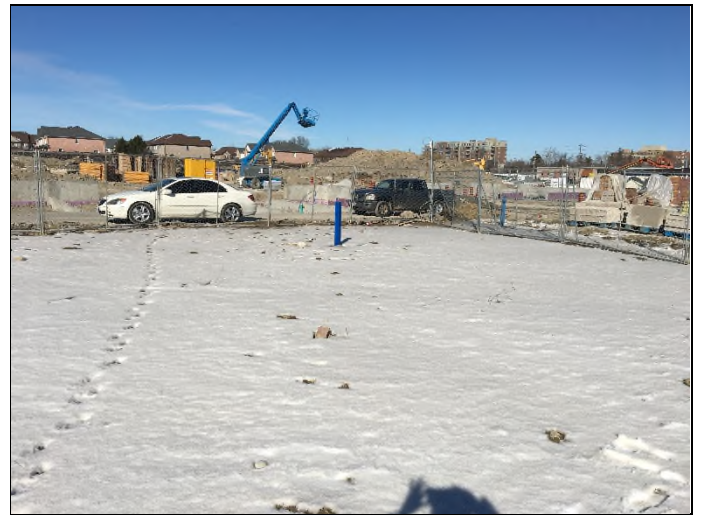
Previously installed monitoring wells (MW1 to MW3, Fisher, 2020, refer to Section 4.1.6) were observed on the northeast corner of the Site. Refer to photo 2 in Appendix B.

2. 86 Thomas Street – View of the northeast corner of the Site looking north.

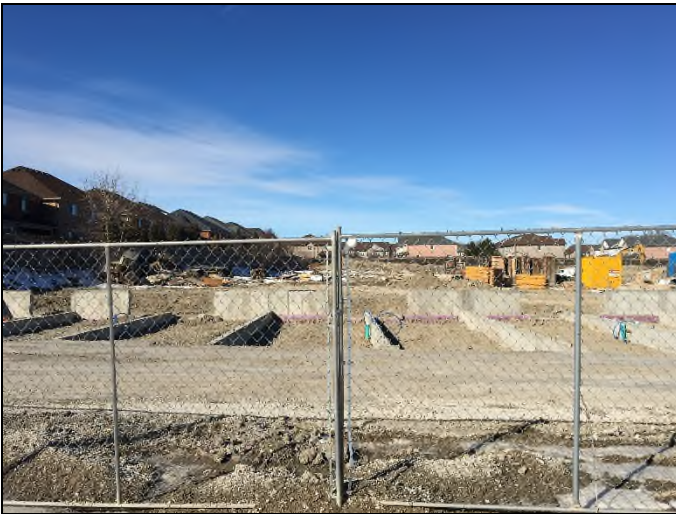
3. 80 Thomas Street – New residential development under construction located to the north of the Site.

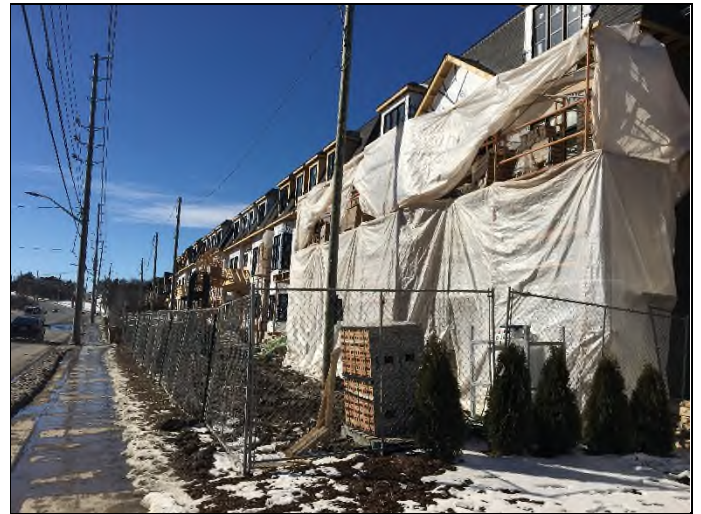
4. 80 Thomas Street – New residential houses under construction located to the east of the Site.

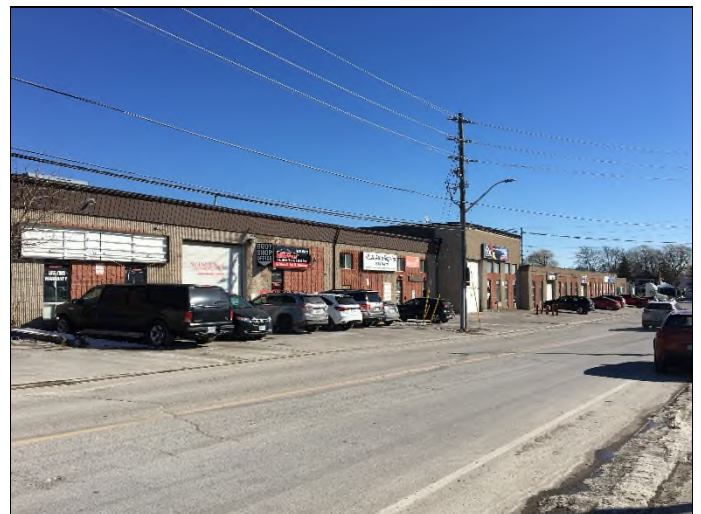
Photo 6 shows the operating auto repair shops at 66 Thomas Street located approximately 120 m east of the Site.

6. 66 Thomas Street – Commercial multi-unit buildings located further east of the Site.

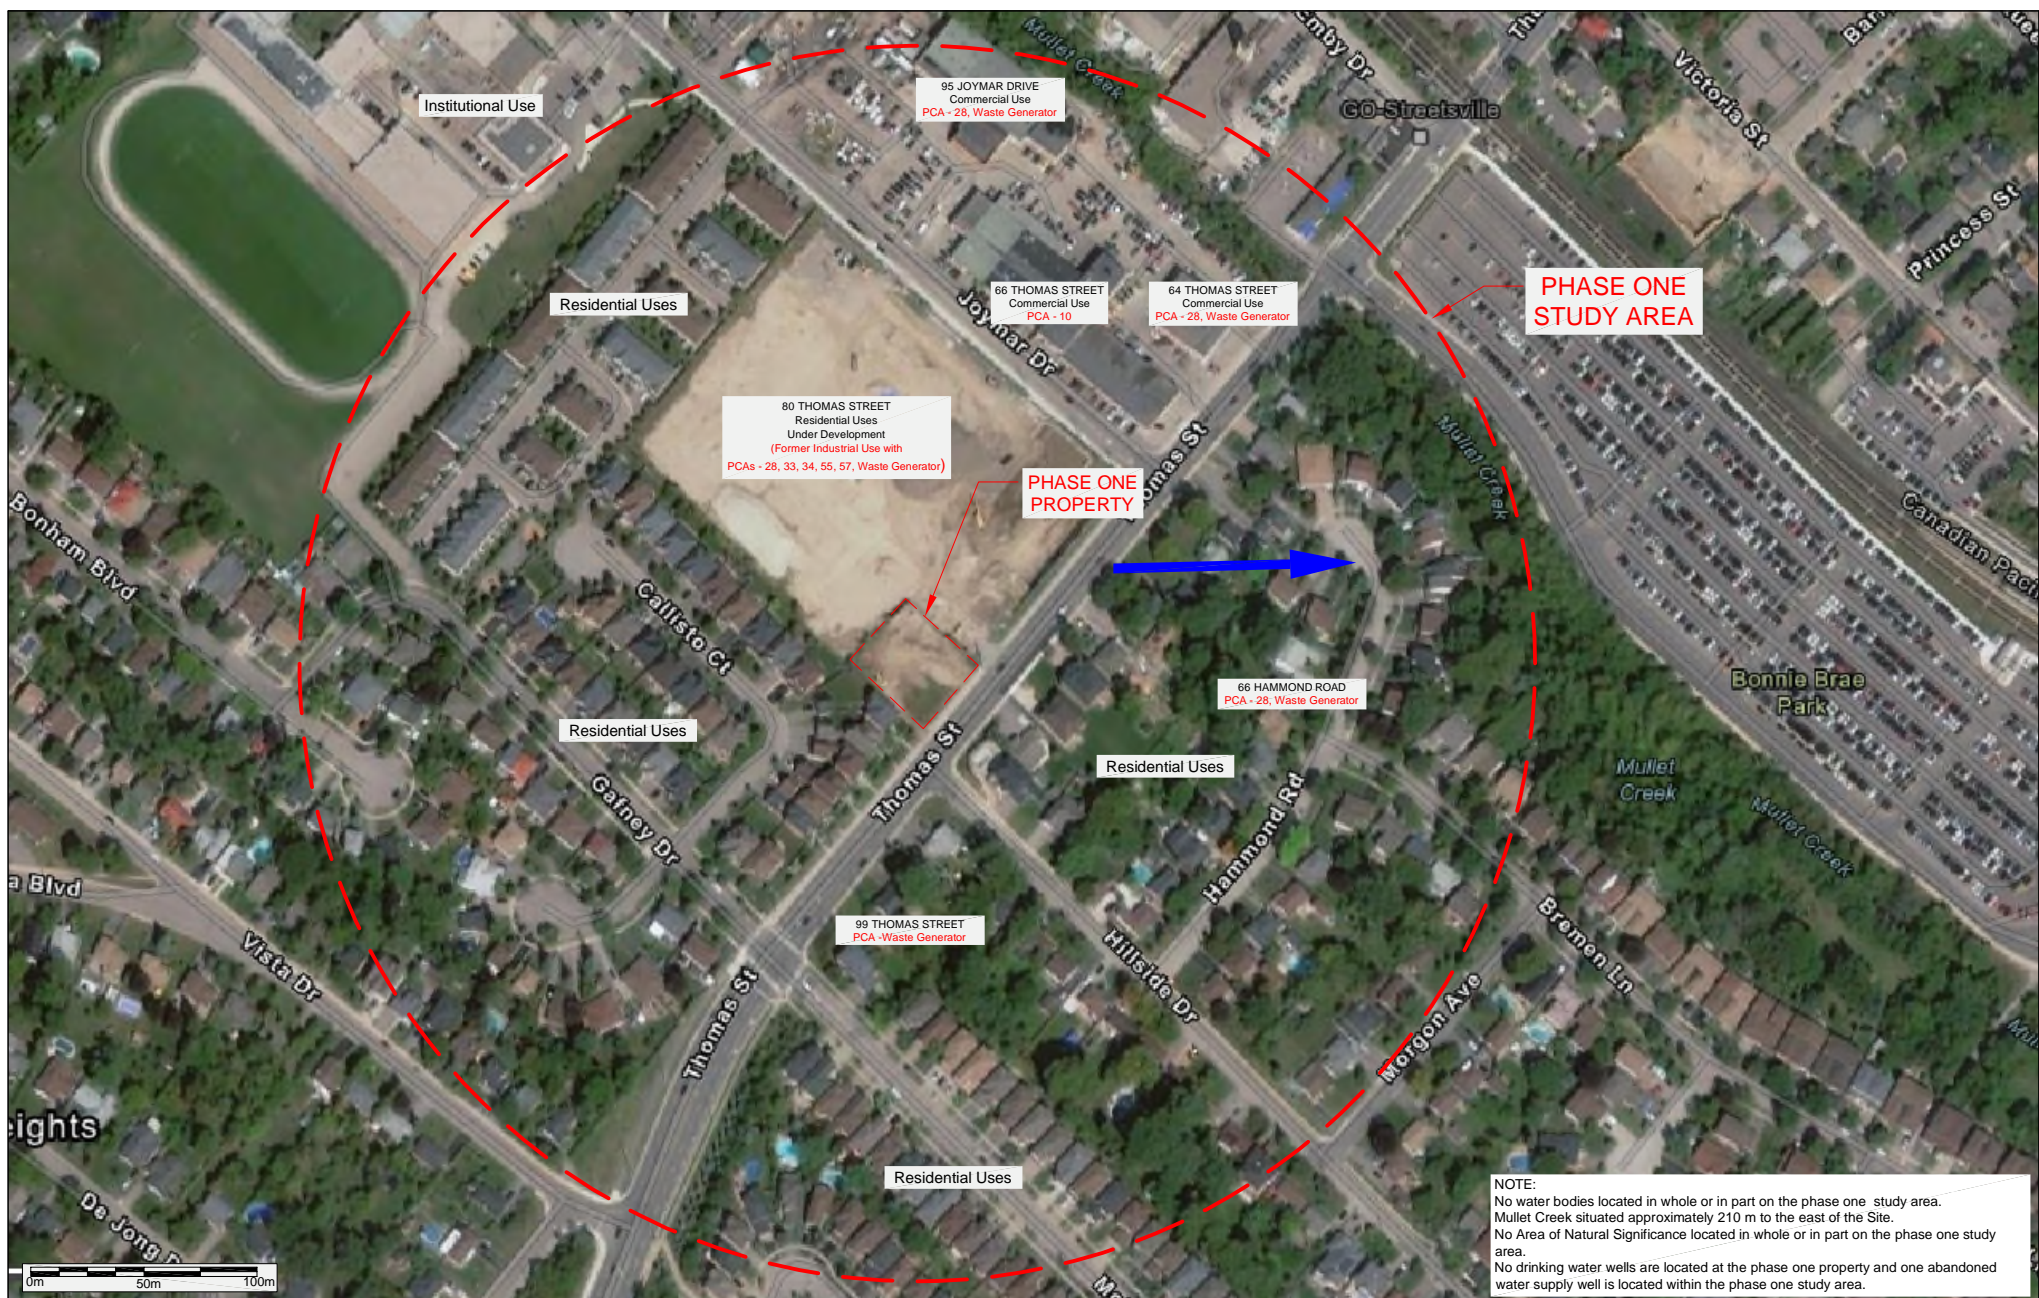
FIGURE 1:  
 PHASE ONE CSM  
 SITE PLAN WITH  
 PHASE ONE STUDY  
 AREA

**NOTE:**  
 No water bodies located in whole or in part on the phase one study area.  
 Mullet Creek situated approximately 210 m to the east of the Site.  
 No Area of Natural Significance located in whole or in part on the phase one study area.  
 No drinking water wells are located at the phase one property and one abandoned water supply well is located within the phase one study area.
