Schedule B Class Environmental Assessment – Project File

Credit River Erosion Control Program From Dundas St. to Hwy 403

Aquafor Beech Limited

October 17, 2024

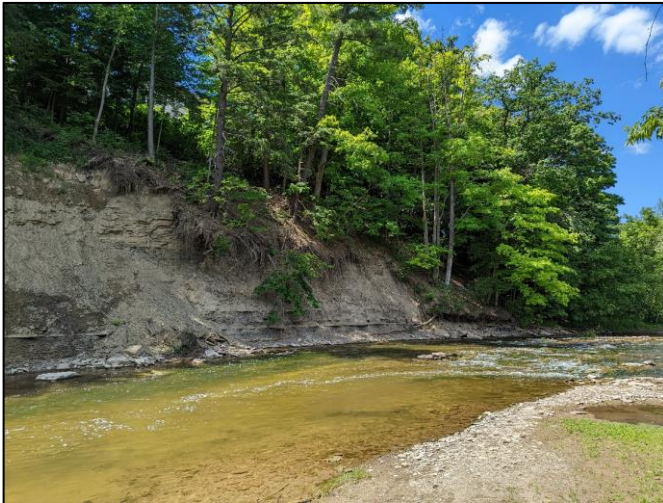
Figure 2-2: Site #5 – Slope Instability Adjacent to Private Property on Summit Court

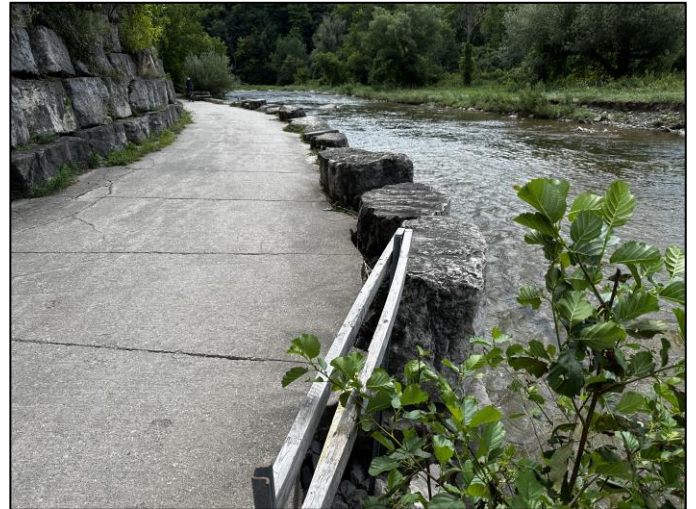
Figure 2-3: Site #4 – Failed Armourstone Retaining Wall

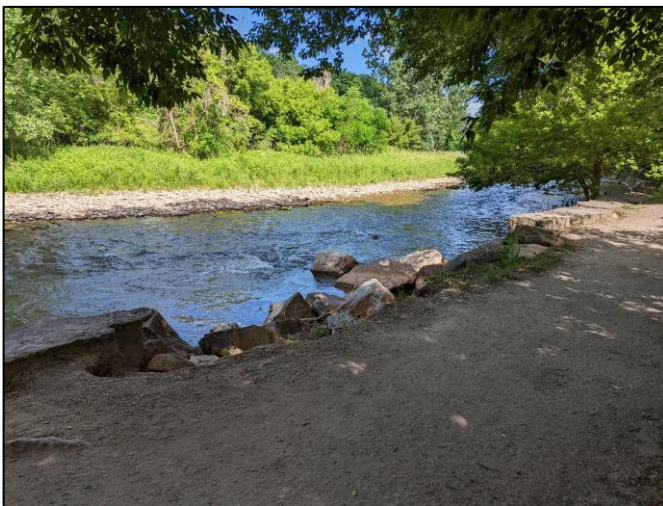
Figure 2-4: Site #2 – Failed Armourstone Retaining Wall Segment Adjoining the Culham Trail

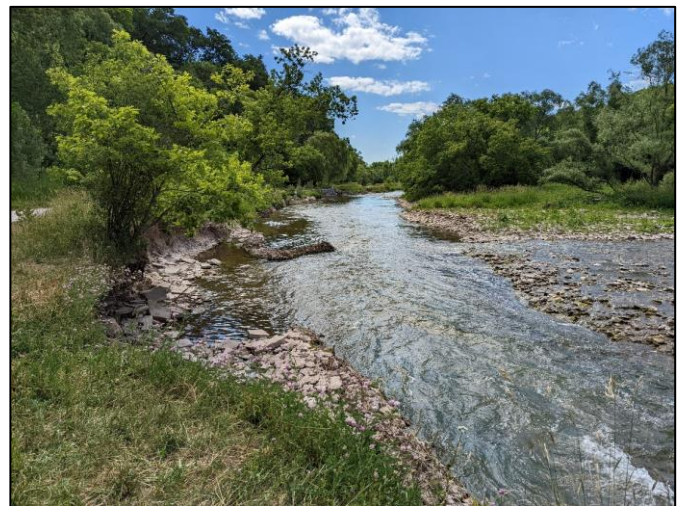
Figure 2-5: Site #3 – Failed Bank Protection Works

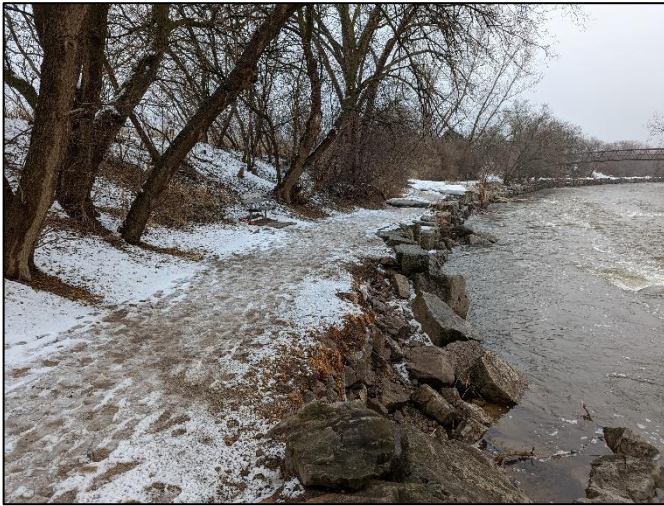
Figure 2-6: Site #6 – Failed Armourstone Retaining Wall Segment Adjoining the Culham Trail

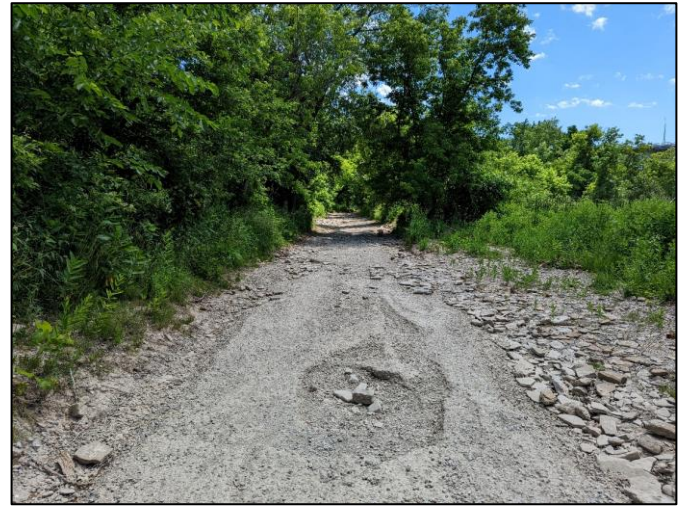
Figure 2-7: Trail Erosion Site #8 – Washout of Gravel Trail due to Frequent Flooding

trail system runs through this floodplain on the east side of the river, and is viewed as a highly valuable recreational resource for the local community. The gravel trail system is severely degraded as a result of ongoing bank erosion and frequent inundation of the floodplain during rainfall events. Engineered bank treatments designed to protect the trail from erosion have failed at a number of locations due to a combination of localized scour (undermining, outflanking), hydrodynamic forces, and damage from severe ice accumulation (**Figure 2-3**, **Figure 2-4**, **Figure 2-5**, and **Figure 2-6**). Frequent flooding has washed out the gravel base along several portions of the trail, particularly upstream of Burnhamthorpe Road (**Figure 2-7**).

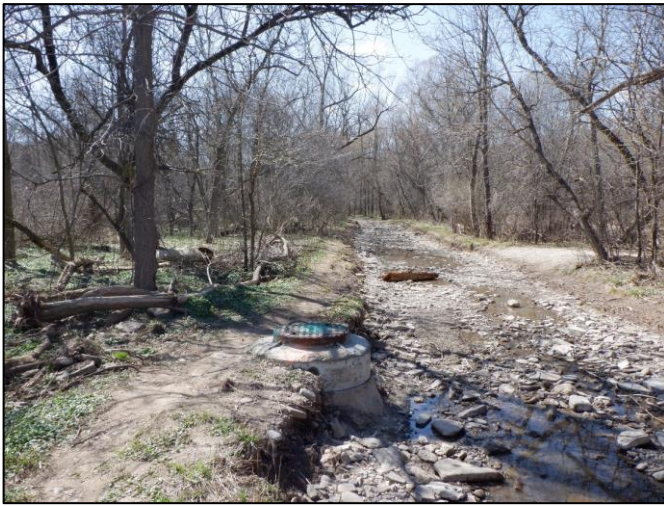
Figure 2-8: Site #8 - Degraded Sanitary Sewer Manhole Structure Along the Culham Trail

Regional sanitary sewer infrastructure is embedded into the eastern floodplain, with manhole elevations low enough to experience frequent inundation with river water during moderate to high intensity storm events. A number of damaged/degraded manholes were observed during Aquafor's site investigations, with at least one manhole partially exposed within the main channel of the Credit River (**Figure 2-8** and **Figure 2-9**).

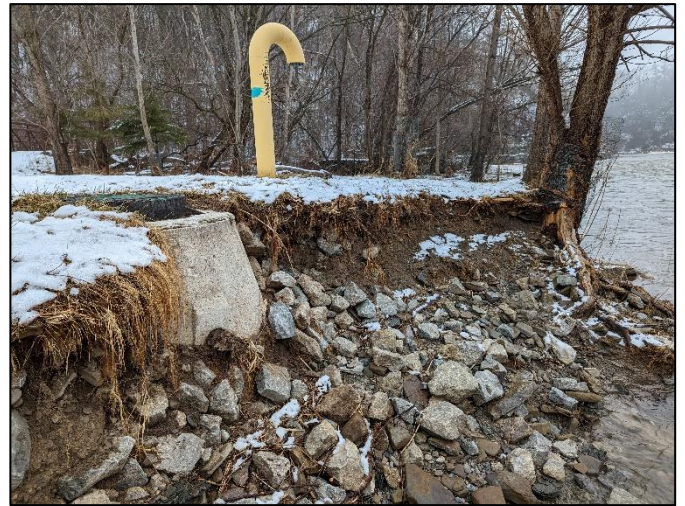
Figure 2-9: Site #7 - Exposed Sanitary Sewer Manhole Along the East Bank of the Credit River

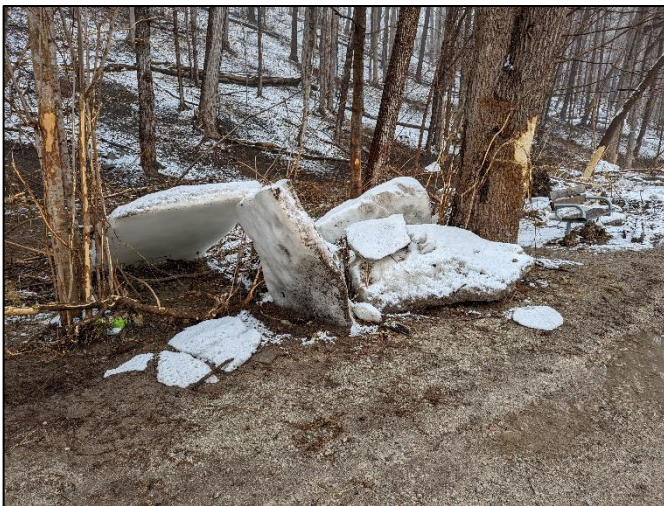
Figure 2-10: Large Chunks of Ice Debris Deposited Along the Culham Trail. Significant Tree Damage Observed.

Unique to the study area is the degree of ice buildup. Large chunks of ice have been observed to settle in the floodplain and along the Culham trail throughout the study area (**Figure 2-10**). A historic Ice Control Structure, managed by the Credit Valley Conservation Authority, is situated towards the downstream extents of the study area near the historic Erindale Dam. Channel widening has resulted in outflanking of the Ice Control Structure along the west bank, creating a bypass channel. While the majority of ice is blocked by the structure, this bypass channel has allowed some ice to flow around the structure and continue downstream (**Figure 2-11**).

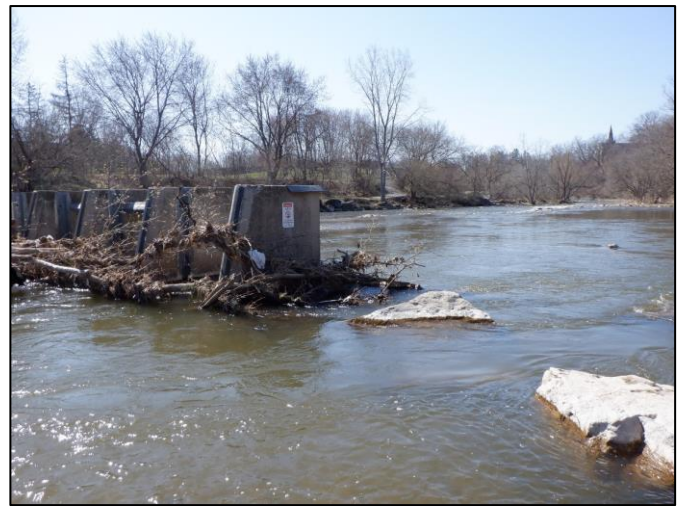
Figure 2-11: Site #1 – Outflanked Ice Control Structure Resulting from Channel Erosion Along the West Bank

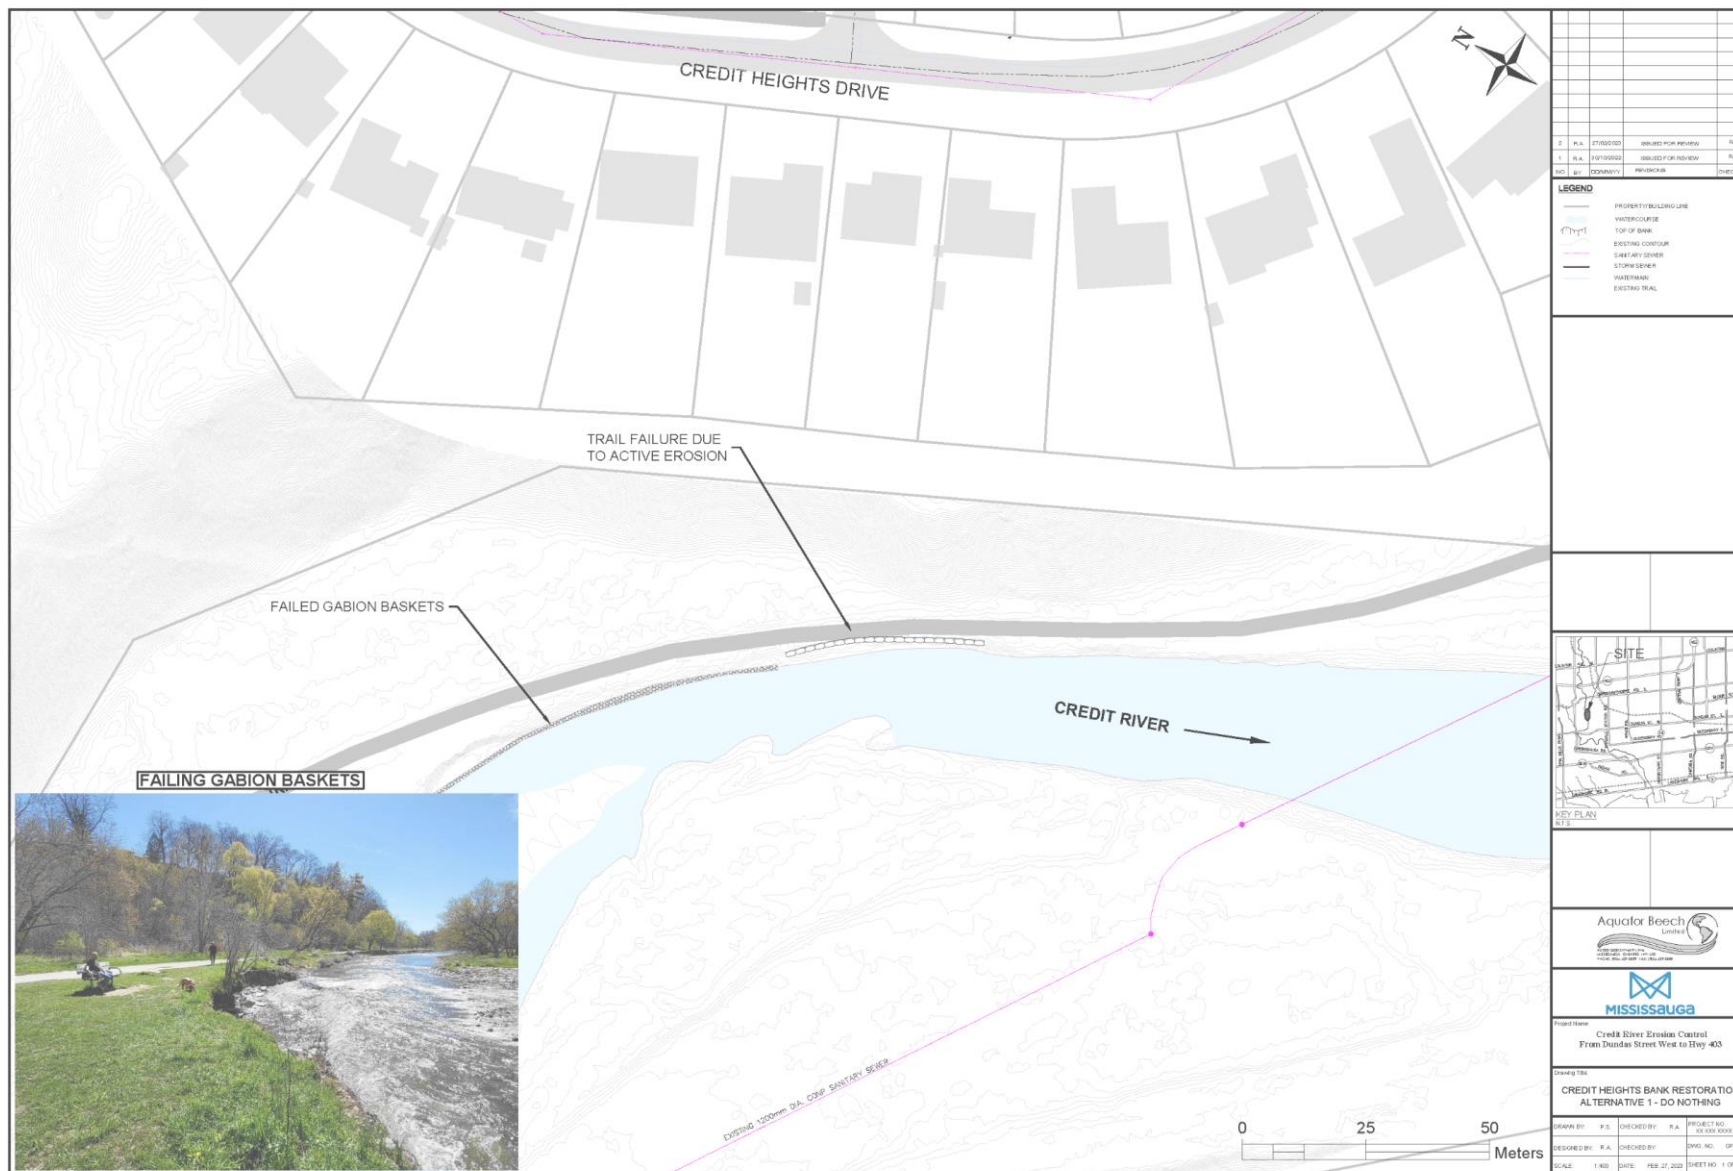
Figure 3-3: Site #3 Existing Conditions

The topographic information was compiled into planform drawings to illustrate existing conditions within the study area, as shown in **Figure 3-1** to **Figure 3-8**.

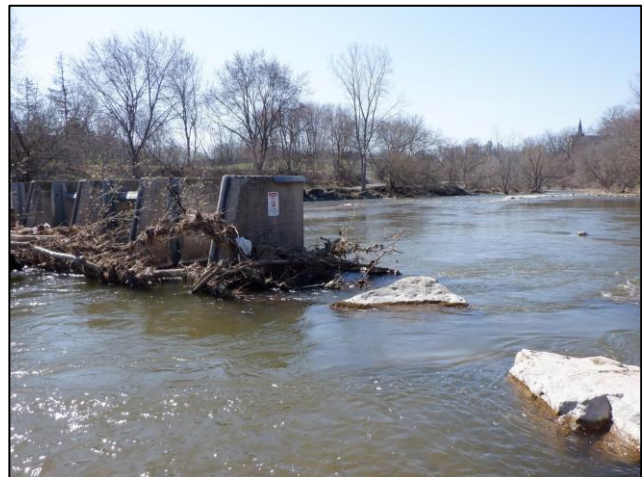
Figure 3-11: Ice Control Structure at Erindale Park

The most downstream reach in the study area extends upstream 2,100 m from the Dundas St West crossing to a mid-channel bar at the northern extent of Principal’s Road. The channel ranges from 20 to 45 m in width and has historically been prevented from widening or migrating with erosion control measures. The channel substrate is composed of cobbles with predominantly sandy bank material (**Figure 3-10**). The ice control structure at Erindale Park creates frequent debris obstructions and has been outflanked due to channel widening in the immediate area (**Figure 3-11**). Additionally, a lobate bar has formed upstream of the ice control structure in response to debris and ice obstruction.

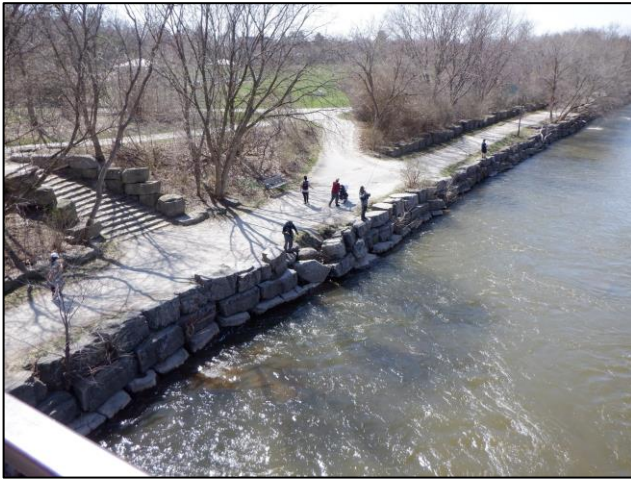
Figure 3-12: Armourstone Retaining Wall and Pedestrian Trail through Reach CRED-0700

A multi-use trail spans the entire length of this reach in close proximity to the east bank. The trail is composed of asphalt and gravel segments. Several sections of the trail are lined with armourstone to protect the trail from being undermined by the channel and to protect the toe of slope (**Figure 3-12**). Previous erosion protection works have failed as a result of channel widening combined with overland drainage issues which washed away interstitial material behind the armourstone (**Figure 3-13**). Improper stone embedment depth and trail drainage issues may have also contributed to the retaining wall failure.

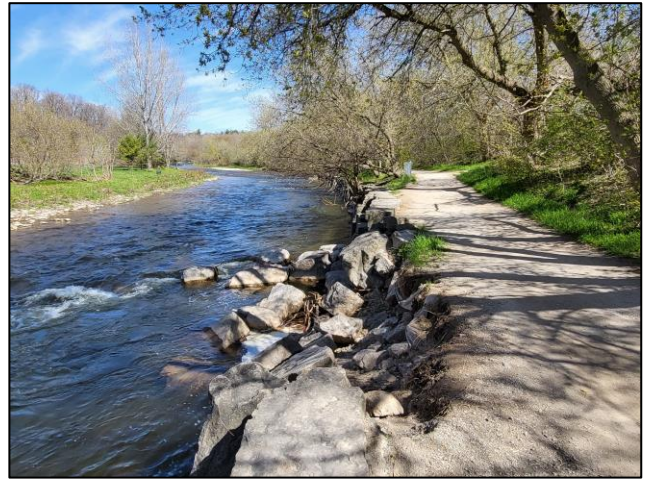
Figure 3-13: Failed Retaining Wall Adjacent to the Trail

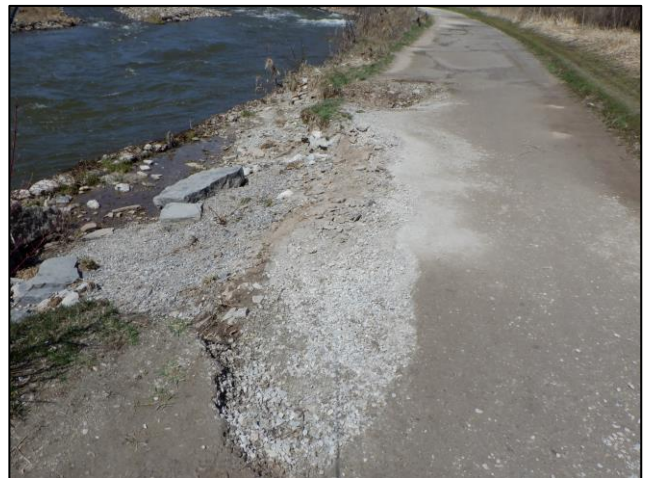
Figure 3-15: Trail Washout from Runoff and Gullying

The middle reach within the study area extends from the bridge crossing at Burnhamthorpe Road West, 750 m downstream to the mid-channel bar at the northern extent of Principal's Road. The channel spans 20 to 55 m in width, with the narrower segments reinforced with armourstone and the widest segment close to the Burnhamthorpe Road bridge (**Figure 3-14**). The pedestrian trail network extends along the northeast bank where a 3 m wide compacted gravel trail runs parallel to the top of bank, at an offset of just 1 m or less. Sections of the trail show a high degree of erosion and are currently in poor condition. The cause of the trail failure is partly due to channel widening and undermining of the armourstone, and partly due to the overland drainage on the valley side of the trail. Similar to the retaining wall collapse in Reach CRED-0700, the channel has scoured beneath the armourstones and removed the material enough for the retaining wall to collapse. Additionally, the lack of trail culverts or culvert capacity causes the overland flow conveyed by the valley slope to overtop the trail berm, converge into drainage pathways, and erode the trail by gullying and channelization (**Figure 3-15**).

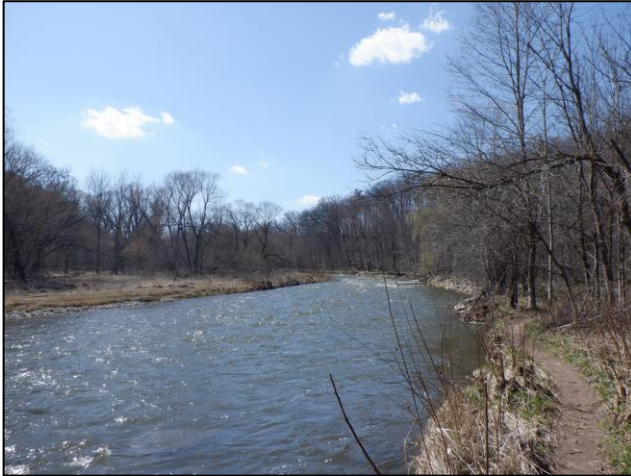
Figure 3-16: Low Banks in the Upper Reach Allow Access to the Floodplain

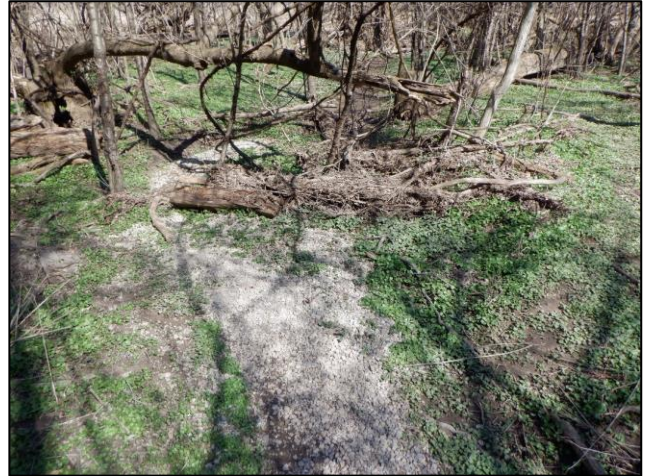
Figure 3-17: Overland Flows Transporting Gravel Material to the Floodplain

The most upstream reach in the study area extends 1,100m downstream of Hwy 403 to Burnhamthorpe Road West. The channel is 20 – 25 m in width for most of the reach, but widens to almost 80 m at Burnhamthorpe to accommodate an island. The banks are lower through this reach with the pedestrian trail aligned further away from the banks. The lack of retraining wall on the northeast bank allows the channel access to the floodplain more easily on that side (**Figure 3-16**). At higher flow stages the flow has exceeded its banks and created chute channels across the floodplain, evident from gravel deposits transported by the overtopping flows (**Figure 3-17**).

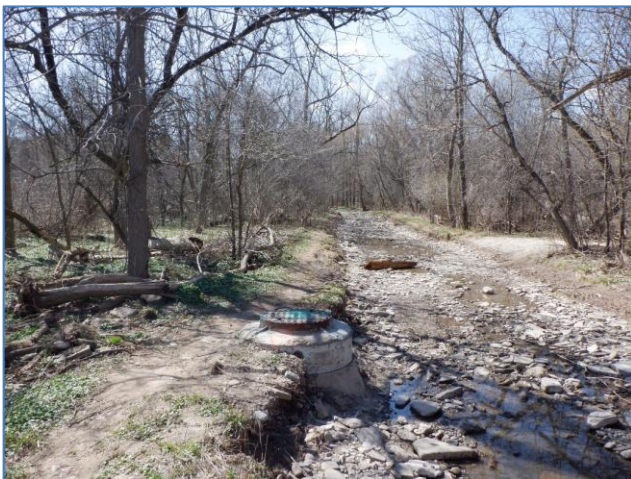
Figure 3-18: Washed Out Pedestrian Trail

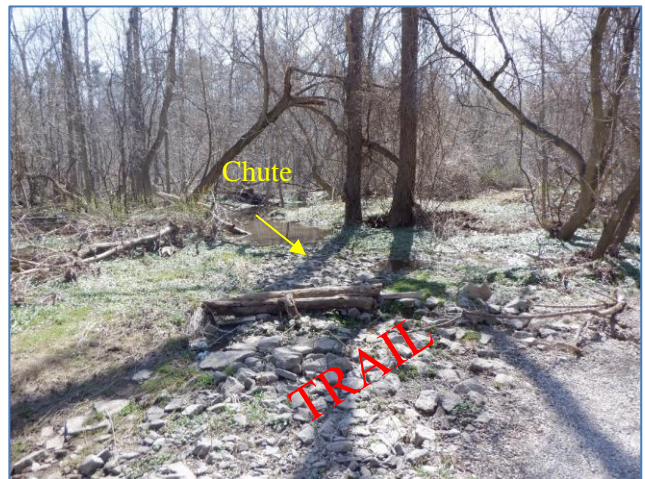
Figure 3-19: Chute Confluence with Trail

The pedestrian trail that runs through the northeast floodplain is coincident with several relict chute channels. The trail is set lower in elevation than the adjacent floodplain or has become so. As a result, the upper layer and much of the trail bed has been eroded or washed away by these overbank flow events. Being a relatively straight, elongate, topographic low with a considerable gradient, this trail has acted like an engineered channel, but without appropriate stone sizing to prevent the transport of material. Manholes along the trail have been scoured down over 0.3 m, and demonstrate the erosion potential of an unvegetated drainage feature in this high energy environment.
