PHASE ONE ENVIRONMENTAL SITE ASSESSMENT

**120 FAIRVIEW ROAD WEST
MISSISSAUGA, ONTARIO**

Project No. FE 23-13004

January 8, 2024

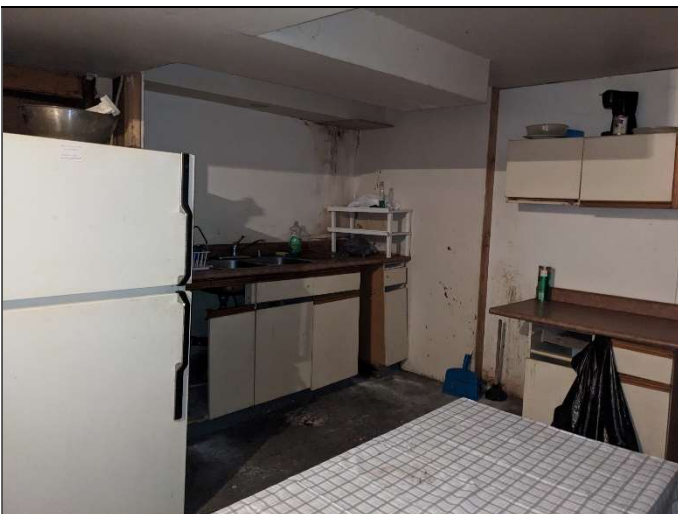
5. View of the kitchen in the basement of the on-site dwelling and signs of water stains/mould.

Potential for future mould growth associated with water stains was observed inside the building during our Site reconnaissance; an assessment to determine the source of the water ingress could be made to prevent future water damage and potential mould growth.

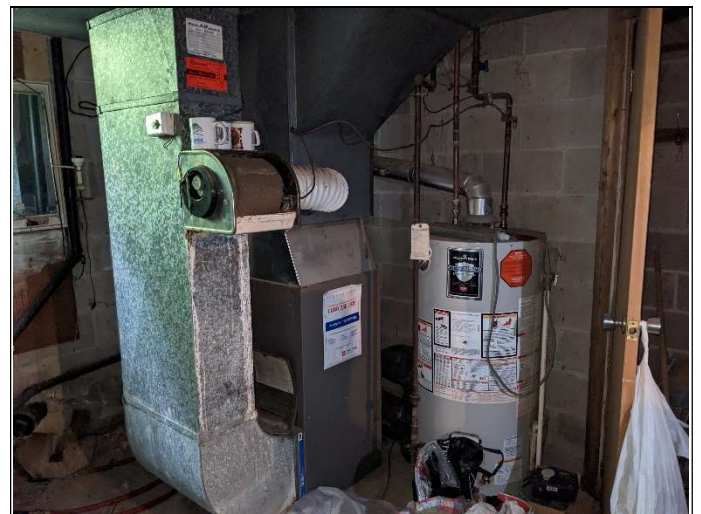
6. View of the boiler room located in the basement of the on-site dwelling.

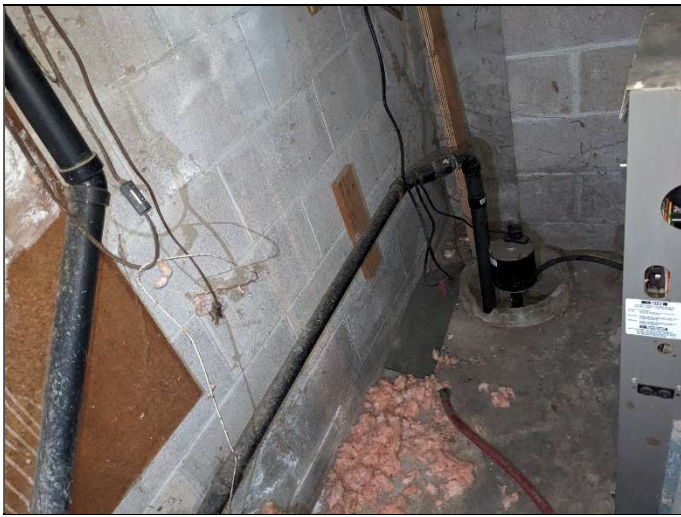
7. View of sump pump behind the HVAC system in the basement of the on-site dwelling.

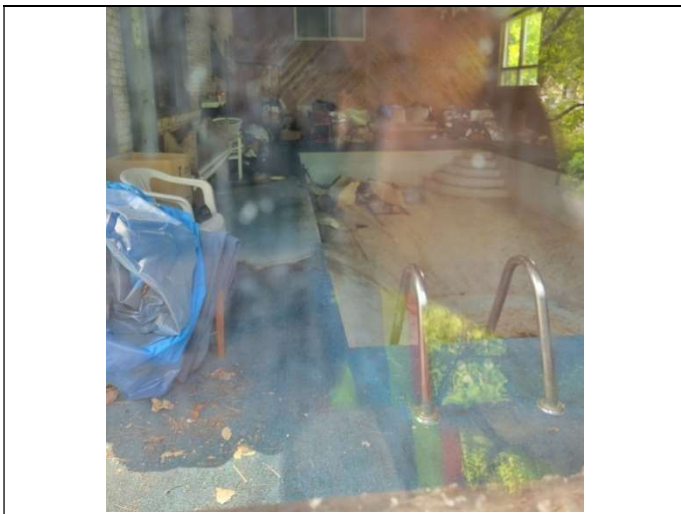
9. View of an indoor pool, backfilled with concrete, located on the southeast portion of the on-site dwelling.

The grade surface at the phase one property was generally flat and slightly slopes towards the south. It is unlikely that fill material was used for grading at the Site. It was noted that based on our site reconnaissance (refer to Section 6.2) and interviews (refer to Section 5), a former indoor pool at the southeast portion of the subject building was reportedly backfilled with concrete.

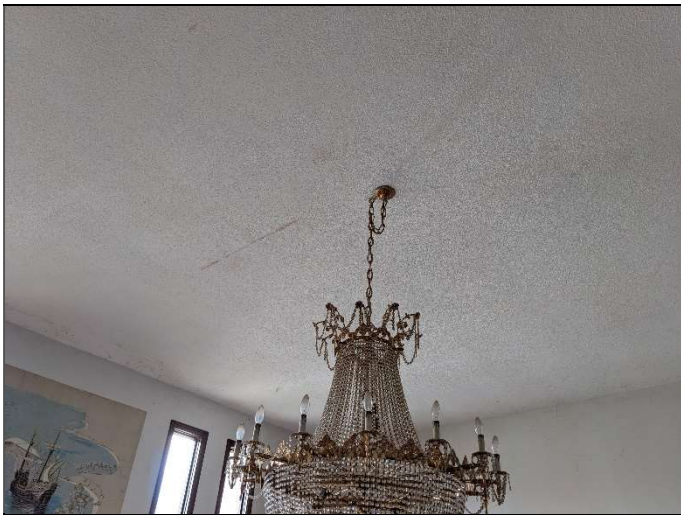
13. View of the water stains on the ceiling located in the main area of the on-site dwelling.

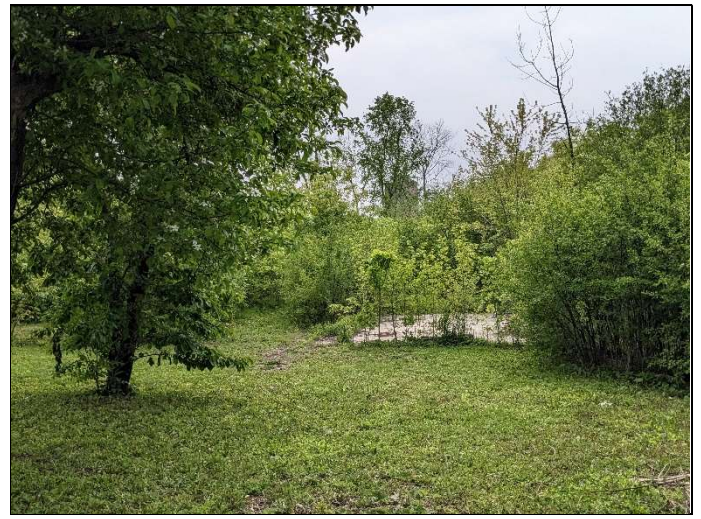
14. View of the location of the historical shed on the west central portion of the Site, facing south.
