Phase Two Environmental Site Assessment

2670 & 2690 Erin Center Boulevard, Mississauga, ON

Phase Two Environmental Site Assessment (ESA)

GTR-00257769-H0

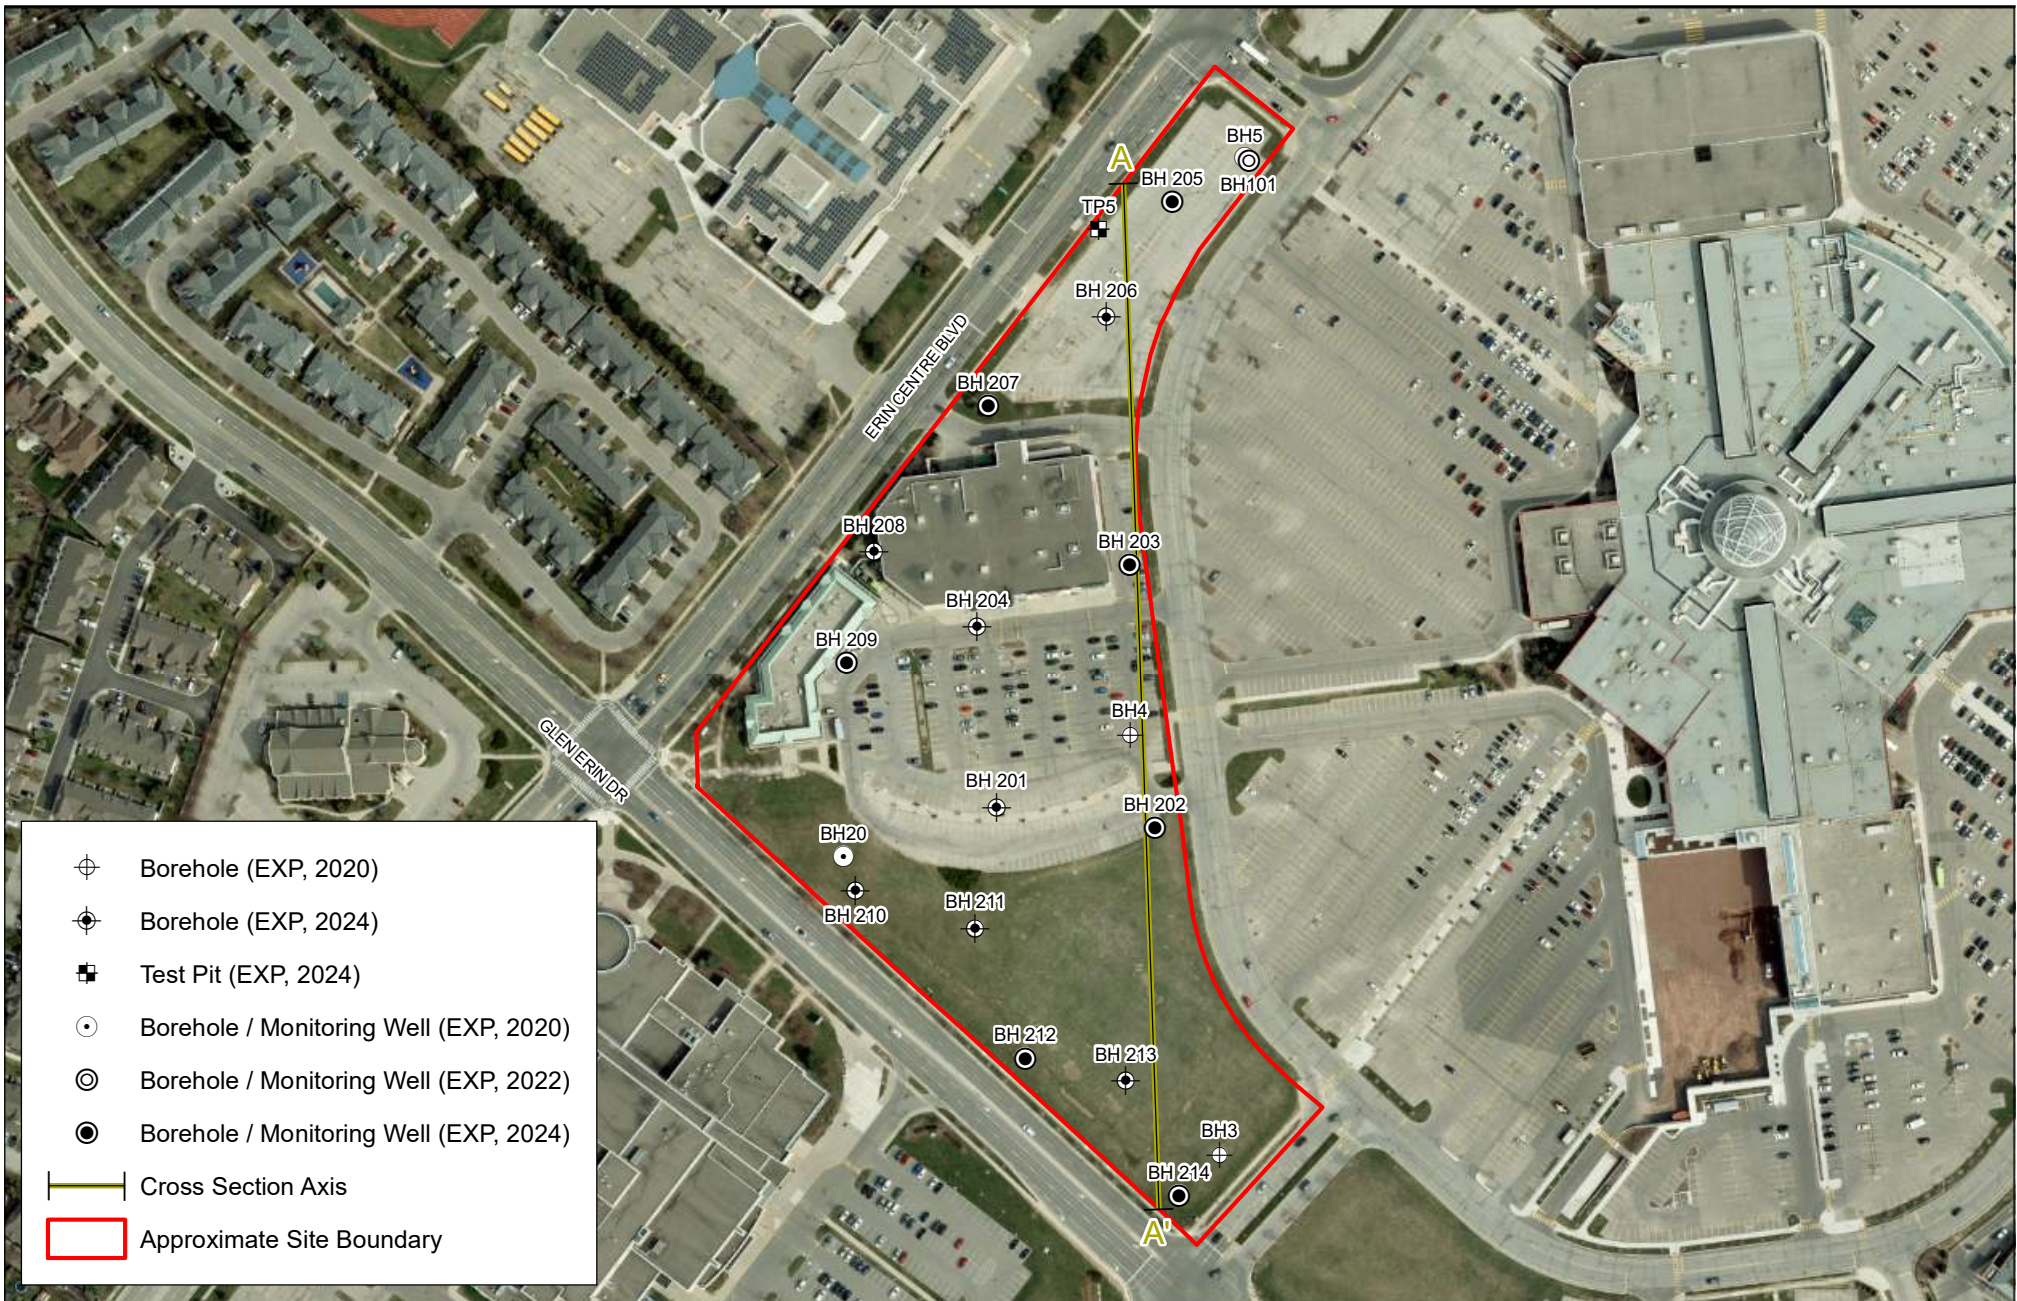
PROJECT No:	GTR-23013629-H0	OWN:	AC
SCALE:	AS NOTED	CHKD:	AG
DATE:	MARCH 2024	FIG. No.:	5A

TITLE AND LOCATION:
**BOREHOLE / MONITORING WELL
 LOCATION PLAN**
 Phase Two Environmental Site Assessment
 5100 Erin Mill Parkway - Block 1
 Mississauga, Ontario

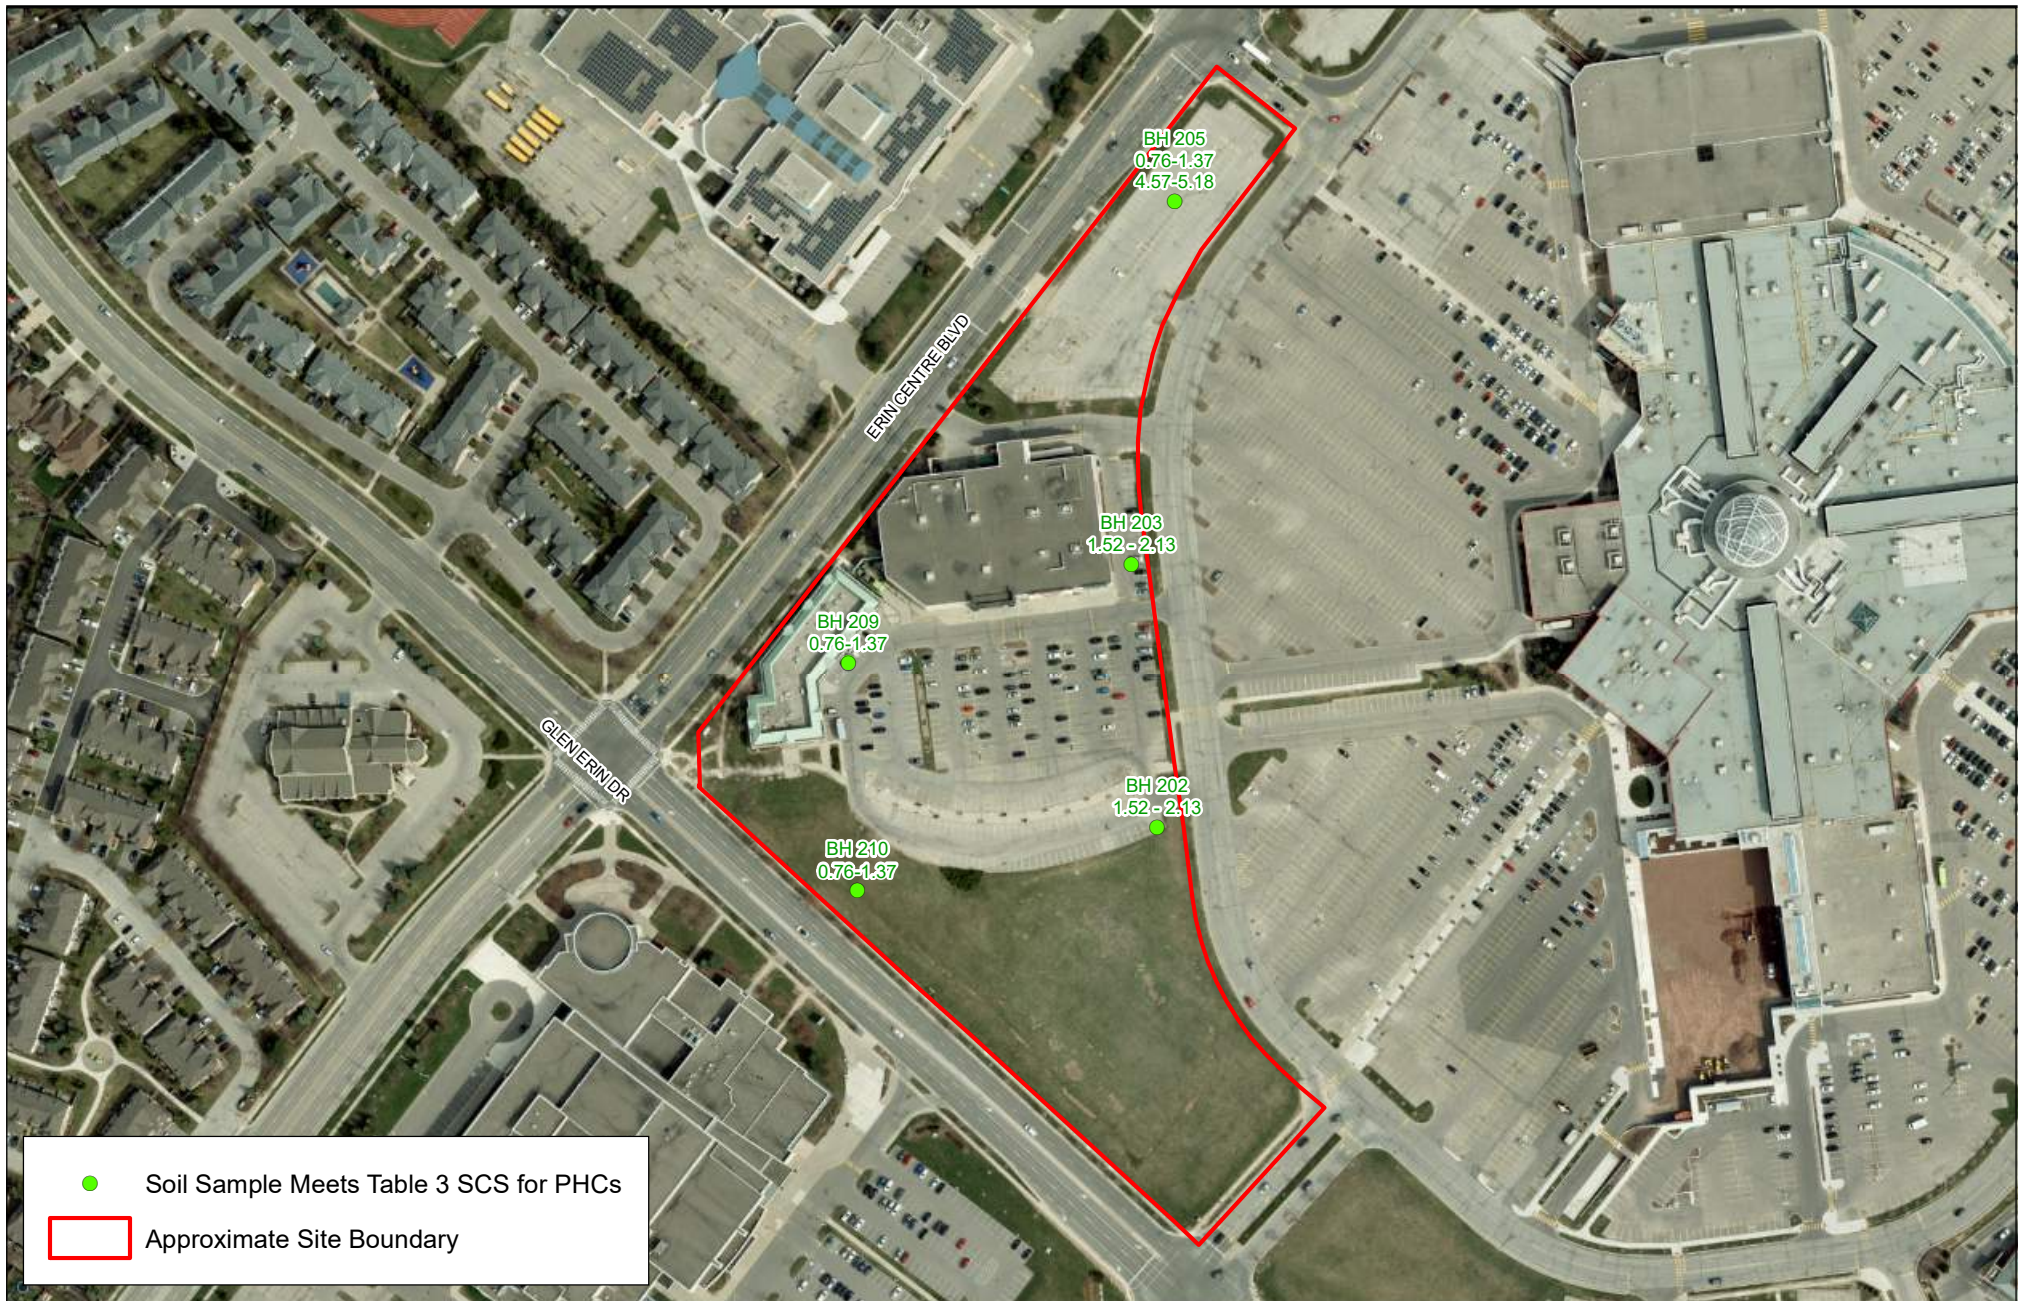
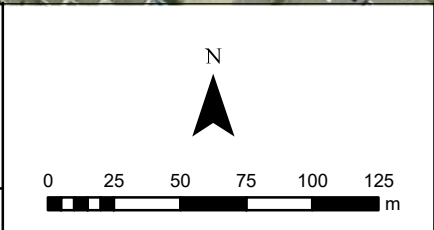
PROJECT No:	GTR-23013629-H0	OWN:	AC
SCALE:	AS NOTED	CHKD:	AG
DATE:	MARCH 2024	FIG. No.:	7

● Soil Sample Meets Table 3 SCS for PHCs
 □ Approximate Site Boundary

TITLE AND LOCATION:
**SOIL ANALYTICAL RESULTS -
 PETROLEUM HYDROCARBONS (PHCs)
 INCLUDING BTEX**
 Phase Two Environmental Site Assessment
 5100 Erin Mill Parkway - Block 1
 Mississauga, Ontario

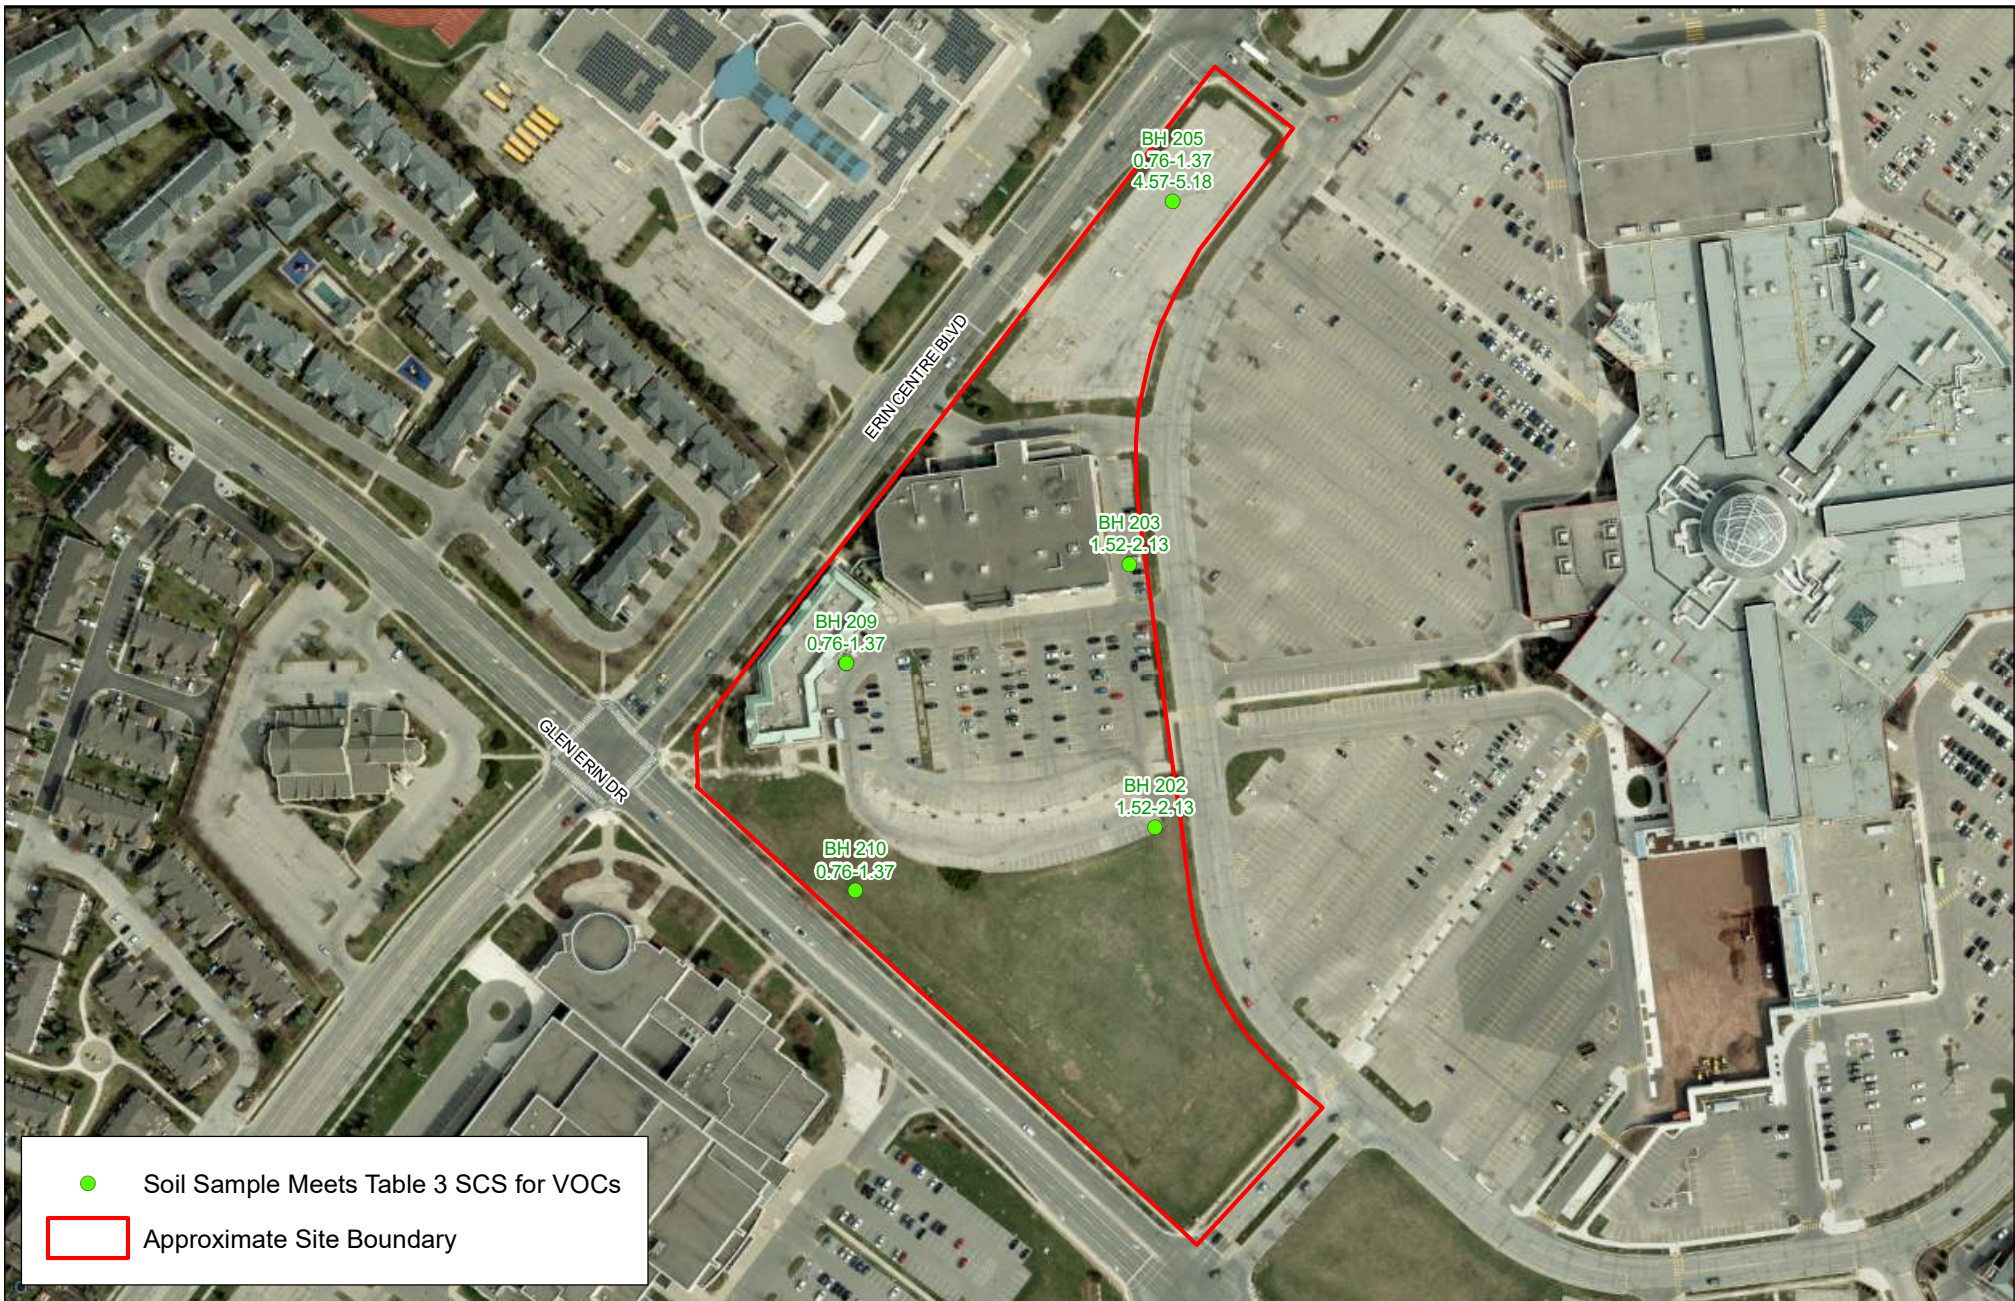
PROJECT No:	GTR-23013629-H0	OWN:	AC
SCALE:	AS NOTED	CHKD:	AG
DATE:	MARCH 2024	FIG. No.:	8

● Soil Sample Meets Table 3 SCS for VOCs
 □ Approximate Site Boundary

TITLE AND LOCATION:
**SOIL ANALYTICAL RESULTS -
 VOLATILE ORGANIC COMPOUNDS (VOCs)**
 Phase Two Environmental Site Assessment
 5100 Erin Mill Parkway - Block 1
 Mississauga, Ontario

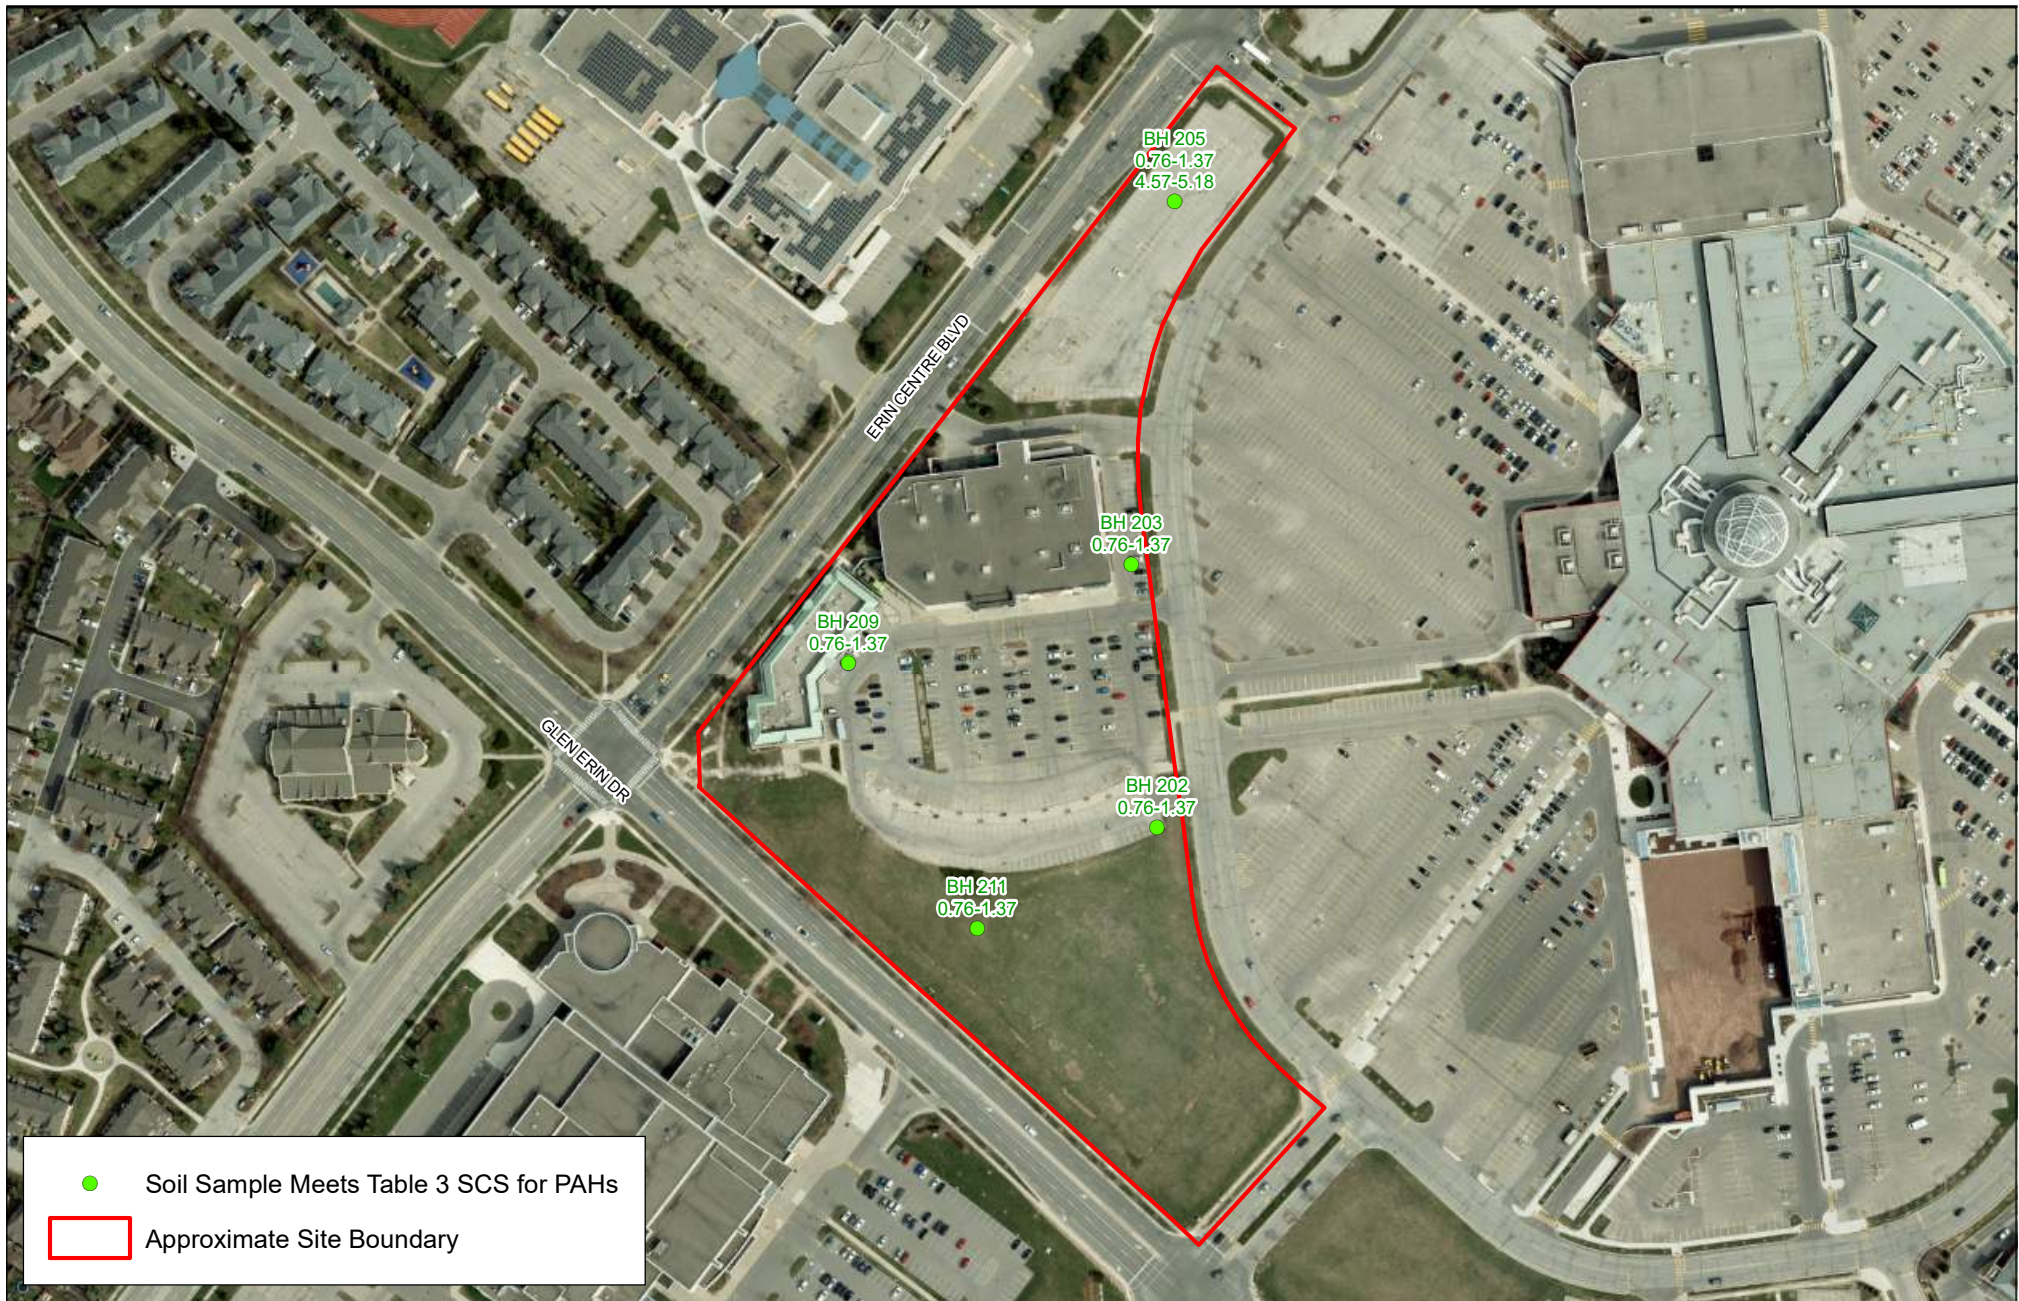
PROJECT No:	GTR-23013629-H0	OWN:	AC
SCALE:	AS NOTED	CHKD:	AG
DATE:	MARCH 2024	FIG. No.:	9

● Soil Sample Meets Table 3 SCS for PAHs
 □ Approximate Site Boundary

TITLE AND LOCATION:
 SOIL ANALYTICAL RESULTS -
 POLYCYCLIC AROMATIC HYDROCARBONS (PAHs)
 Phase Two Environmental Site Assessment
 5100 Erin Mill Parkway - Block 1
 Mississauga, Ontario

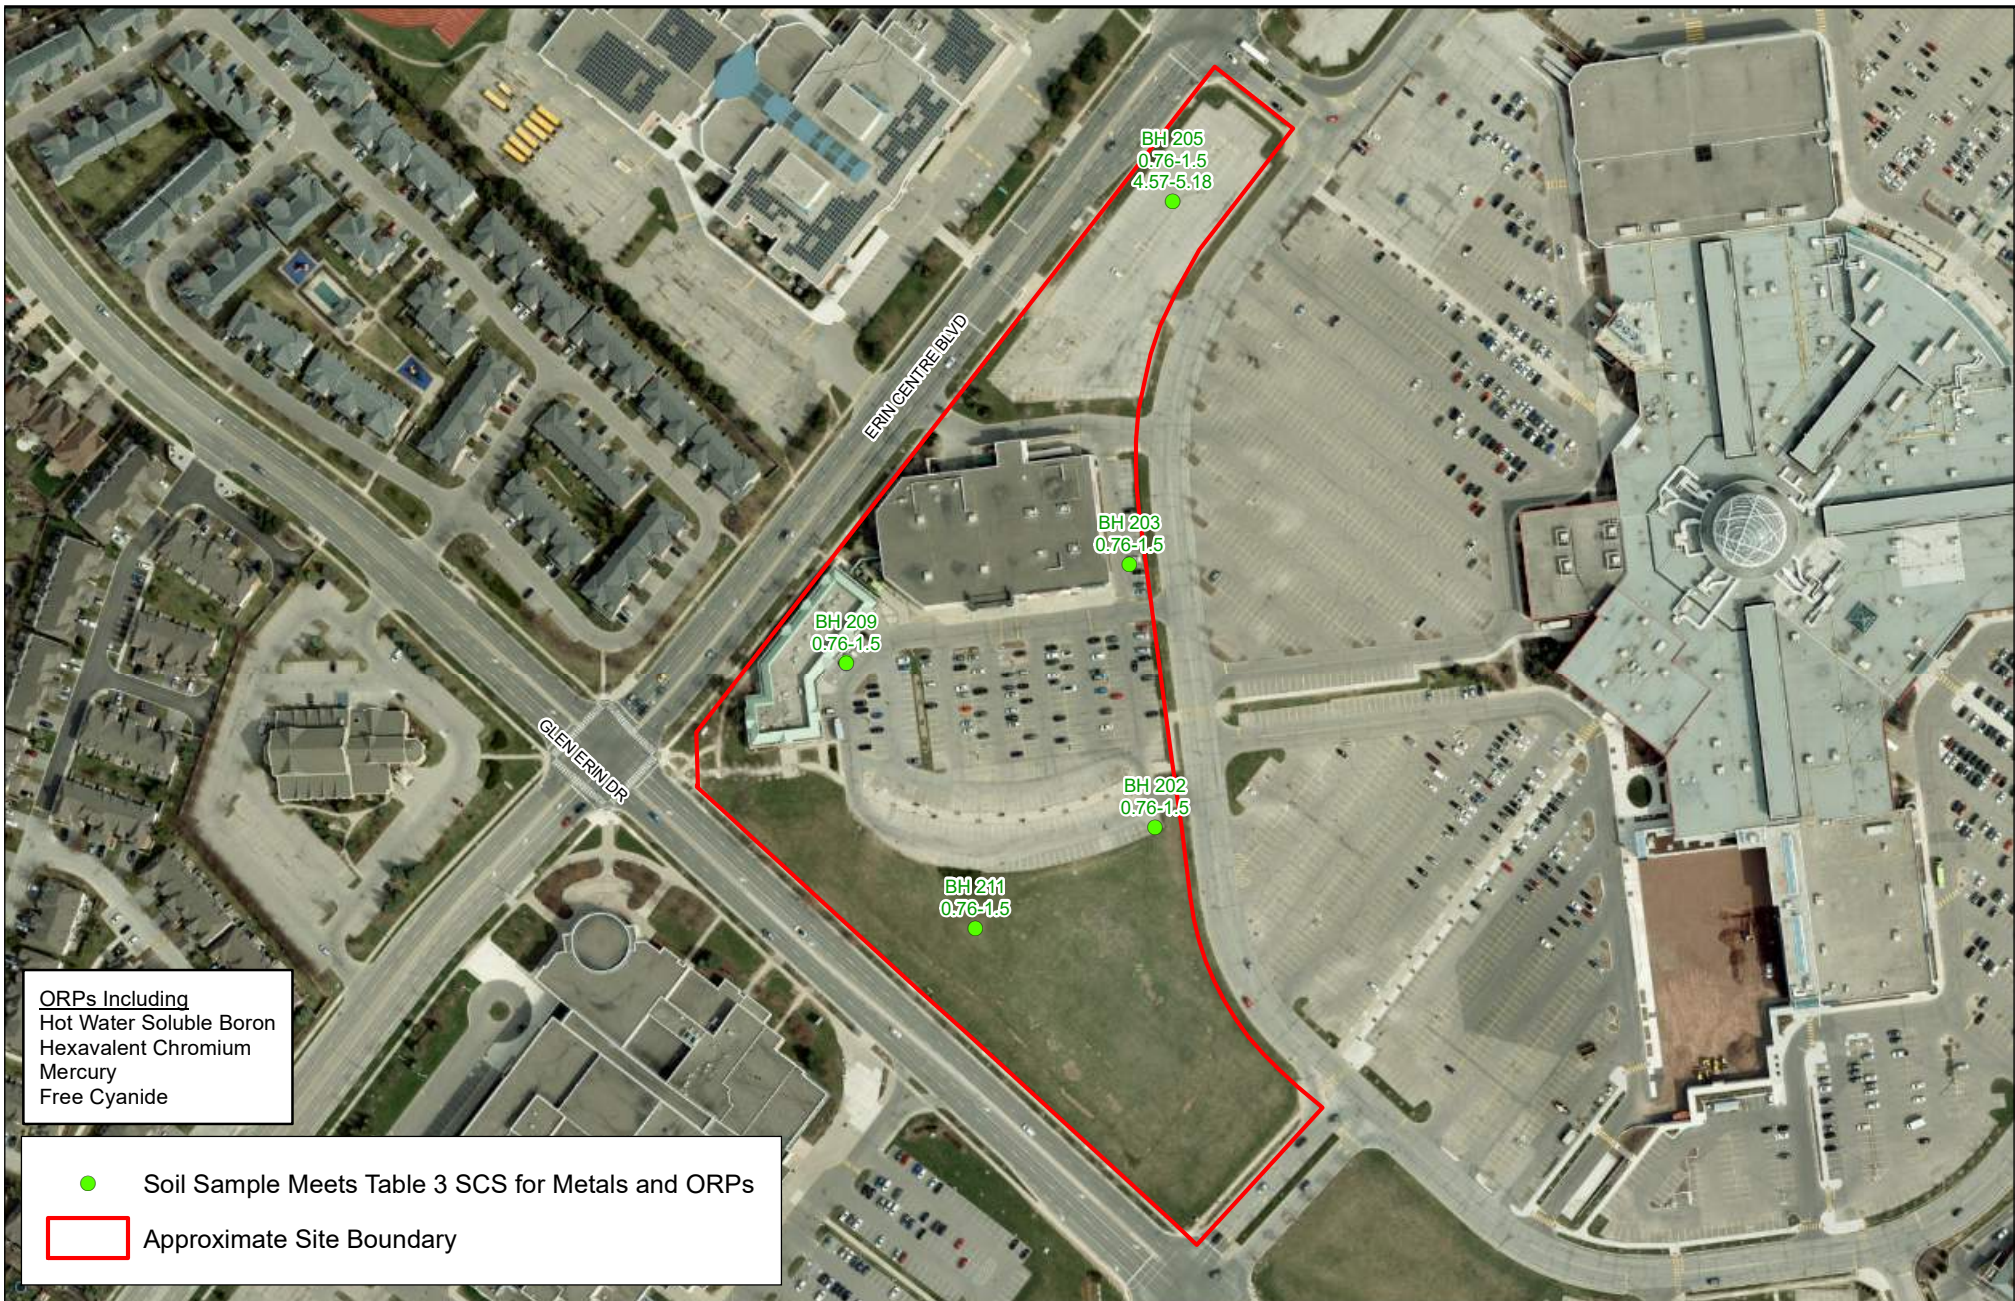
PROJECT No:	GTR-23013629-H0	OWN:	AC
SCALE:	AS NOTED	CHKD:	AG
DATE:	MARCH 2024	FIG. No.:	10

● Soil Sample Meets Table 3 SCS for Metals and ORPs
 □ Approximate Site Boundary

TITLE AND LOCATION:
 SOIL ANALYTICAL RESULTS -
 METALS INCLUDING HYDRIDE-FORMING METALS
 AND OTHER REGULATED PARAMETERS (ORPs)
 Phase Two Environmental Site Assessment
 5100 Erin Mill Parkway - Block 1
 Mississauga, Ontario

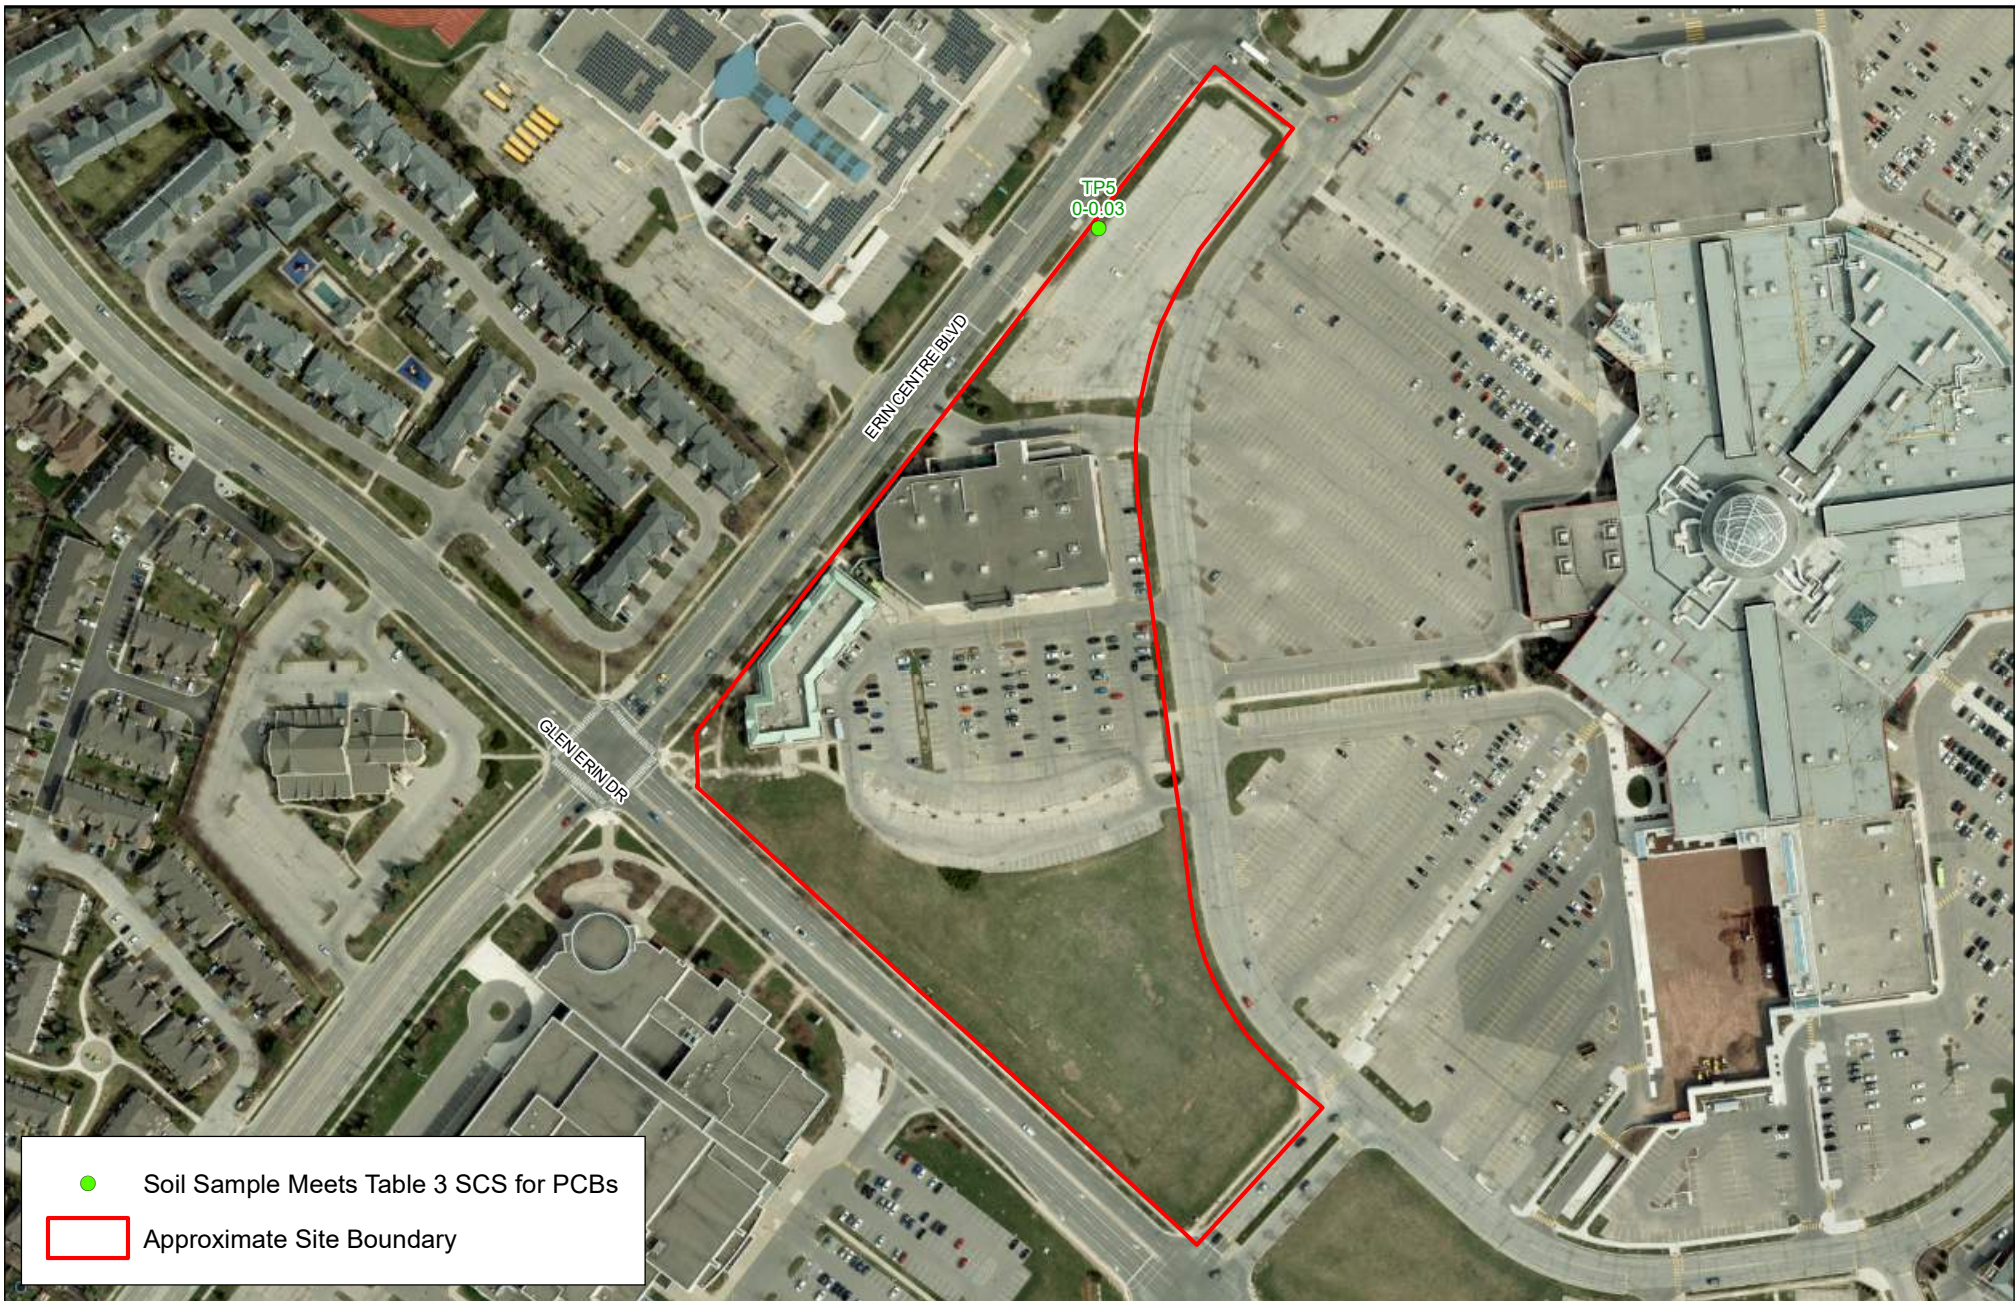
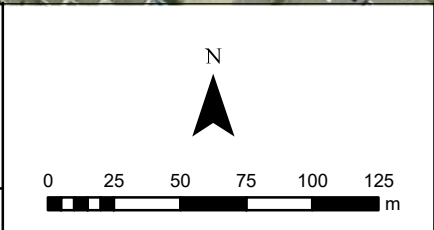
PROJECT No:	GTR-23013629-H0	OWN:	AC
SCALE:	AS NOTED	CHKD:	AG
DATE:	MARCH 2024	FIG. No.:	12

● Soil Sample Meets Table 3 SCS for PCBs
 Approximate Site Boundary

TITLE AND LOCATION:
 SOIL ANALYTICAL RESULTS -
 POLYCHLORINATED BIPHENYLS (PCBs)
 Phase Two Environmental Site Assessment
 5100 Erin Mill Parkway - Block 1
 Mississauga, Ontario

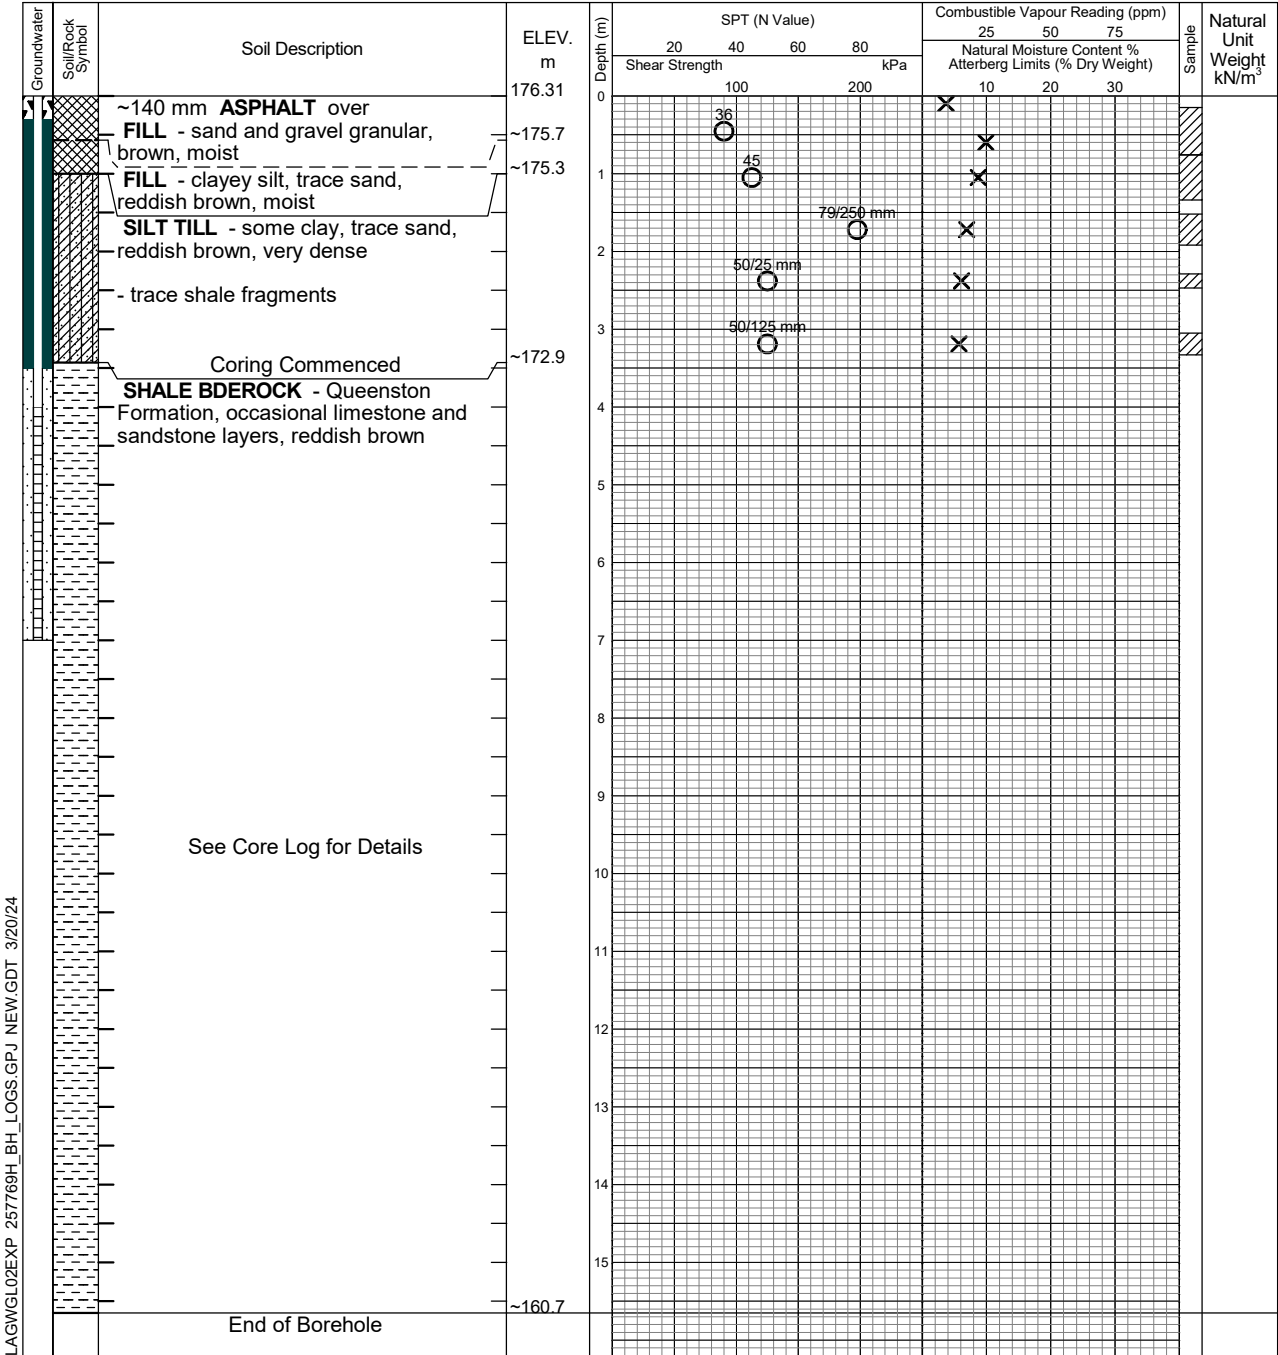
Notes:
 1. Borehole advanced to completion at ~15.7 m depth by conventional soil sampling methods using a specialist drilling subcontractor. For borehole definitions, see notes prior to logs.
 2. This drawing forms part of and must be read in conjunction with the subject report (Ref. No.: GTR-00257769-H0); borehole data requires interpretation assistance by exp professional staff before use by others.

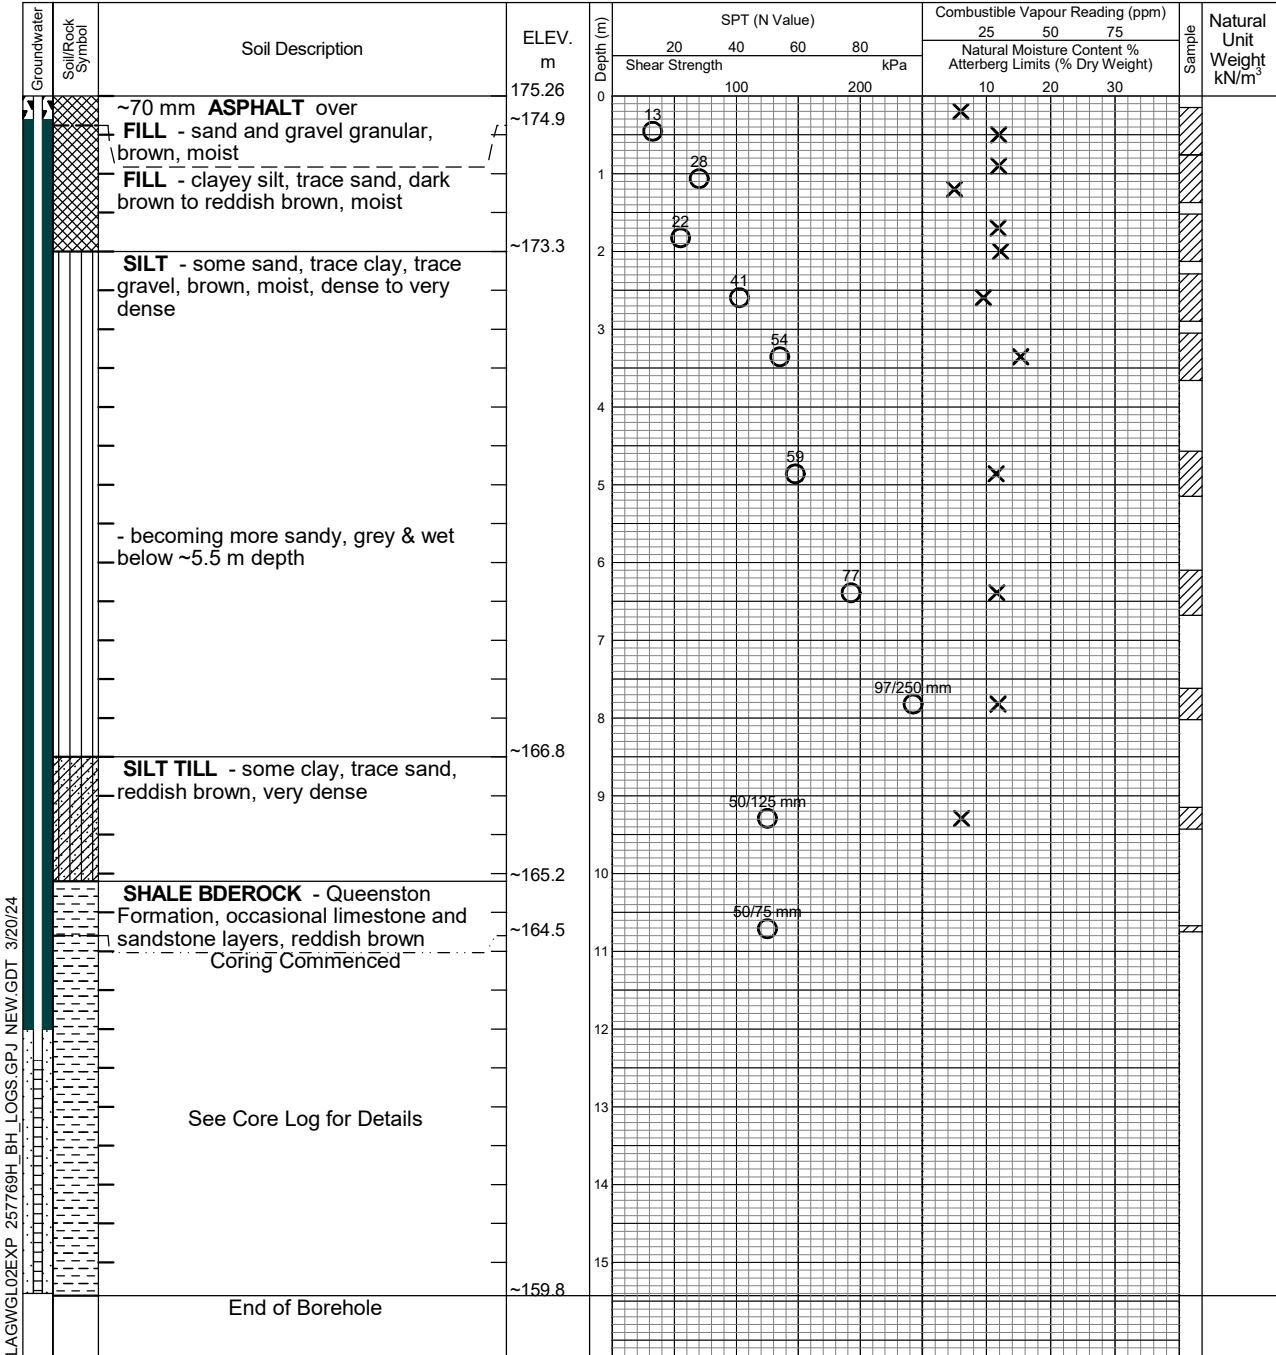
- Borehole advanced to completion at ~15.4 m depth by conventional soil sampling methods using a specialist drilling subcontractor. For borehole definitions, see notes prior to logs.
- This drawing forms part of and must be read in conjunction with the subject report (Ref. No.: GTR-00257769-H0); borehole data requires interpretation assistance by exp professional staff before use by others.

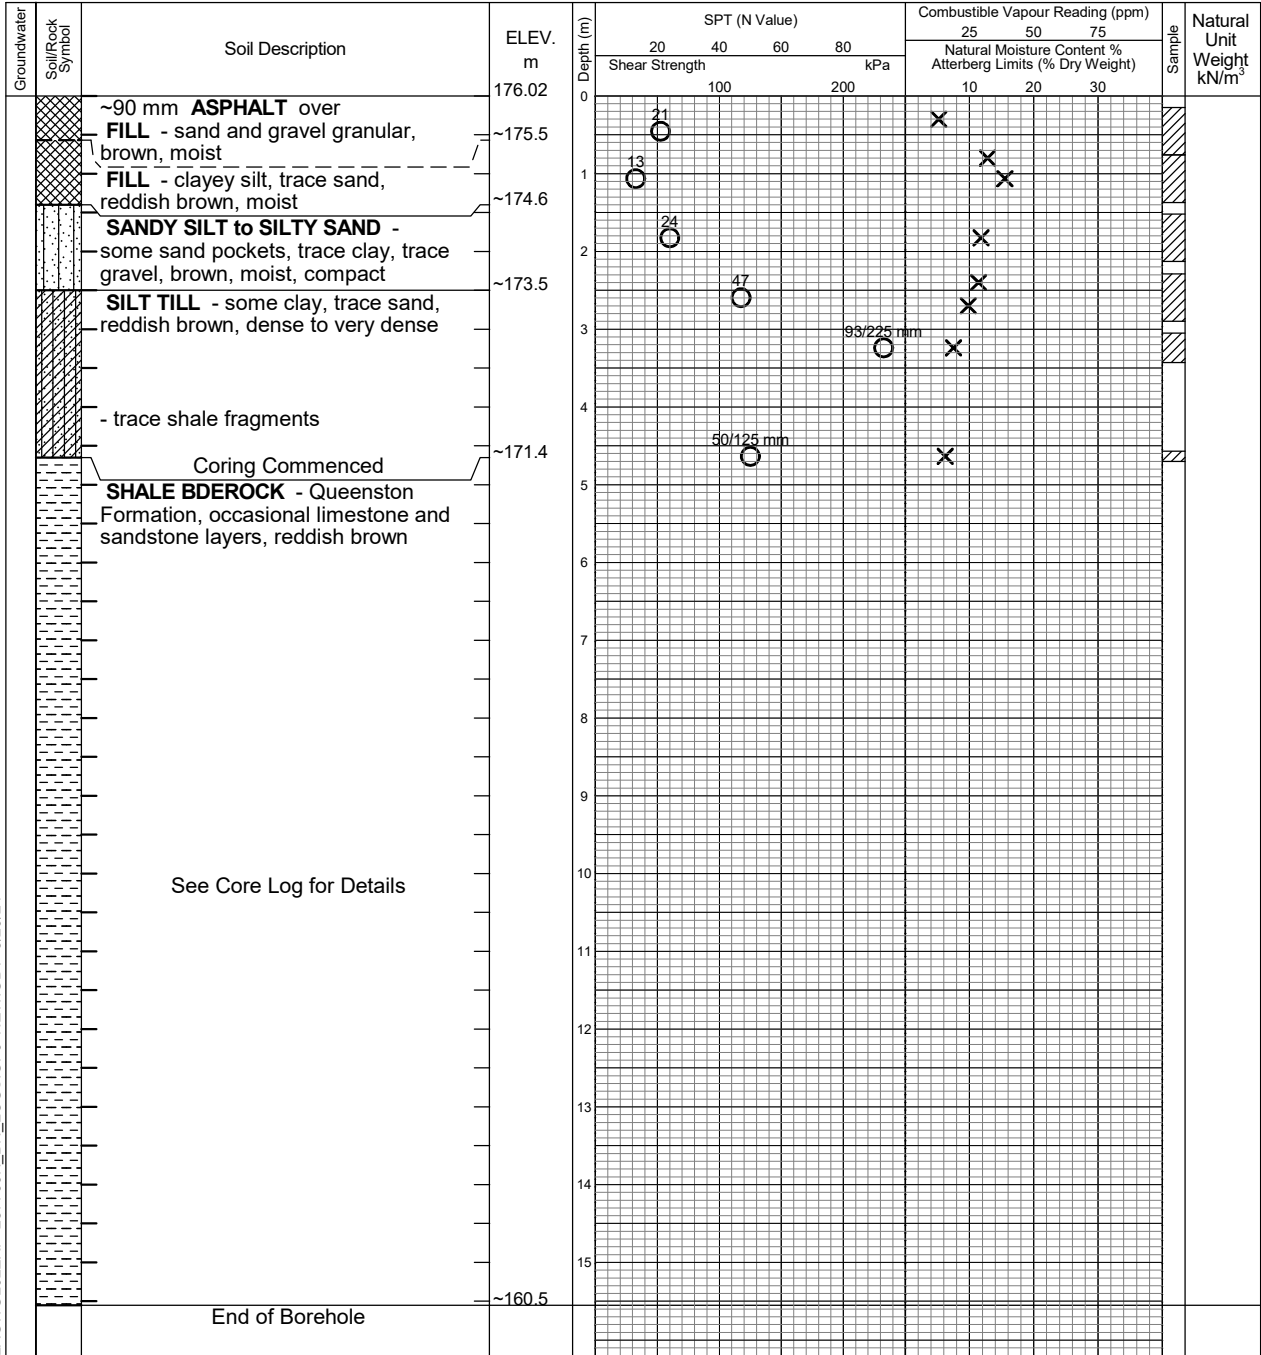
Notes:
 1. Borehole advanced to completion at ~15.6 m depth by conventional soil sampling methods using a specialist drilling subcontractor. For borehole definitions, see notes prior to logs.
 2. This drawing forms part of and must be read in conjunction with the subject report (Ref. No.: GTR-00257769-H0); borehole data requires interpretation assistance by exp professional staff before use by others.
