Phase Two Environmental Site Assessment

2670 & 2690 Erin Center Boulevard, Mississauga, ON

Phase Two Environmental Site Assessment (ESA)

GTR-00257769-H0

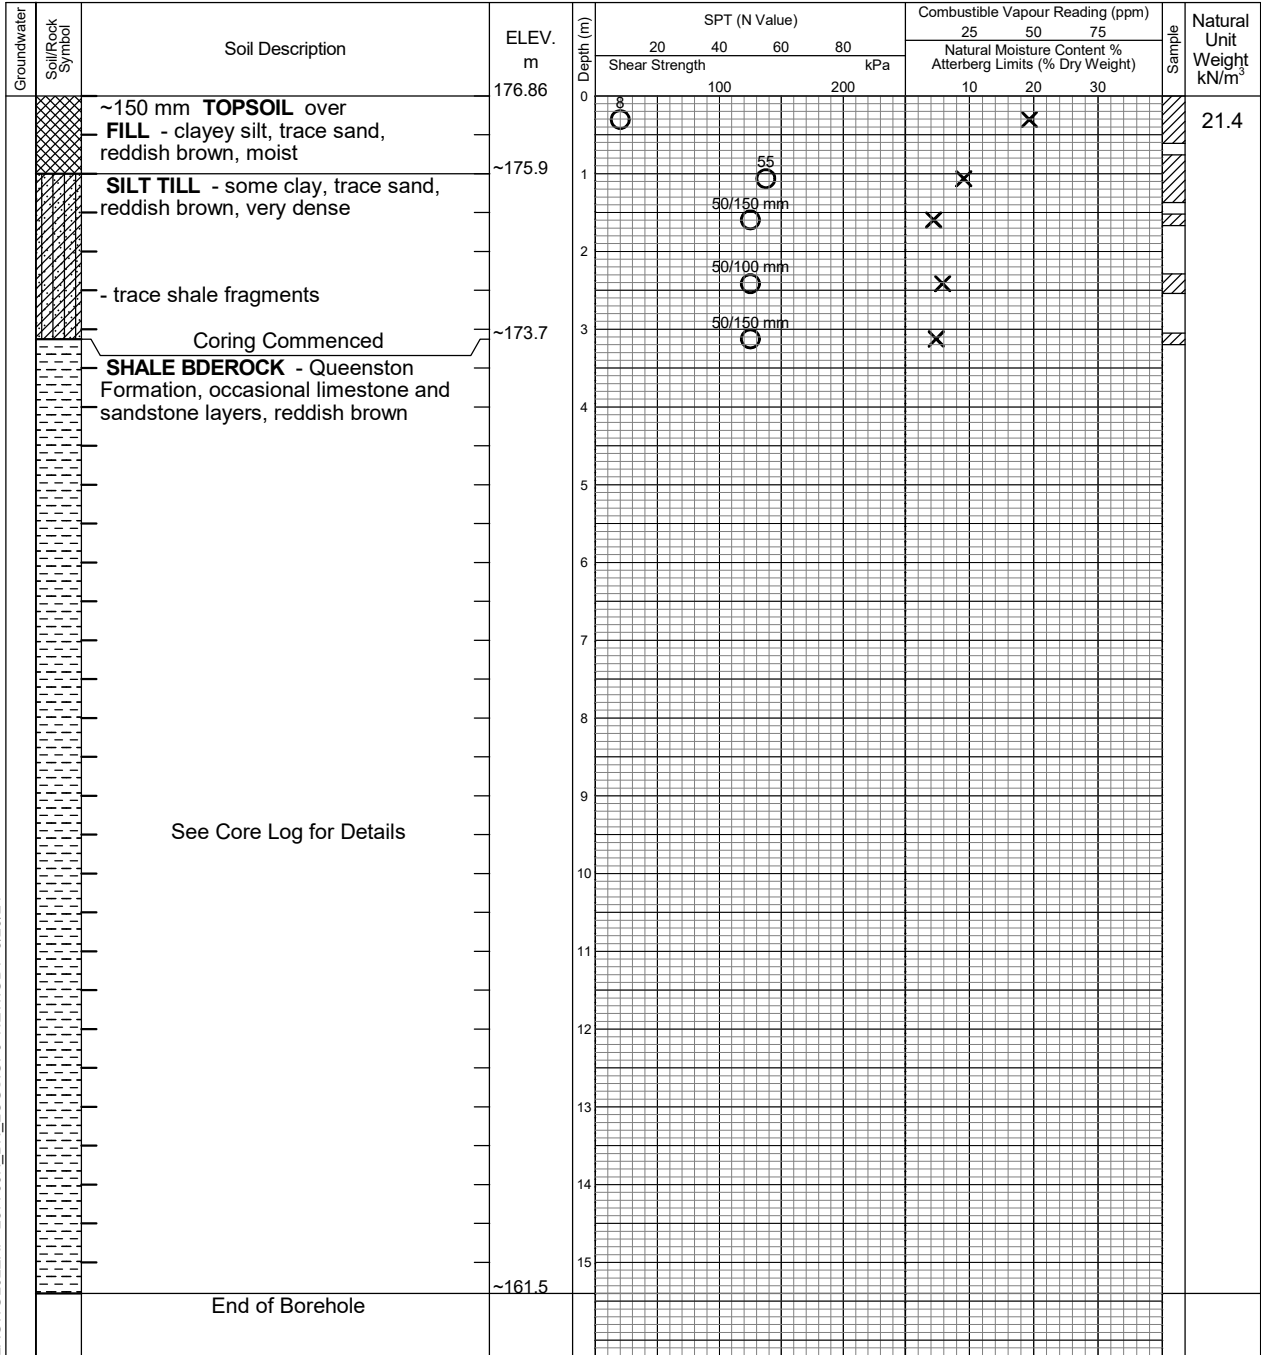
Notes:
 1. Borehole advanced to completion at ~15.4 m depth by conventional soil sampling methods using a specialist drilling subcontractor. For borehole definitions, see notes prior to logs.
 2. This drawing forms part of and must be read in conjunction with the subject report (Ref. No.: GTR-00257769-H0); borehole data requires interpretation assistance by exp professional staff before use by others.

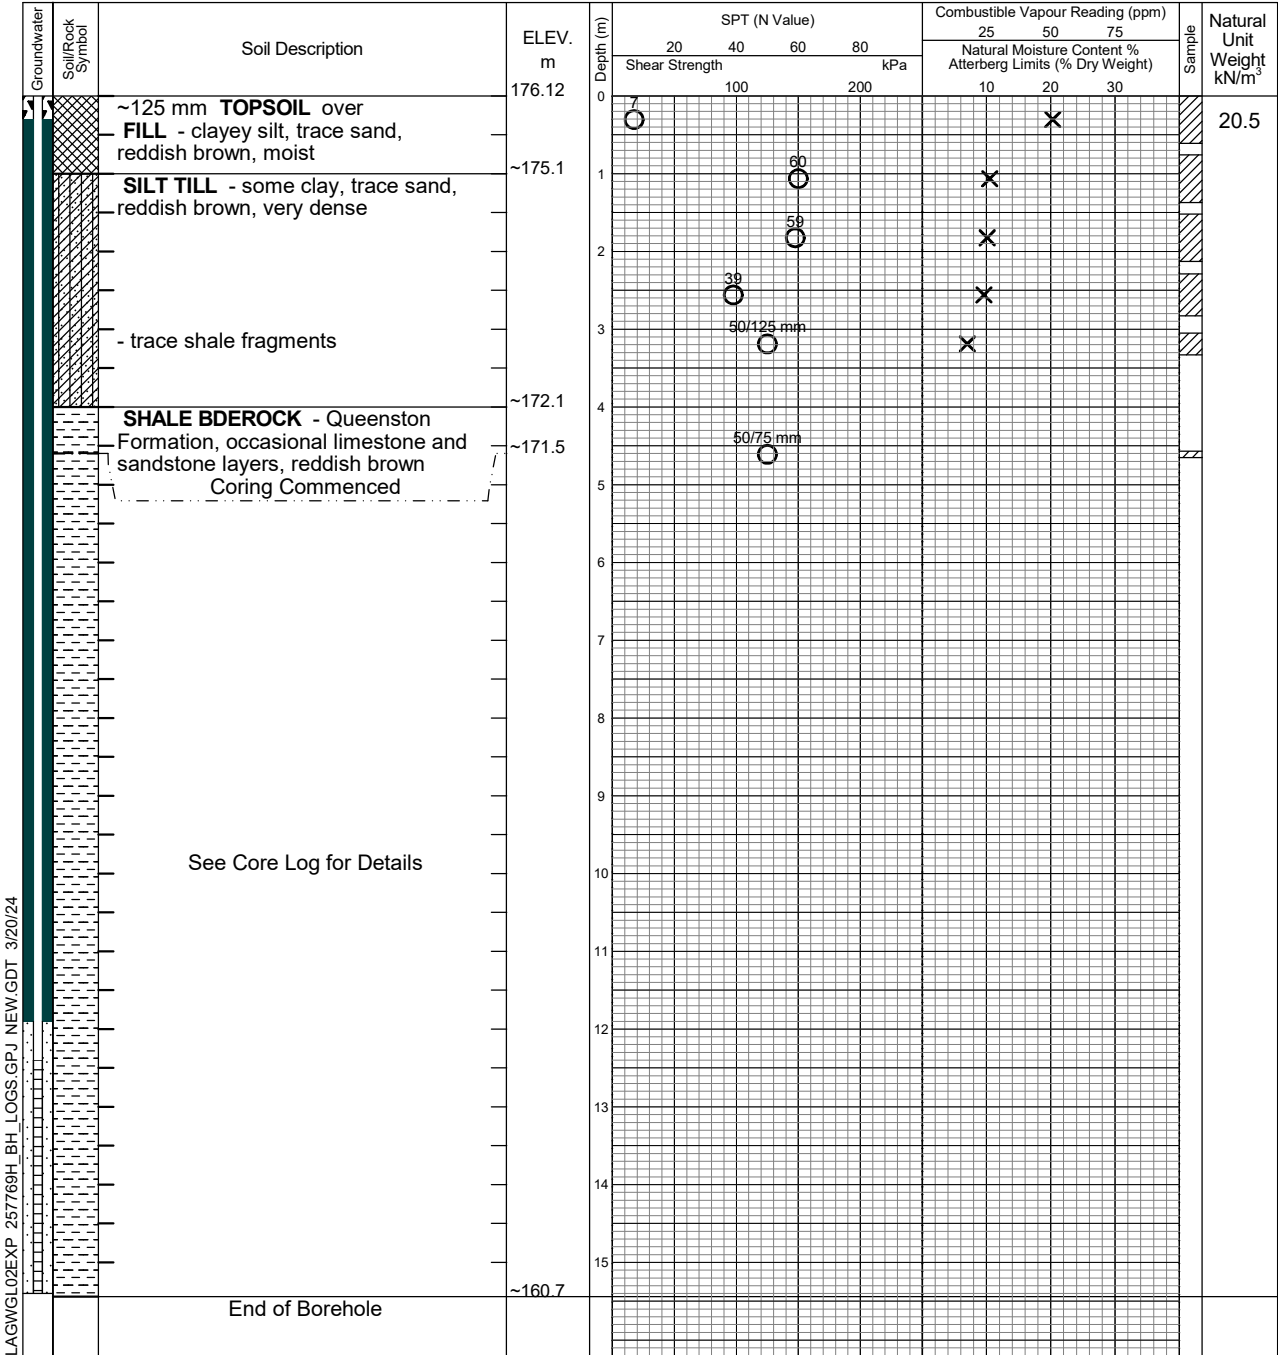
Notes:
 1. Borehole advanced to completion at ~15.4 m depth by conventional soil sampling methods using a specialist drilling subcontractor. For borehole definitions, see notes prior to logs.
 2. This drawing forms part of and must be read in conjunction with the subject report (Ref. No.: GTR-00257769-H0); borehole data requires interpretation assistance by exp professional staff before use by others.
