**Erin Mills Twon Centre  
Proposed Mixed-Use Development  
5100 Erin Mills Parkway, Mississauga, Ontario**

Geotechnical Investigation

GTR-00257769-H0

March 21, 2024

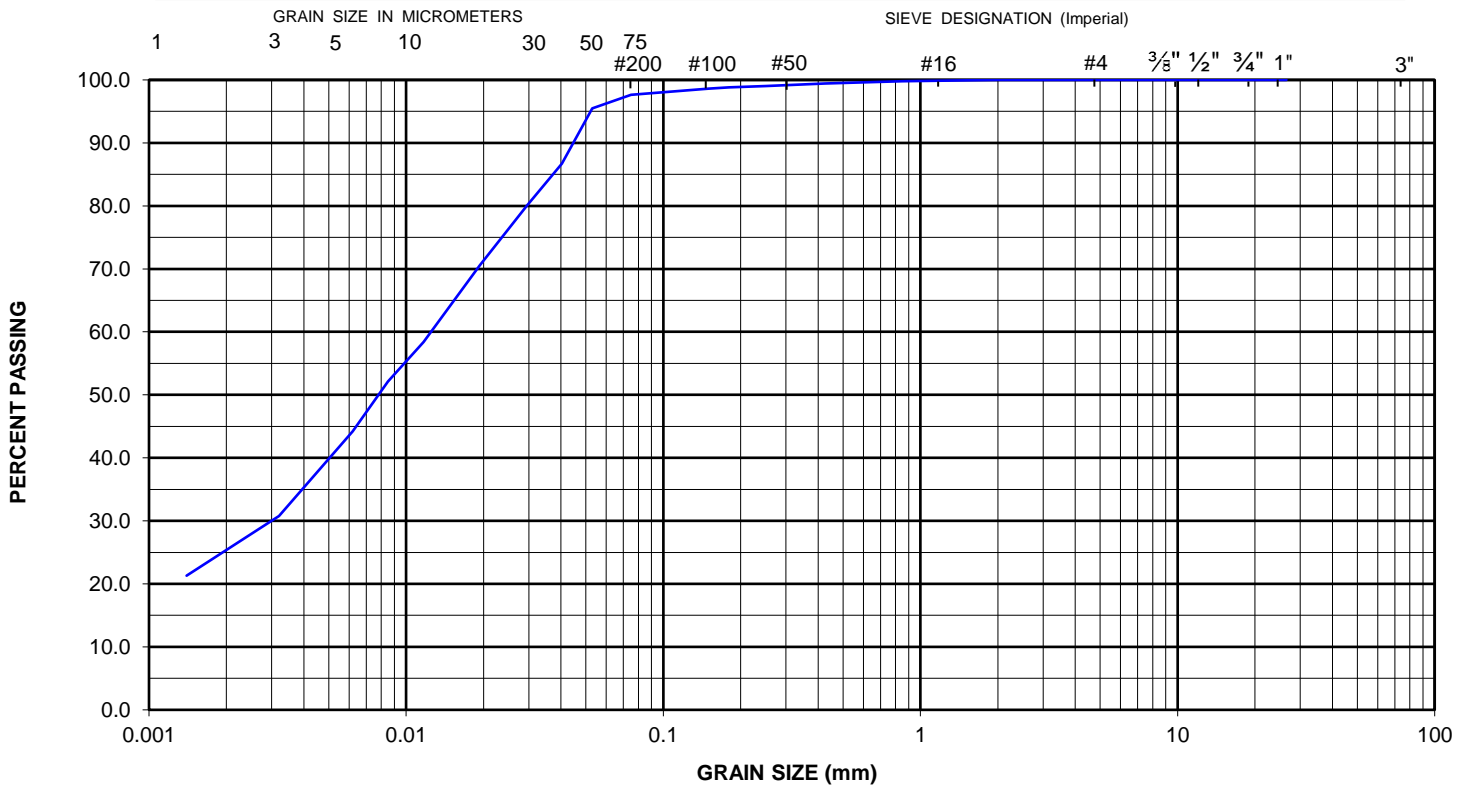
UNIFIED SOIL CLASSIFICATION SYSTEM

CLAY AND SILT	SAND			GRAVEL	
	Fine	Medium	Coarse	Fine	Coarse

Appendix A: Grain Size Analysis Results
