Phase One Environmental Site Assessment Update

3403-3445 Fieldgate Drive, Mississauga, Ontario
G2S24018A

Forest Glen Shopping Centre Ltd.
c/o Sajecki Planning Inc.
227 Pape Avenue,
Toronto, Ontario
M4M 2W3

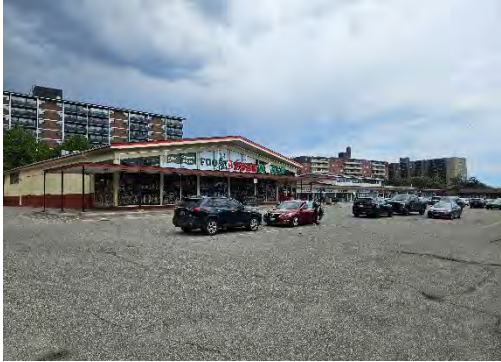
<p>Photo #1: A partial view of the south portion of Building 1.</p>	<p>Photo #2: A partial view of the north wall of Building 1.</p>

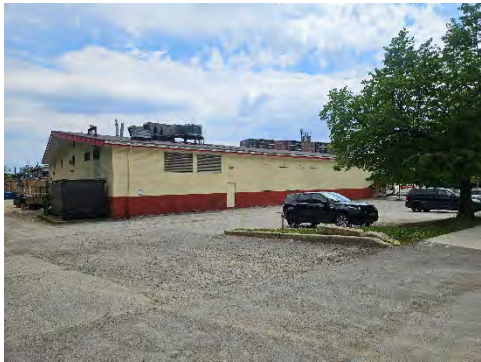
<p>Photo #3: The west wall of Building 1.</p>	<p>Photo #4: The east wall of Building 1.</p>

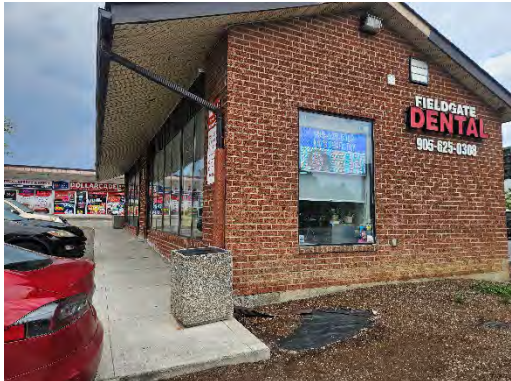
<p>Photo #5: The west and south walls of Building 2.</p>	<p>Photo #6: The north and east walls of Building 2.</p>
