**UPDATED PHASE ONE ENVIRONMENTAL SITE ASSESSMENT
PROPOSED REDEVELOPMENT
64 AND 66 THOMAS STREET,
95 JOYMAR DRIVE, AND 65 TANNERY STREET
MISSISSAUGA, ONTARIO**

Project: SP24-00306-00 (SP18-306-20-01)
December 18, 2024

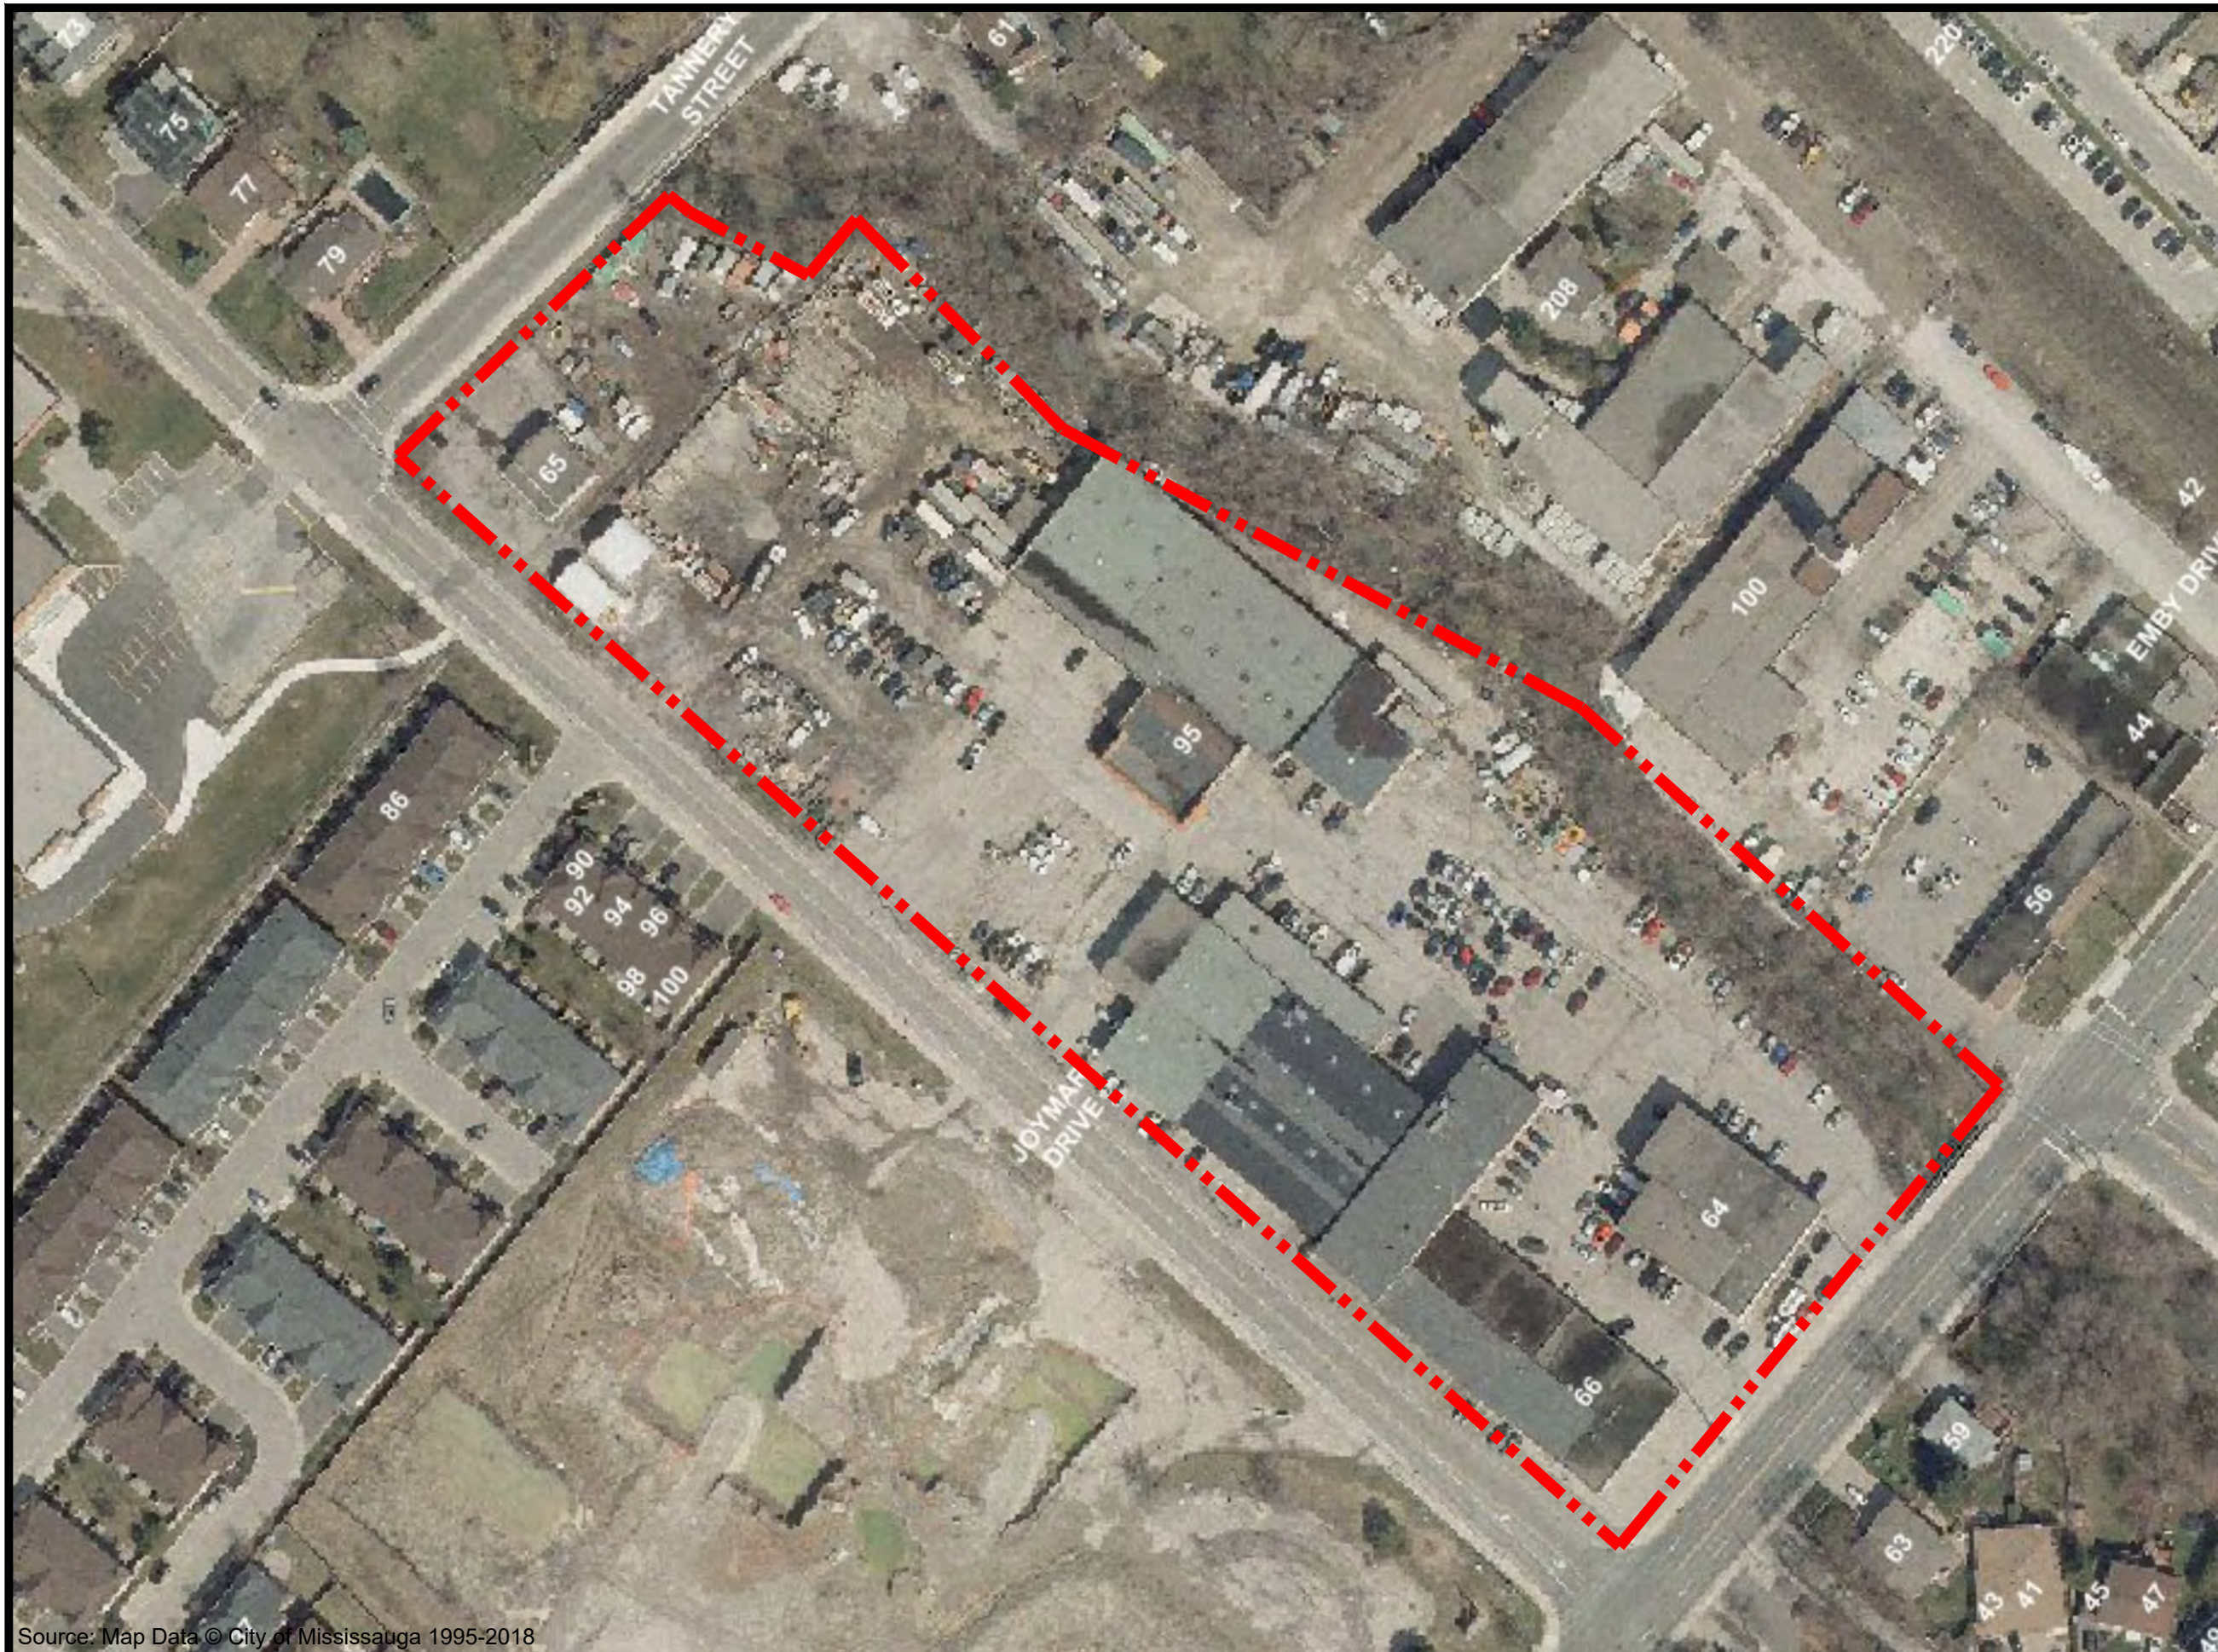
Figure Number:
 1

At the time of SIRATI's site visit, conducted on April 26, 2018, and December 18, 2024, the Property was used for commercial purposes. The Property location is shown in Figure 1.

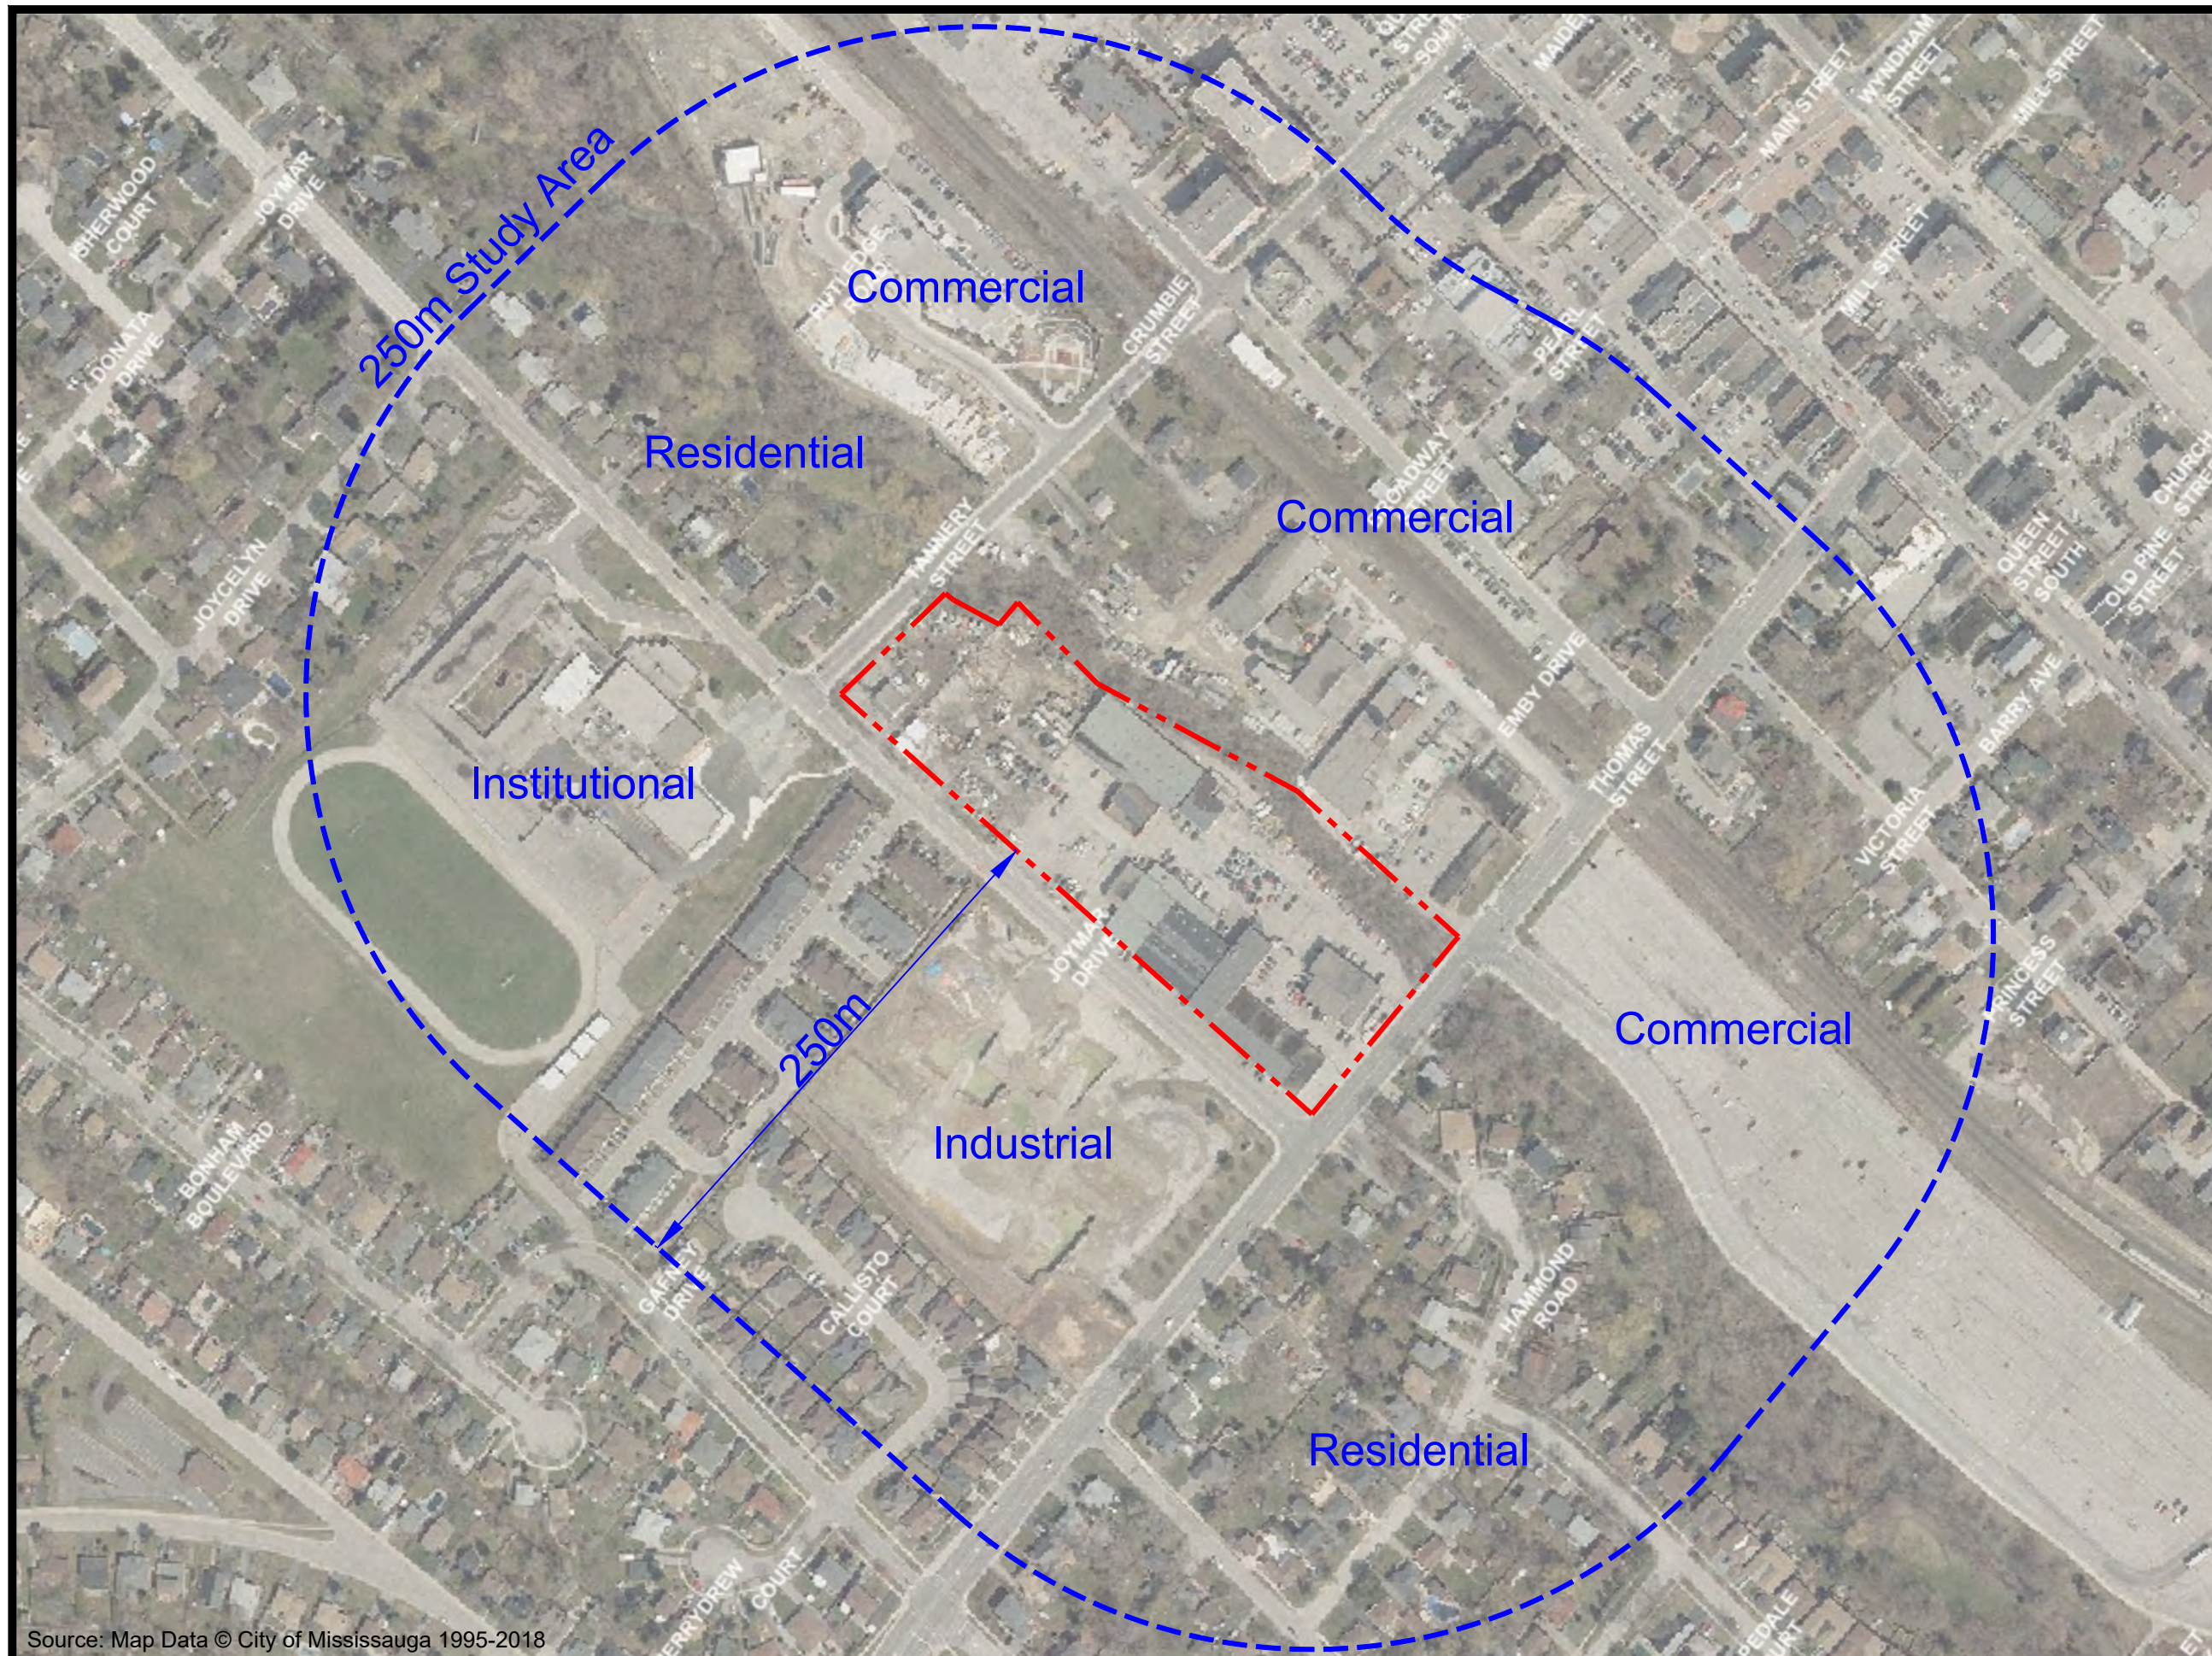
3

Properties located beyond 250 m of the Property boundaries were not included in the Phase One Study Area. The Phase One Study Area is presented in Figure 3.

The Property is bounded by Thomas Street to the southeast, Joymar Drive to the southwest, and Tannery Street to the northwest. The surrounding properties are mainly commercial and residential in land use (as shown in Figure 3).

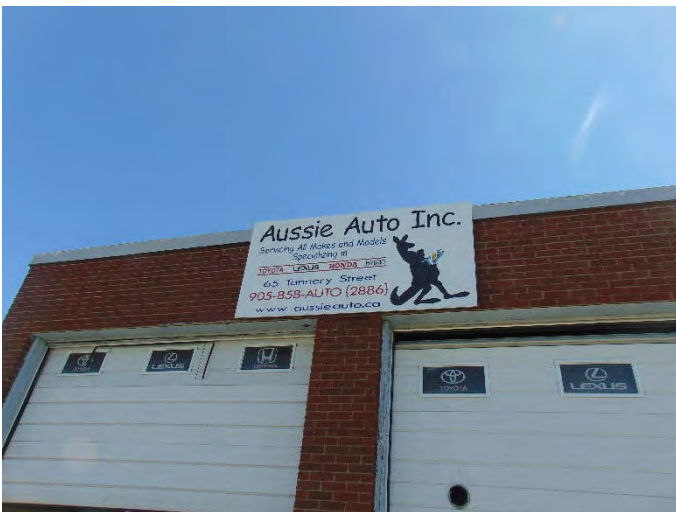
Photograph 3

Location: Phase One Property
Viewing: Southeast
Description: View of Aussie Auto Inc. (auto shop) located at 65 Tannery Street

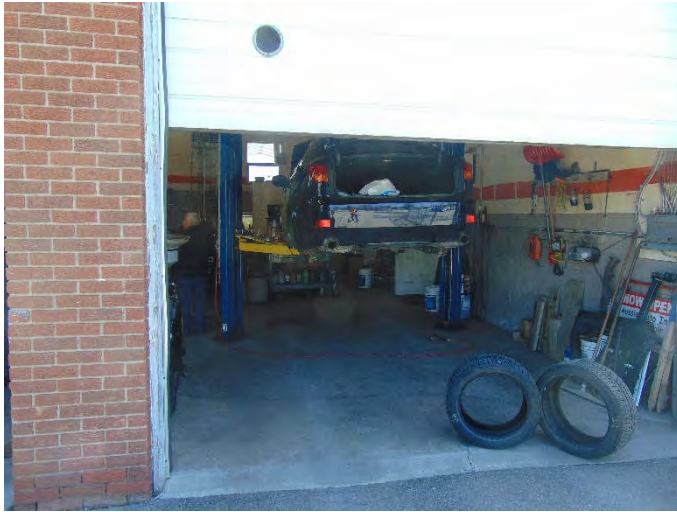
Photograph 4

Location: Phase One Property
Viewing: N/A
Description: View of the interior of the auto shop (Aussie Auto Inc.)

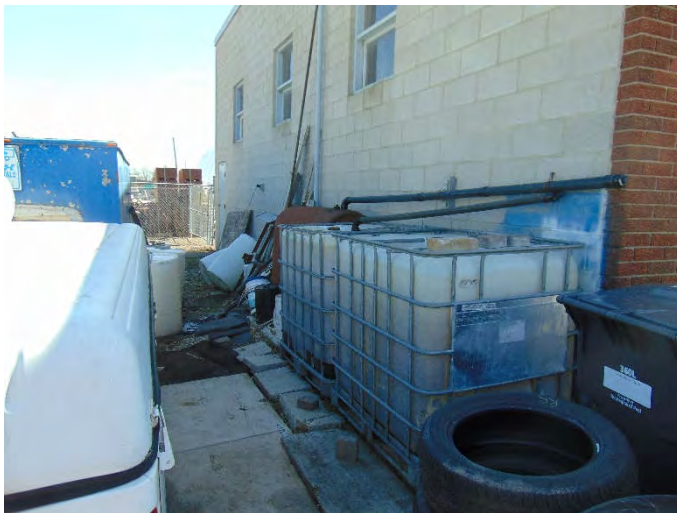
Photograph 5

Location: Phase One Property
Viewing: South
Description: View of the waste oil tank located adjacent to northeast wall of the building (Aussie Auto Inc.)

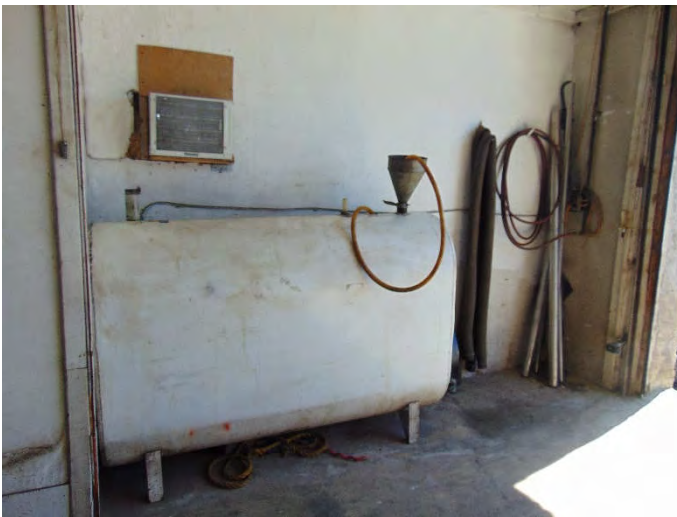
Photograph 14

Location: Phase One Property
Viewing: N/A
Description: View of the waste oil tank located near the bay door of the shop (J. Salema & Sons Auto Service Ltd.)

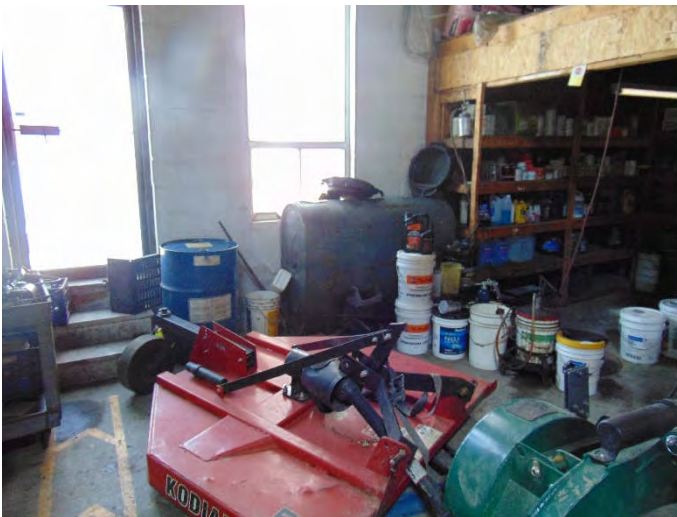
Photograph 17

Location: Phase One Property
Viewing: N/A
Description: View of the waste oil tank located in the west section of the shop (Turf Lawn Care & Maintenance Inc.)

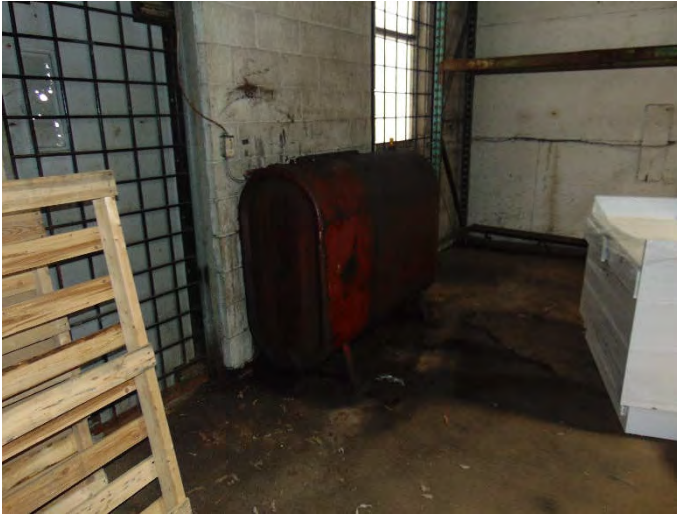
Photograph 19

Location: Phase One Property
Viewing: N/A
Description: View of the waste oil tank located against the northeast wall of the building (empty unit at 95 Joymar Drive)

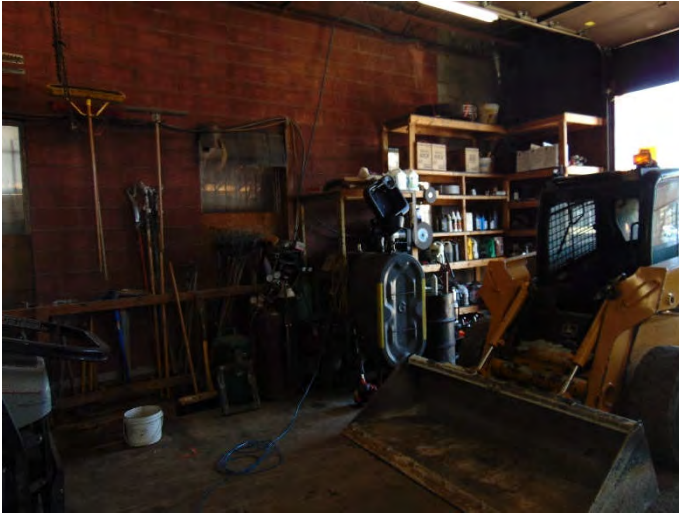
Photograph 22

Location: Phase One Property
Viewing: N/A
Description: View of the waste oil tank located next to the bay door of the shop (Cedar Grounds Maintenance Inc.)

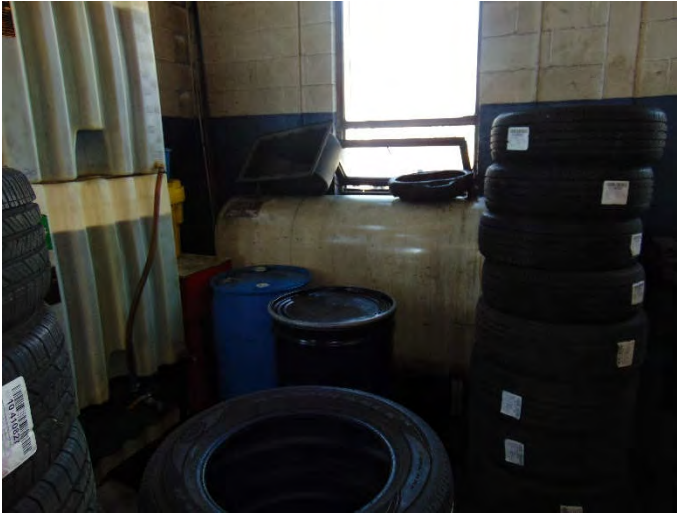
Photograph 25

Location: Phase One Property
Viewing: N/A
Description: View of the waste oil tank located at north corner of the shop (Streetsville Auto & Tire)

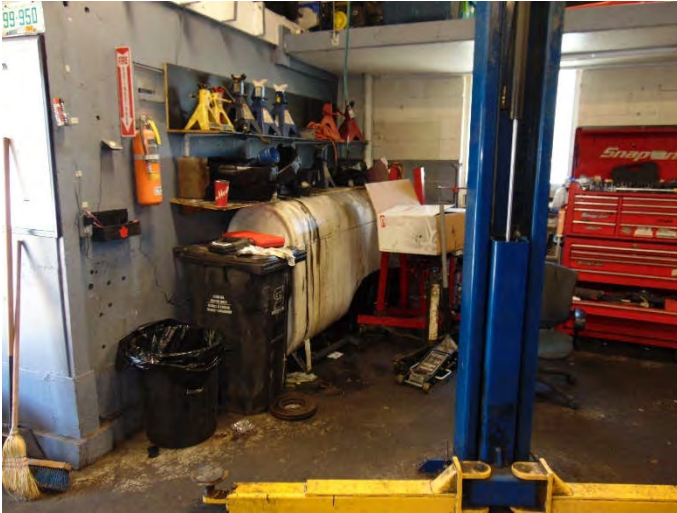
Photograph 28

Location: Phase One Property
Viewing: N/A
Description: View of the waste oil tank located at the north corner of the shop (Correct Automotive)

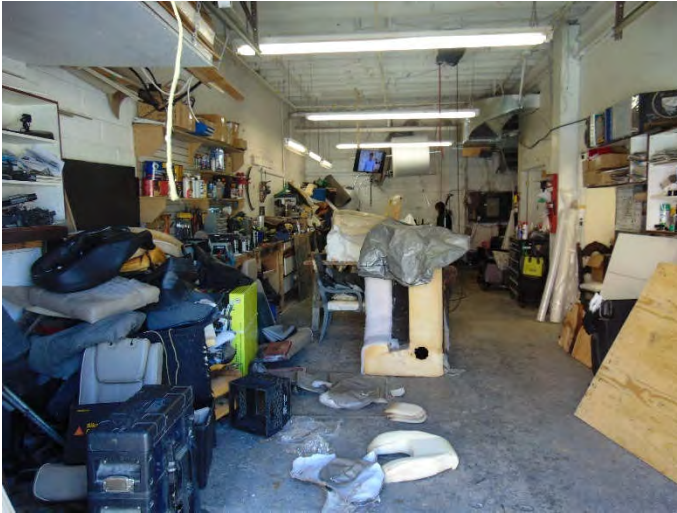
Photograph 30

Location: Phase One Property
Viewing: West
Description: View of Auto Glass and Custom Upholstery shop located at 66 Thomas Street

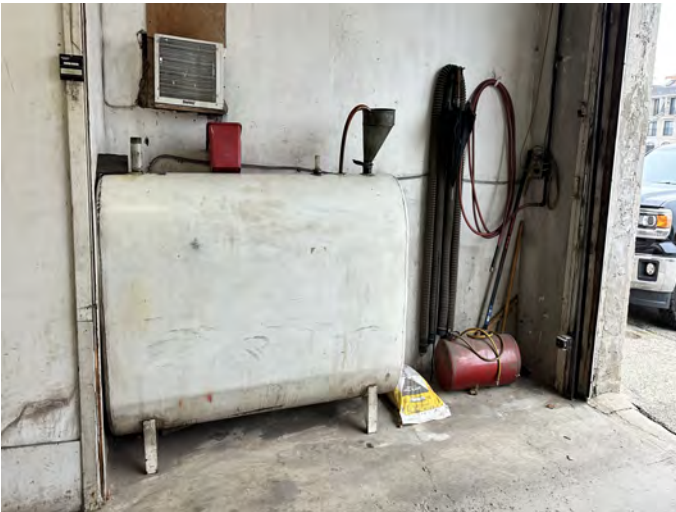
Photograph 14

Location: Update Phase One Property
Viewing: N/A
Description: View of the waste oil tank located near the bay door of the shop (J. Salema & Sons Auto Service Ltd.)

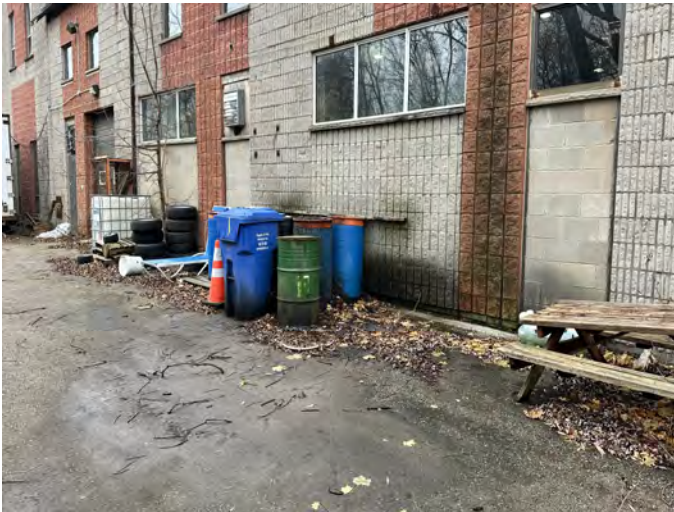
Photograph 17

Location: Update Phase One Property
Viewing: South
Description: View of the waste oil drums located in the back door of the shop (Turf Lawn Care & Maintenance Inc.)

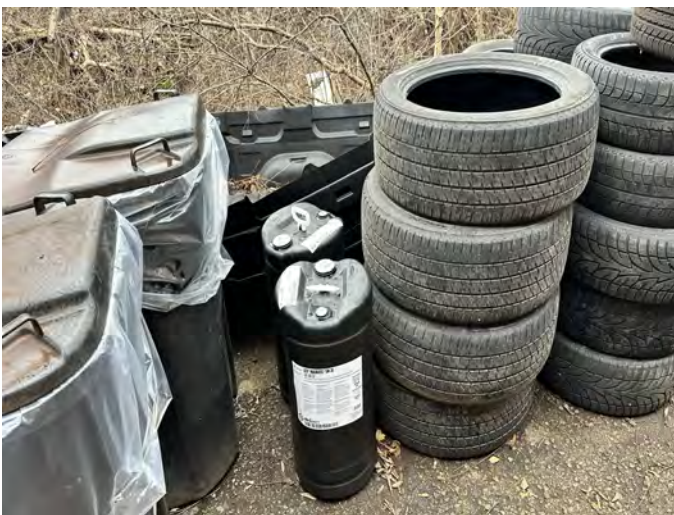
Photograph 18

Location: Update Phase One Property
Viewing: Northeast
Description: View of the waste oil Containers located near the back door of the shop (J. Salema & Sons AutoService Ltd.)

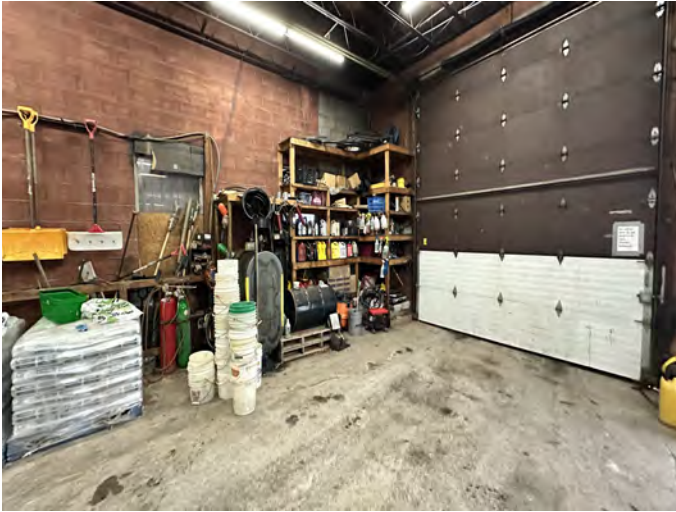
Photograph 22

Location: Phase One Property
Viewing: N/A
Description: View of the waste oil tank located next to the bay door of the shop (Cedar Grounds Maintenance Inc.)

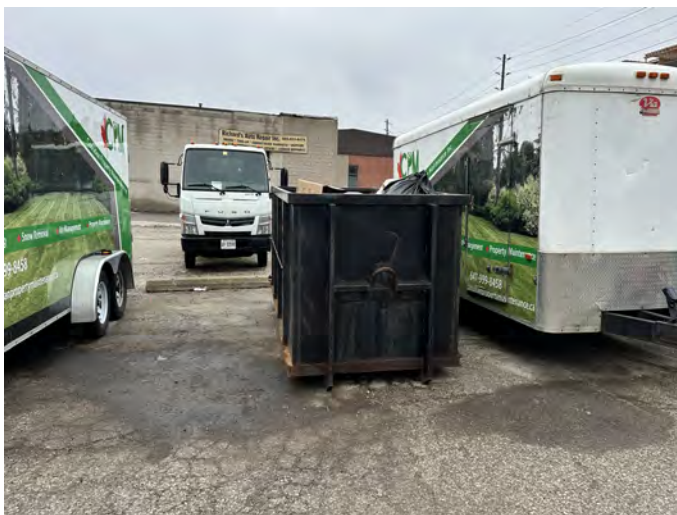
Photograph 24

Location: Phase One Property
Viewing: Southeast
Description: View of the bin at the center of the site and oil stains were observed on the ground and around the bin.

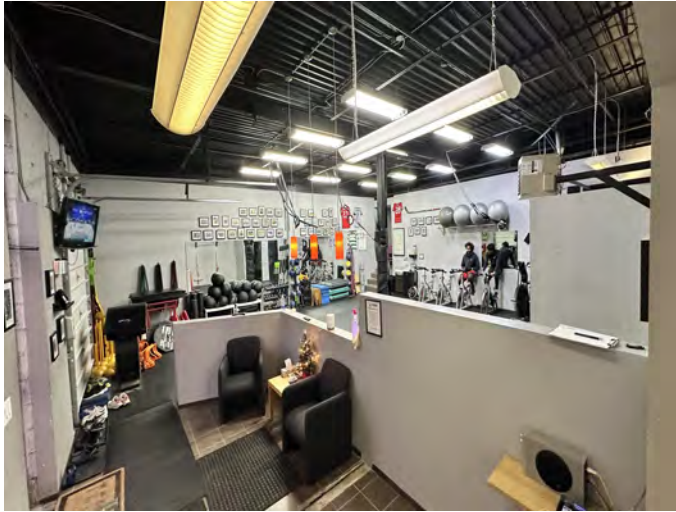
Photograph 30

Location: Phase One Property
Viewing: West
Description: View of the fitness and athletics Training at 66 Thomas Street. In 2018, this unit operated as an Auto Glass and Custom Upholstery shop.

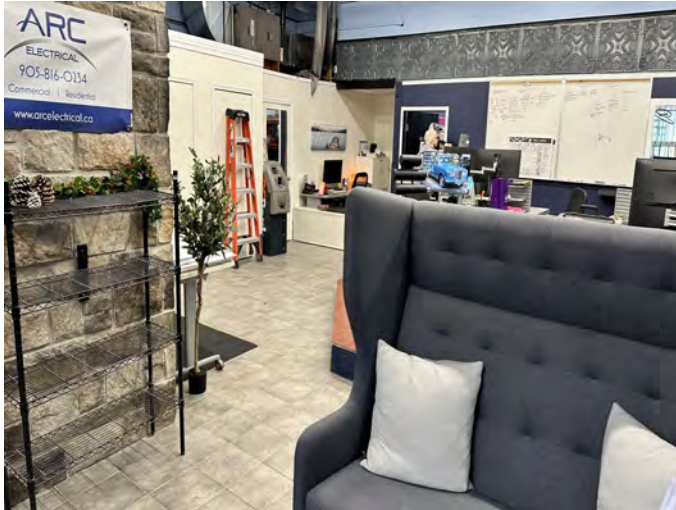
Photograph 33

Location: Update Phase One Property
Viewing: Northwest
Description: View of the ARC Electrical, located at 66 Thomas Street. In 2018 this unit was Malefic Tattoos.
