# Arborist Report

## 51 & 57 Tannery Street and 208 Emby Avenue City of Mississauga

*Prepared For:*  
**NYX Tannery LP**

*Prepared By:*  
**Beacon Environmental Limited**

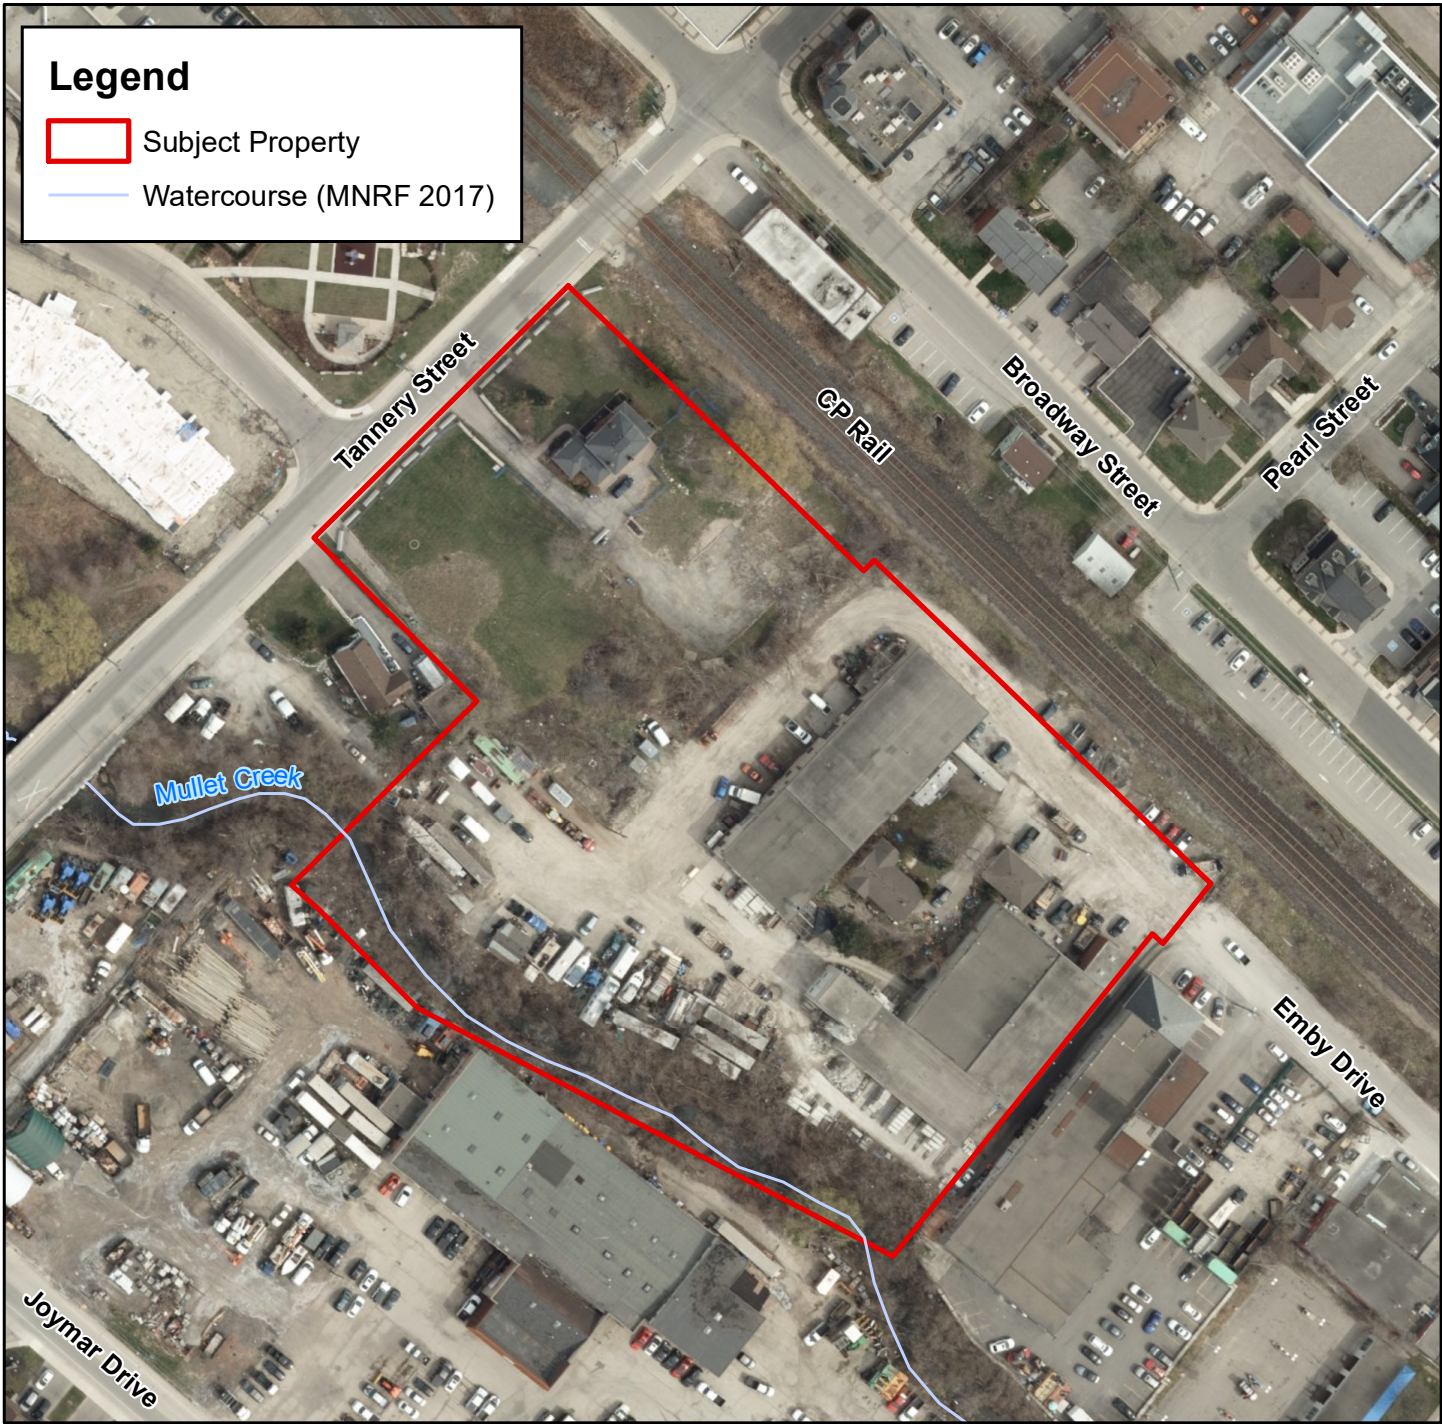
**Photograph 1. Tree 467 (March 2024)**

In addition, one tree (#467), located on adjacent private property, is recommended for removal due to poor structural condition and potential risk. One trunk leans toward the subject property and the other leans over a garage on the adjacent property. The tree exhibits branch and leader dieback,

broken/hanging branches, large patches of missing bark, and extensive trunk decay (**Photograph 1**). Permission from the adjacent property owner must be obtained in order to remove the tree.
