**Tree Inventory and Preservation Plan
&
Ravine Rehabilitation Stewardship Plan Report
2570 – 2590 Argyle Road
Mississauga, Ontario**

11 May 2023; revised 4 July 2023

KUNTZ FORESTRY CONSULTING INC. Project P3714

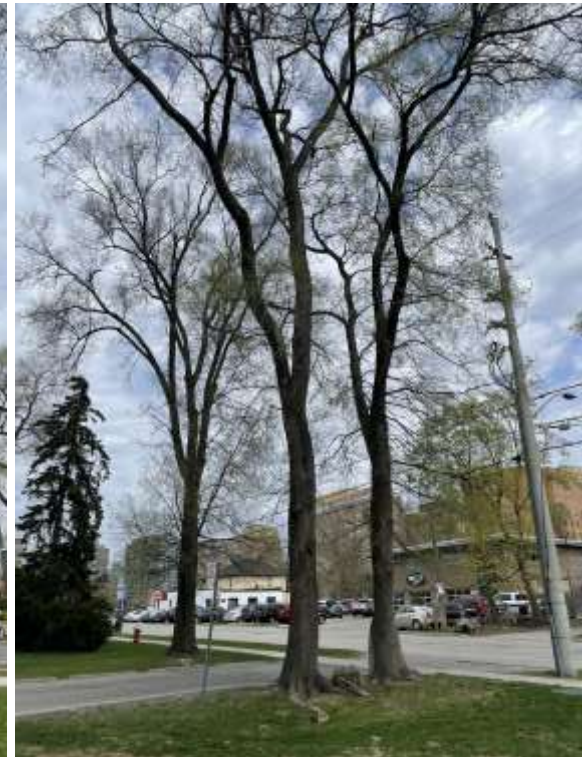
Image 5. From left to right, Trees 490, 488, and 489

Encroachment into the mTPZs of Trees 106, 116, 127, 490, 495, 1357, 1358, 1361, 1363, 1390, 1396, and 1398 will be required to accommodate the removal of existing hardscape (i.e. asphalt surface parking areas and walkways), and in some areas, the removal and replacement of existing hardscape. If the following mitigation measures are employed, long-term adverse effects are not anticipated for these trees.

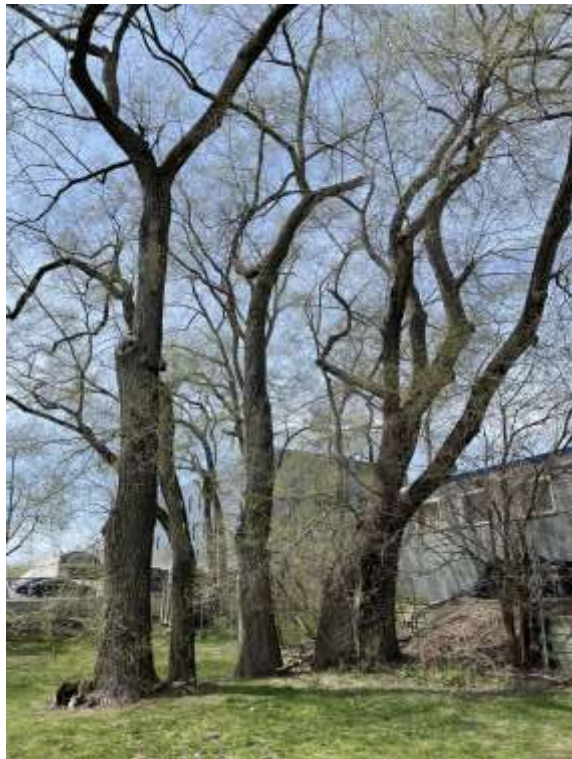
Image 11. From left to right, Trees 499, 500, 1350 – 1352

The removal of three additional trees is recommended regardless of the proposed development due to their poor condition. Trees identified for removal due to their condition include Trees 484, 494, and 1351.
