ARBORIST REPORT AND TREE PRESERVATION PLAN

1148 and 1154 Mona Road
Mississauga, ON

2 August 2024, revised 25 March 2025

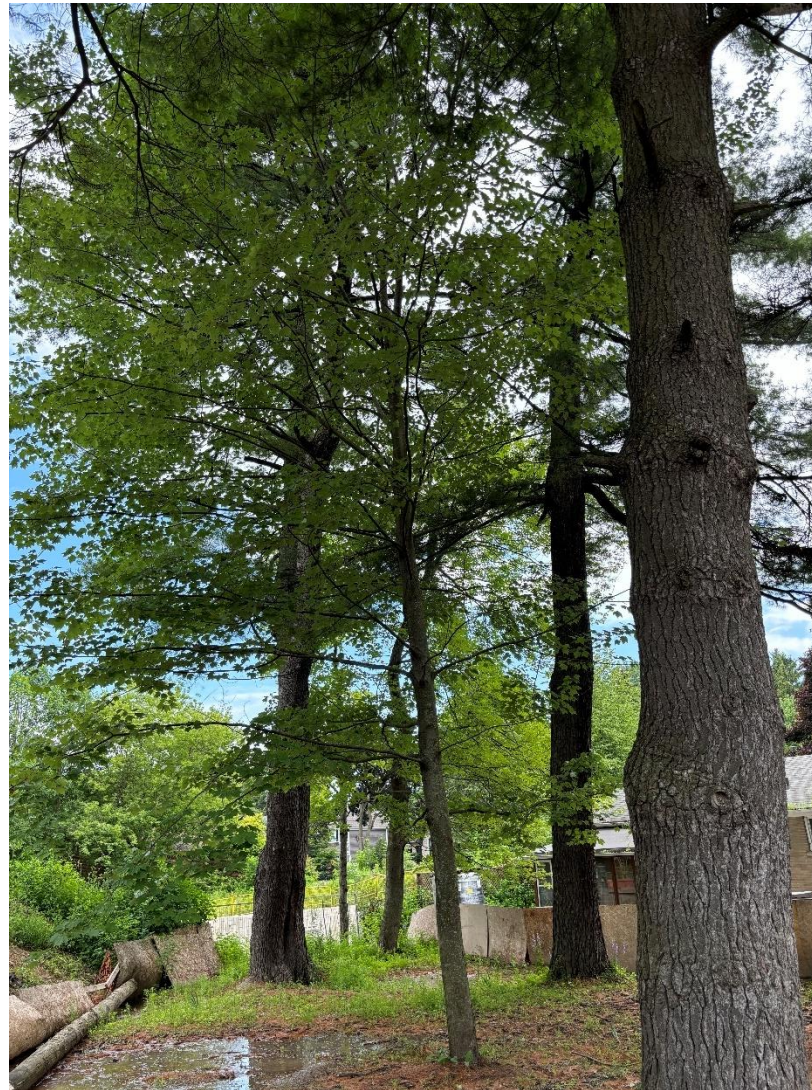
Photo 6. Tree 13 (centre, foreground), view looking north

Trees 1, 2, and 6 to 8 will require removal to accommodate the excavation for the proposed townhouse foundations and/or the acoustic barrier. Trees 11 to 23, 28, 29, 31 and 33 will require removal to accommodate the proposed buildings and/or new paved surfaces (road, driveways, walkways).
