Hydrogeological Investigation

3403-3455 Fieldgate Drive, Mississauga, Ontario
G2S24018D

Sajecki Planning Inc.
227 Pape Avenue
Mississauga, ON
M4M 2W3

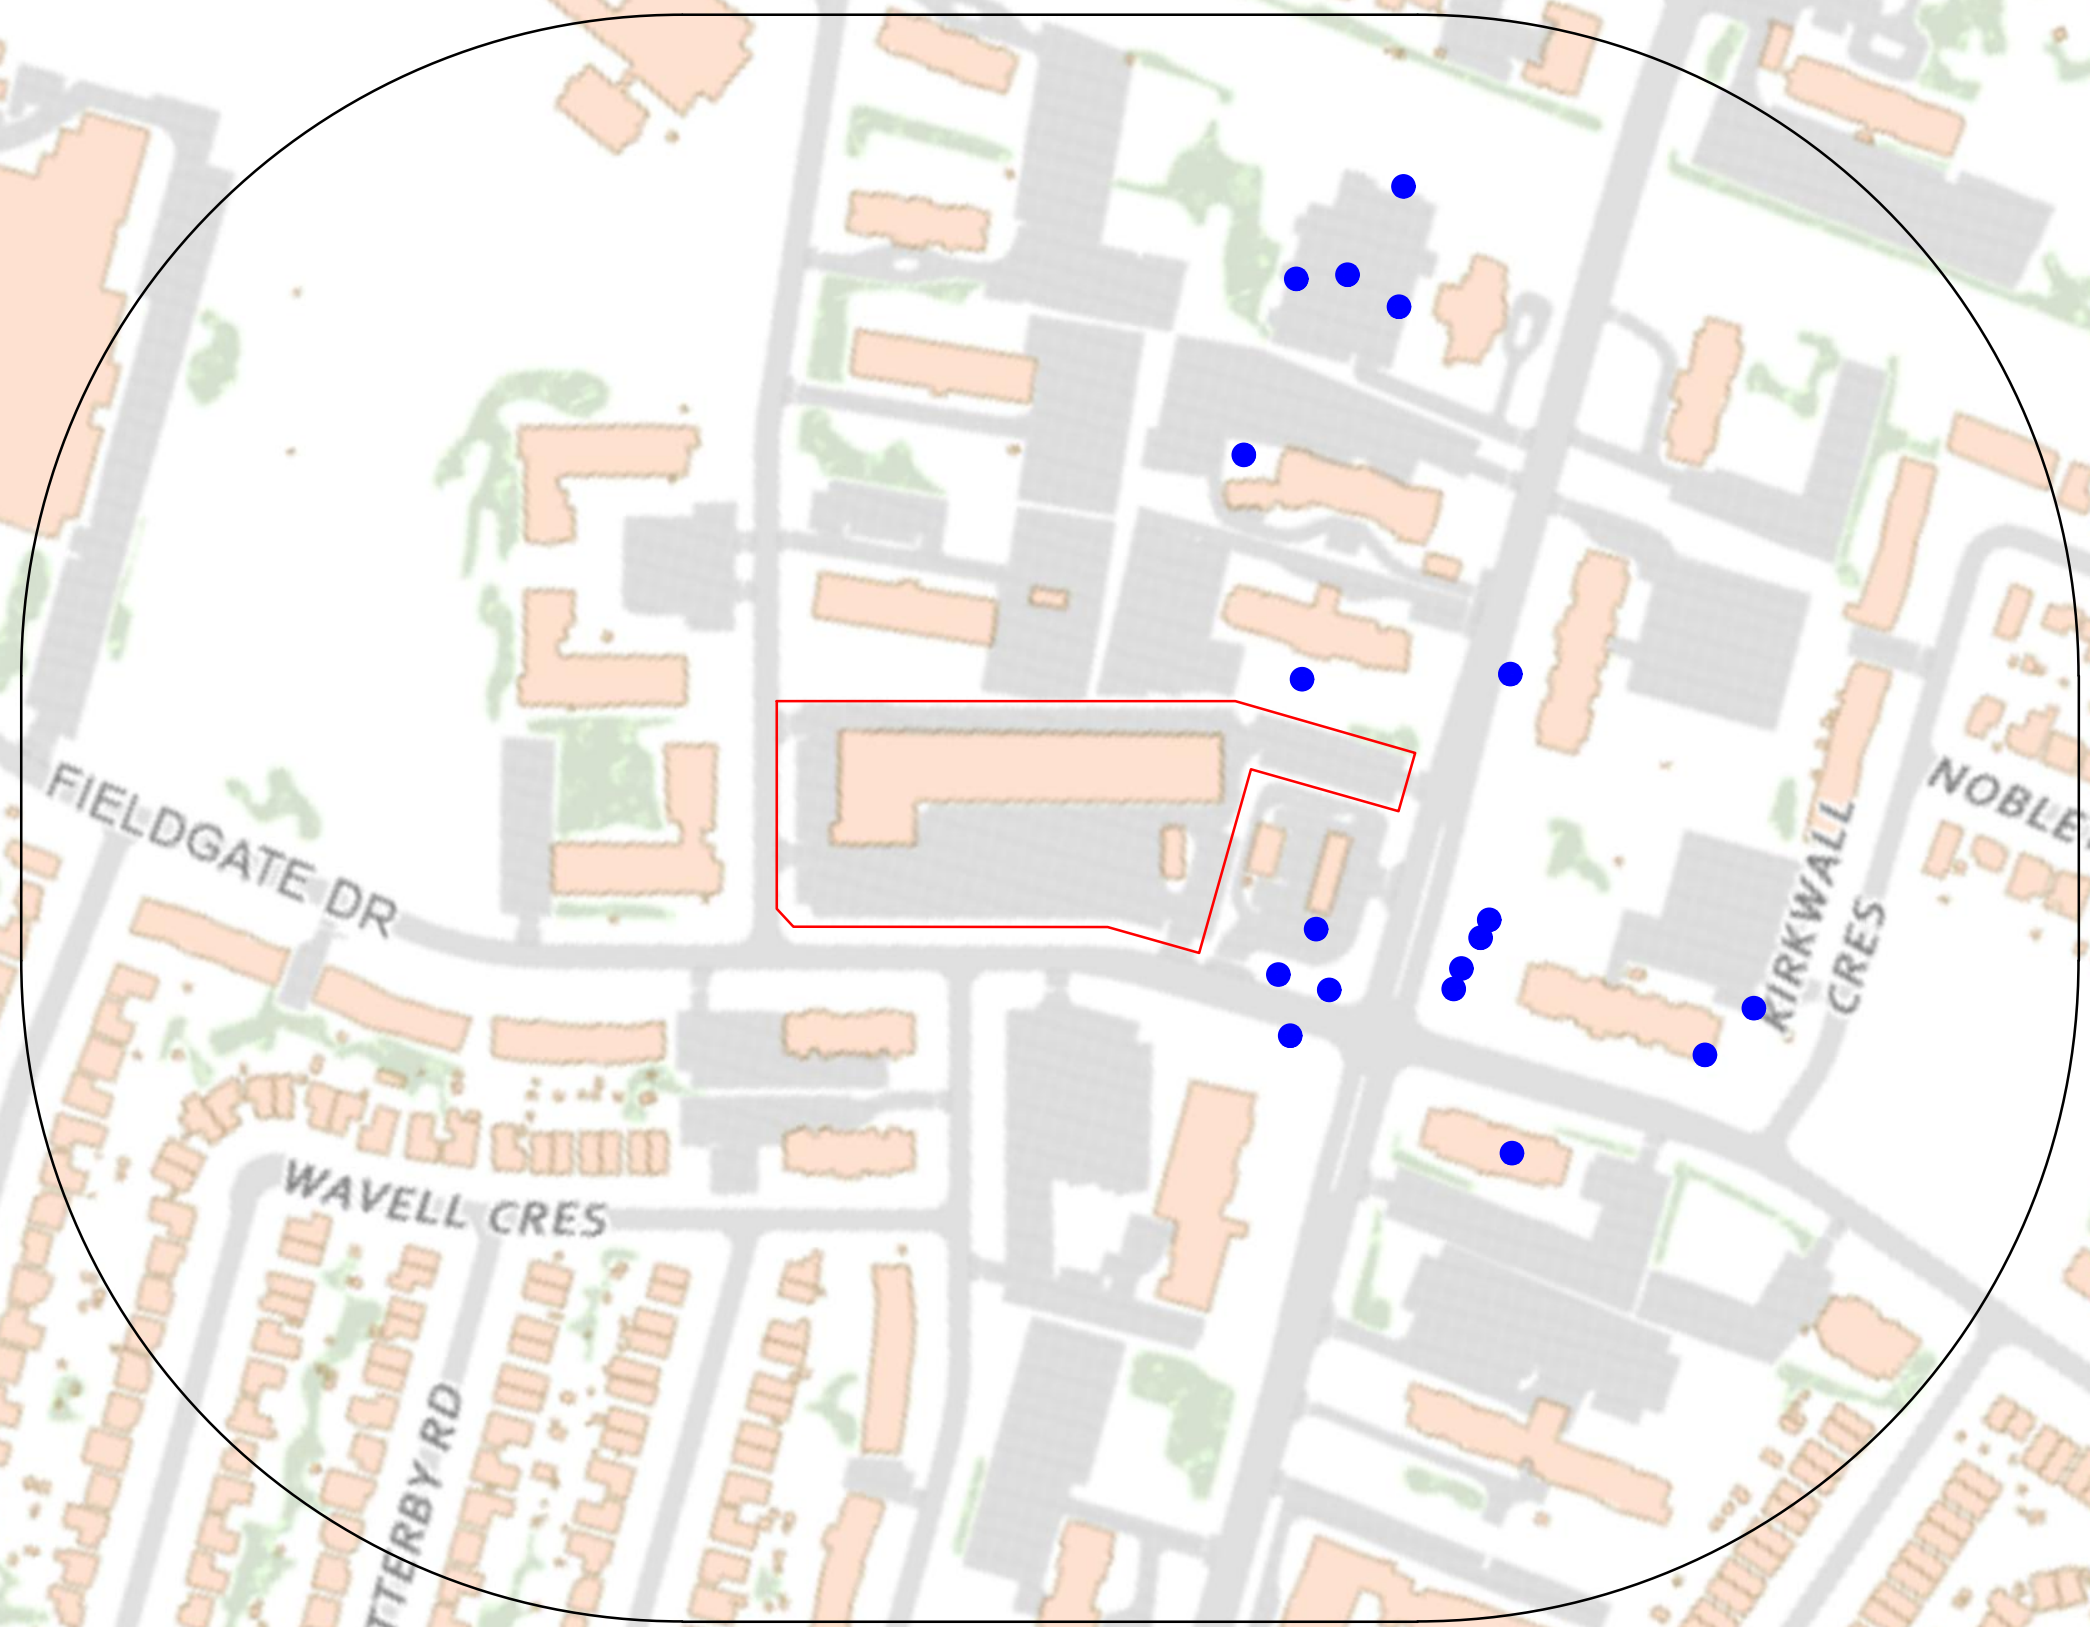
- LEGEND**
- APPROXIMATE SITE BOUNDARY
 - APPROXIMATE 250 m RADIUS STUDY AREA
 - APPROXIMATE WATER WELL LOCATION BASED ON MECP WELL RECORD MAP

REFERENCE:
DRAWING REPRODUCED USING CITY OF MISSISSAUGA AND MECP WELL RECORD MAP
